SAFE WOOD PELLET STORAGE WORKSHOP

Case Studies on Major Incidents that Resulted from
Runaway Self-Heating Consequences and Lessons
Learnt

Presented by John Swaan – Operations Expert-FutureMetrics

Daigas Case Study: Silo Fire at Sodegaura Biomass Power Plant

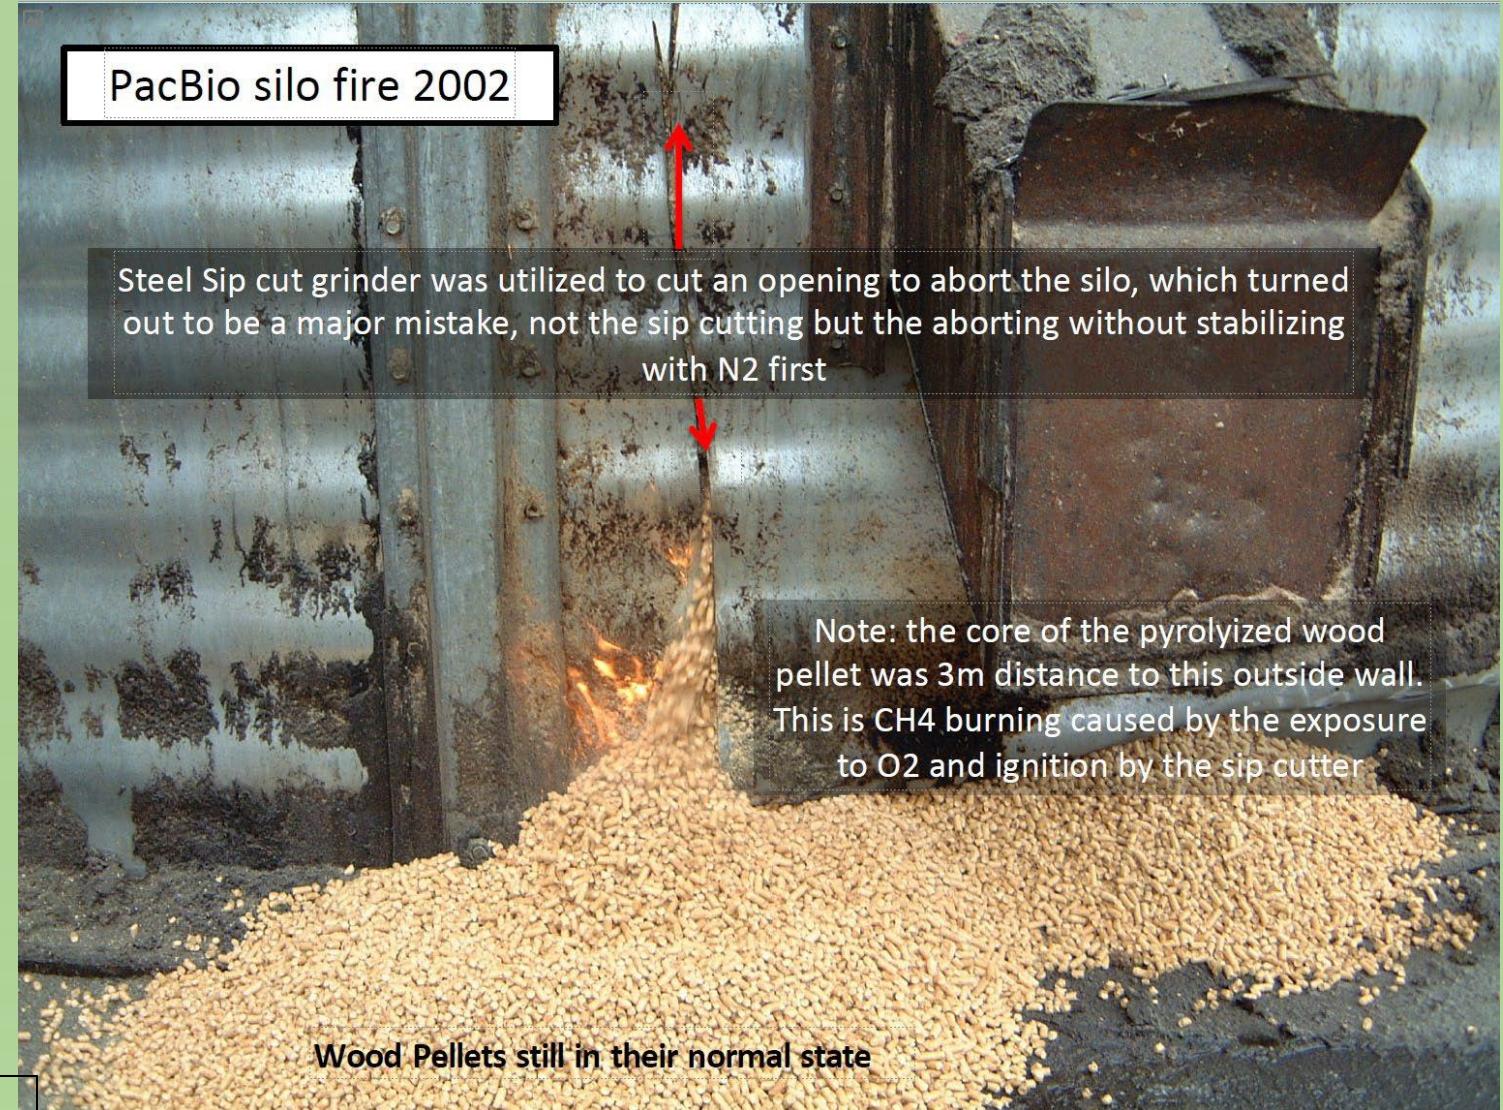
“First Experience” – 2002

CAUSE OF THE FIRE – EXTERNAL HOT MATERIAL

So what caused the explosion???

- Pyrolysis of the smoldering pellet generate CH4, CO, CO2, H2 gases.
- Lowering (aborting) the level of wood pellets in silo down to the smoldering pellets allowed O2 to make contact with the smoldering pellets releasing CH4 causing the ignition and subsequent explosion.
- Smoldering pellets glue together and become clumps that cause bridging and blockage when aborting the silo

- Wood Pellet Fire incidents MUST be stabilized before aborting a silo and/or warehouse

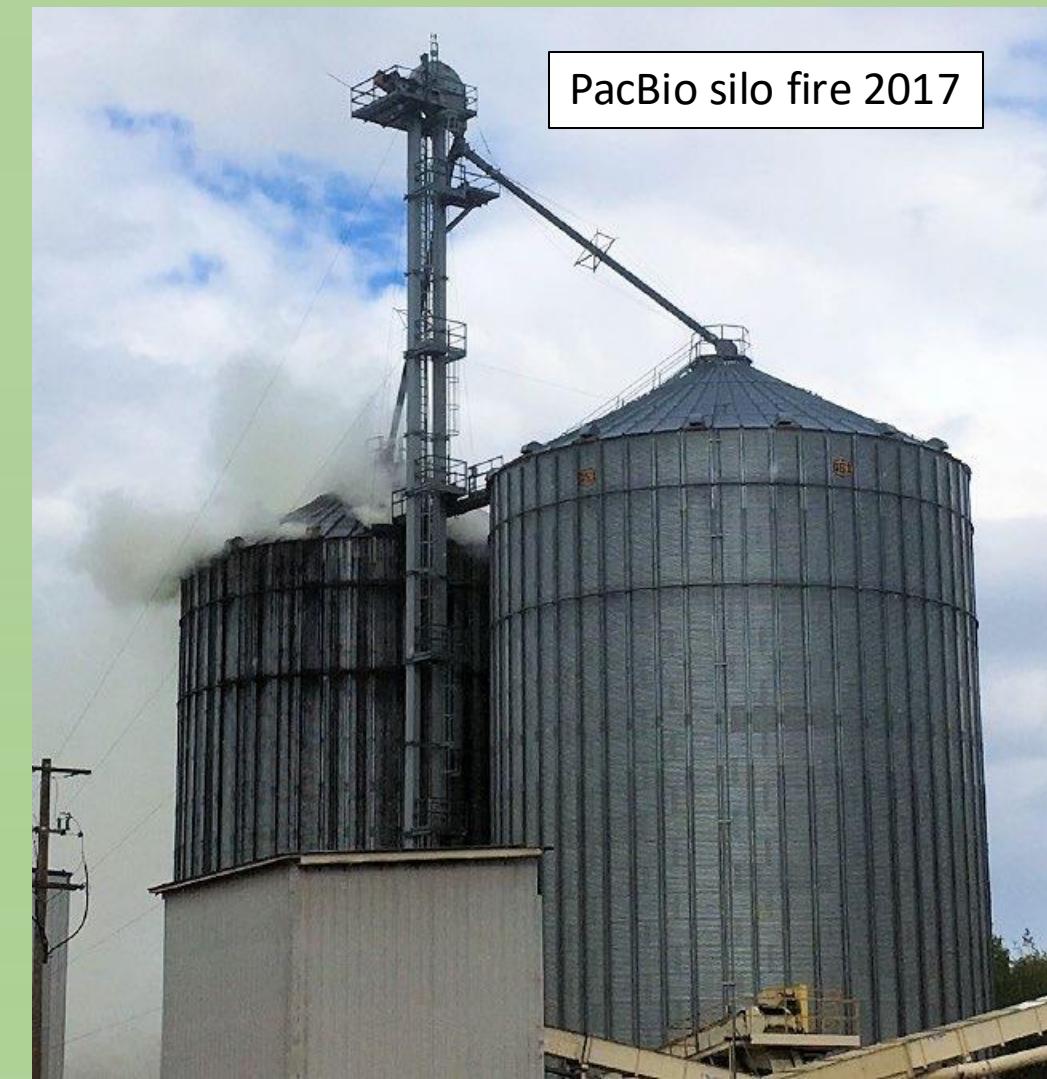
“Second Experience” – 2017

CAUSE OF FIRE – BELIEVED TO BE SELF-HEATING

Concluding results of the Swedish Research were followed and a safe outcome was the result. NO injury's or loss of life and NO loss of assets.

- Research at the Swedish SP Technical Institute conducted experiments and produced a report “Silo Fires” by Henry Persson on how to correctly deal with wood pellet silo fires.
- Best practices for dealing with wood pellet fire incidents found N2 injection to be the most effective to stabilize the smoldering pyrolysis of the pellets before safely discharging silo's, minimizing personnel danger and damage to the silo(s) and/or surrounding facilities.
- Volume and flow rates for N2 injection were also calculated and verified.
- Restricting O2 and injecting N2 into the silos head space proved to have positive results, although utilizing medium or high density foam spray was identified as an option to assist with N2 losses from the top of the silo and potential fire.

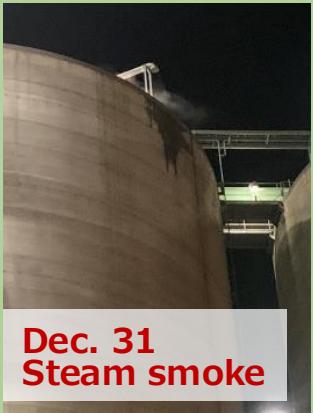
Dec. 31
Steam smoke

White smoke was observed from A1 and B1 silos of the 4 silos.

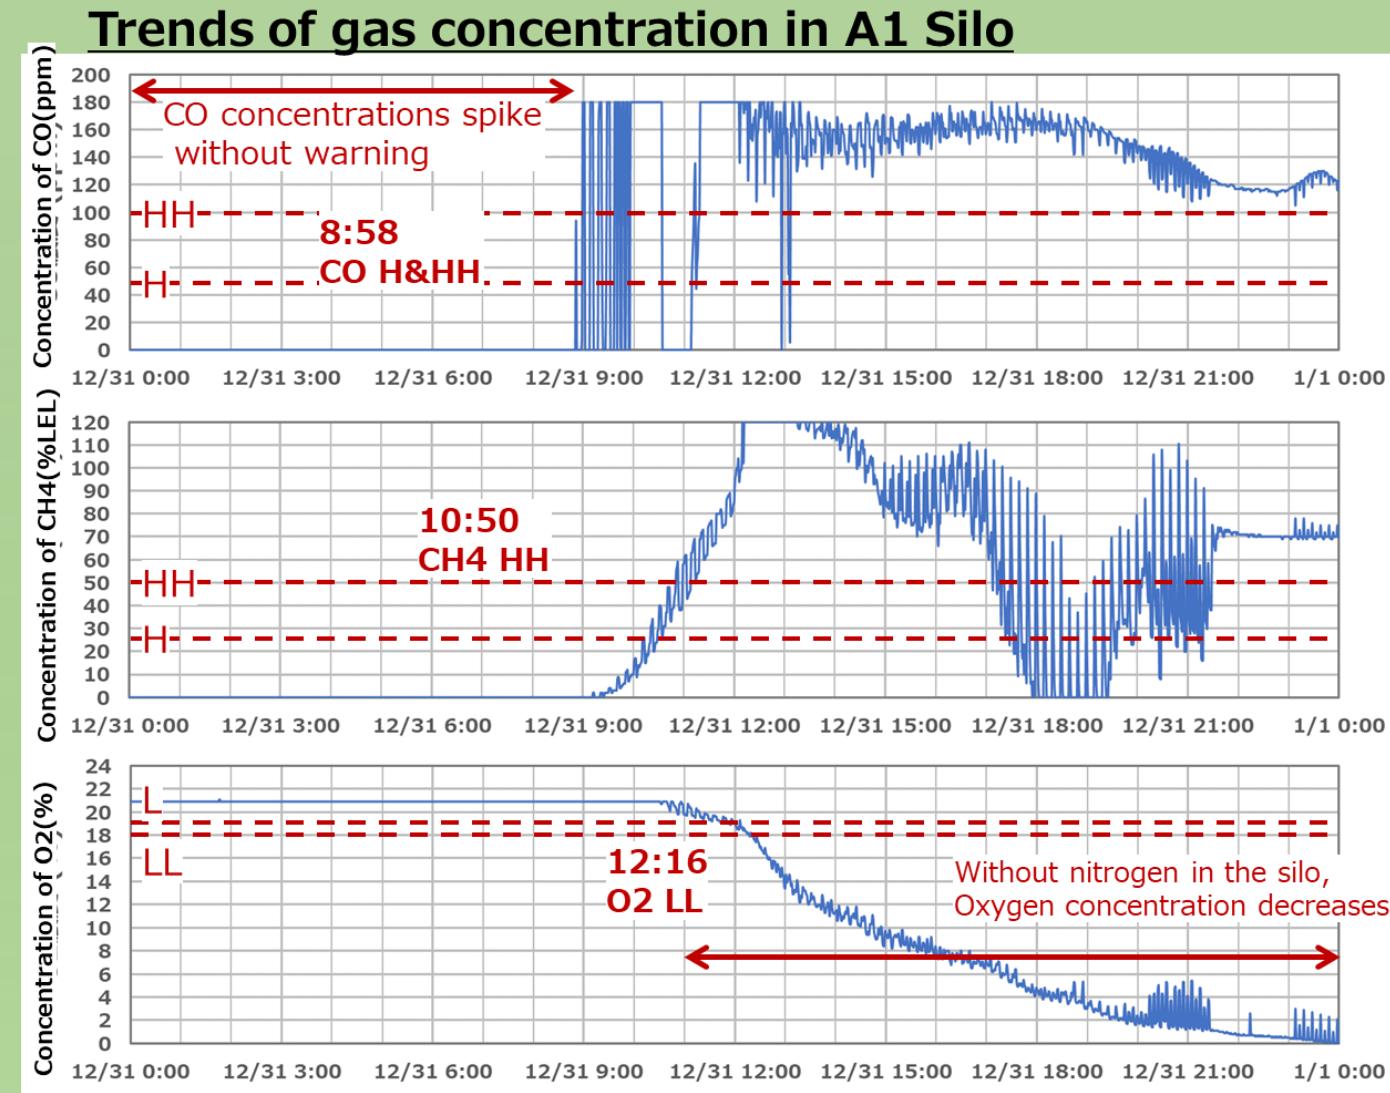
Background of the smoldering fire

● Suddenly the gas concentration increased on 31st Dec. 2022.

- Wood pellets had been stored in the silos for 6 months, because of the troubles on power plant commissioning.
- Temperature and gas concentrations in the silos had been monitored.
- Continuous ventilation had been performed to reduce CO concentration.

- Suddenly the gas concentration increased on 31st Dec. 2022.
- Temperature in the silos had been showing normal temp.

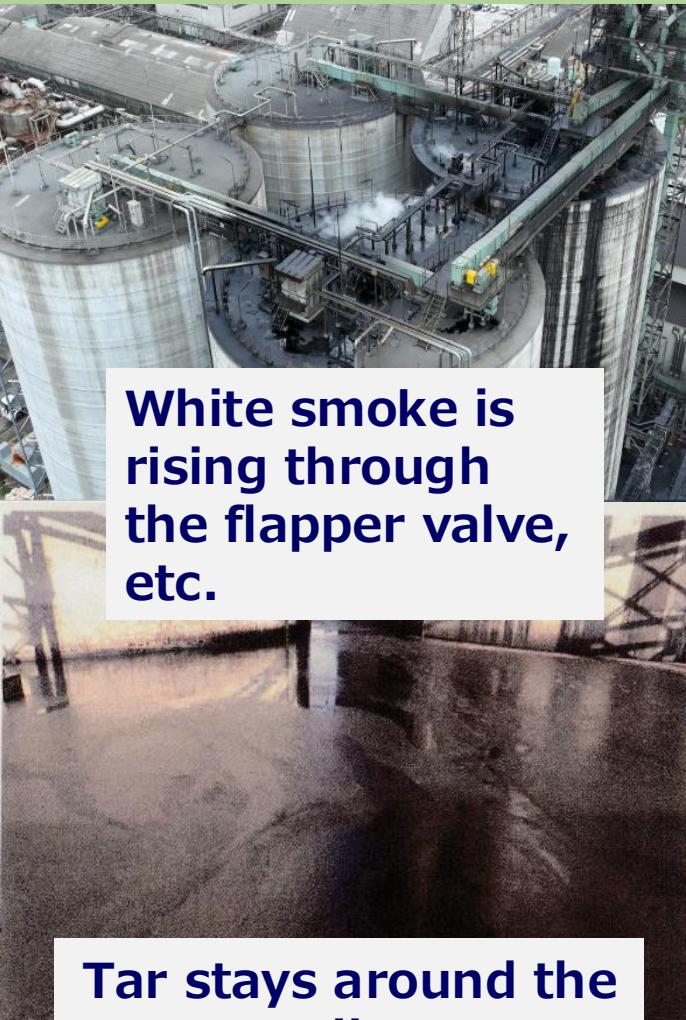
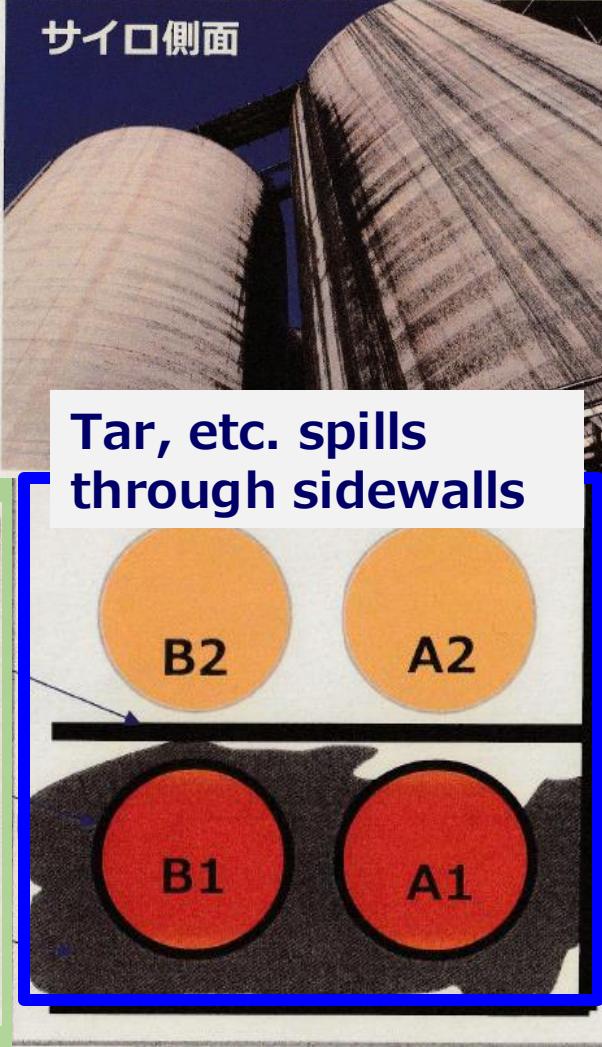
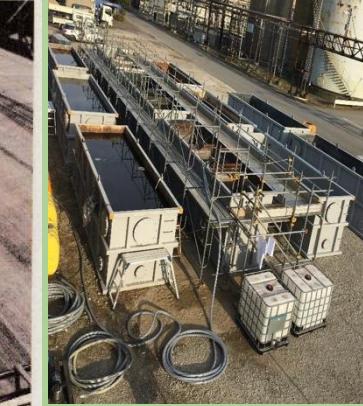
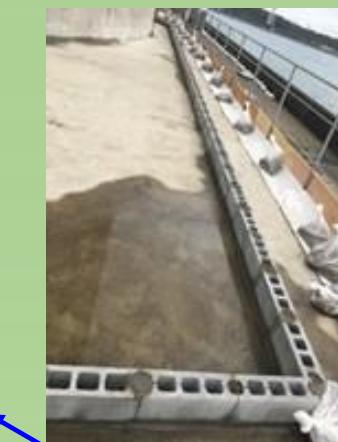
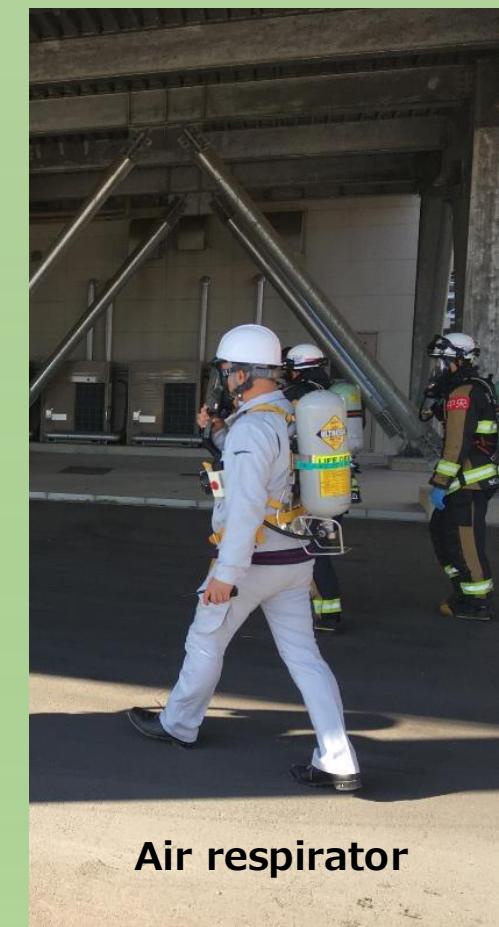
Condition of silo after fire

- White smoke was generated from the tops of the A1 & B1 silos, and tar adhered to the tops and walls of the silos and the surrounding area, causing an odor. In addition, the area around the silos became a high CO concentration environment, which greatly hindered firefighting activities.

5	<ul style="list-style-type: none"> Prevention of tar and wastewater runoff 	<ul style="list-style-type: none"> Review of water collection methods in silo area (prevention of external runoff) Preparation of treatment methods for tar-containing wastewater

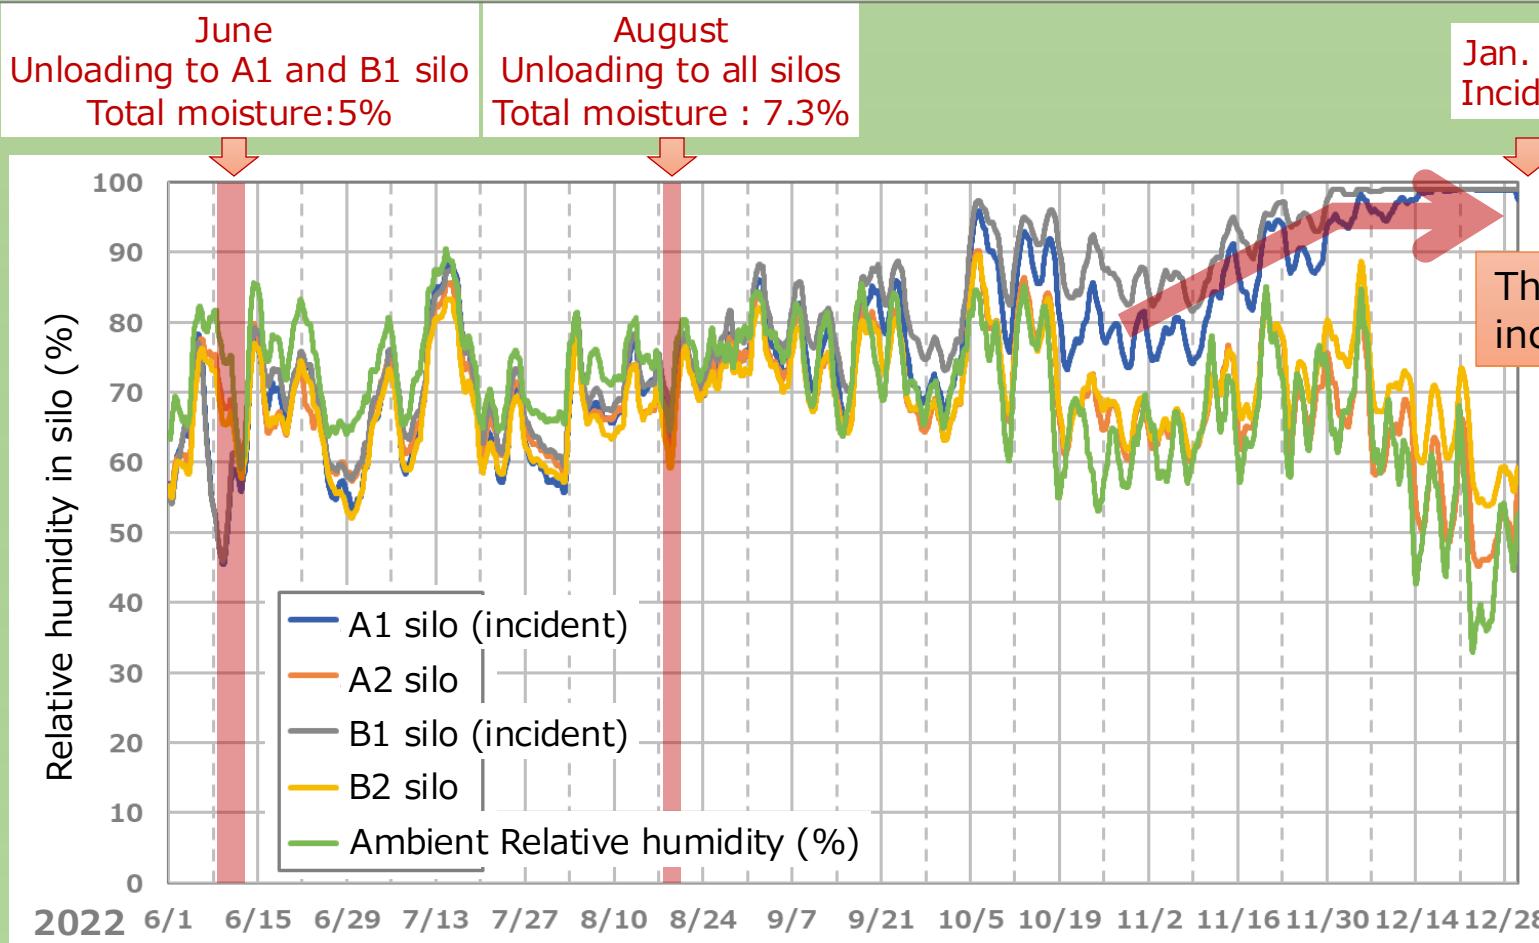
Humidity History in Silos

No signs of moisture entering from the outside → humidity increased caused by self-heating of wood pellets in the silo.

The relative humidity only increased in the incident silos.

Note : The gas concentration and bulk temp. did not detect any abnormal values until the incident occurred.

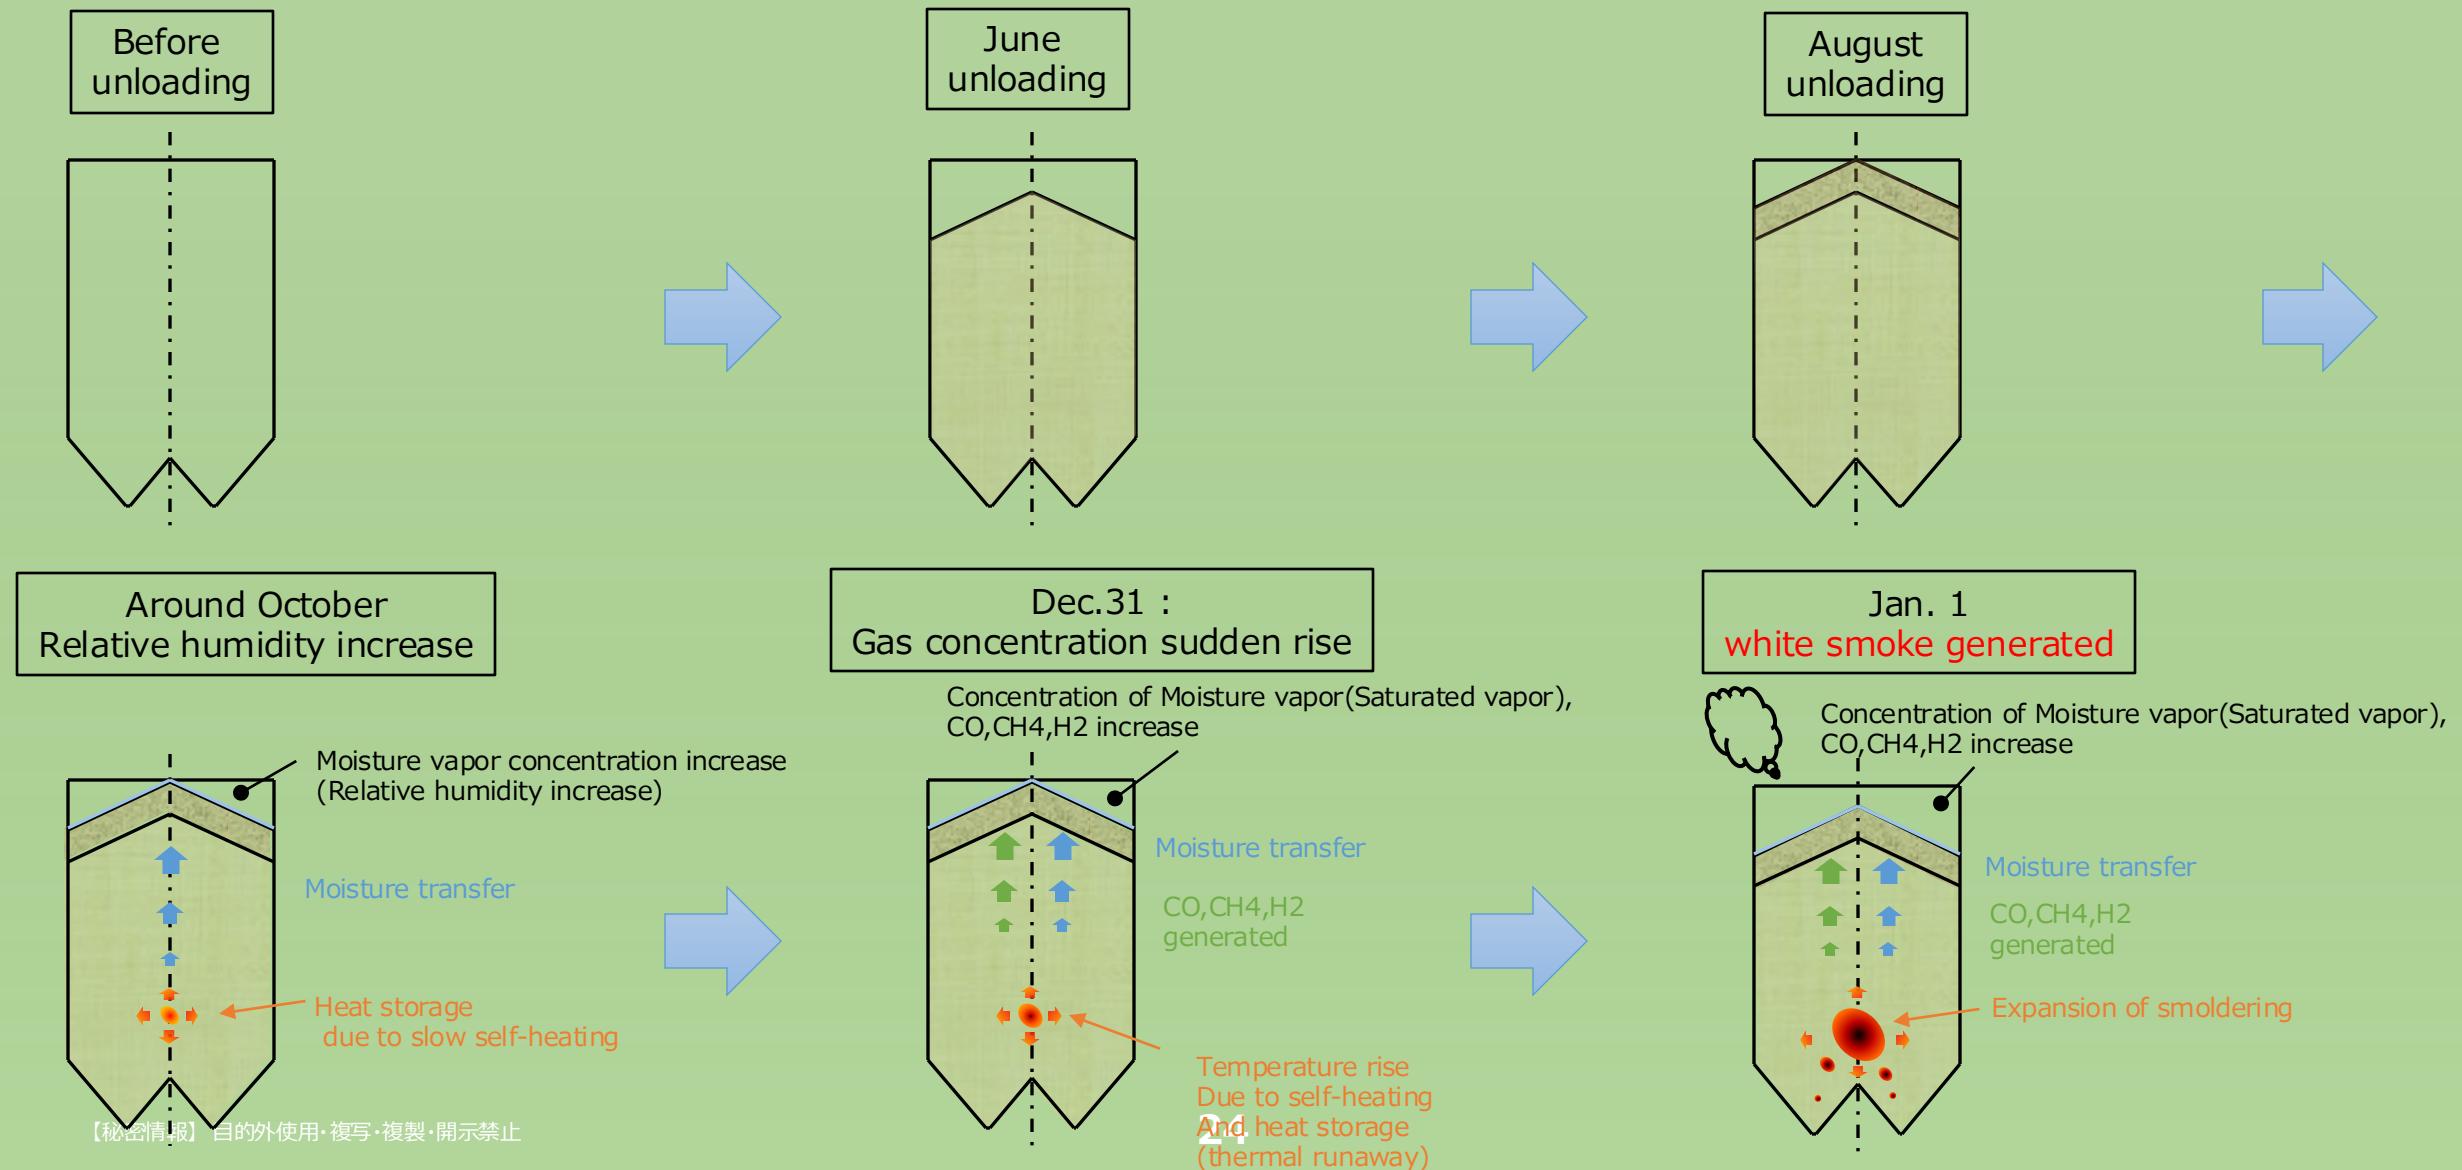
Smoldering fire mechanism estimation

Probable causes of silo fire

- Self-heating of the stored wood pellets
- Issues with the operational rules for long-term storage

- Revise silo operation strategy
- Installation of nitrogen generator
