Ørsted

# Studstrup wood pellet silo fire

## September 2022

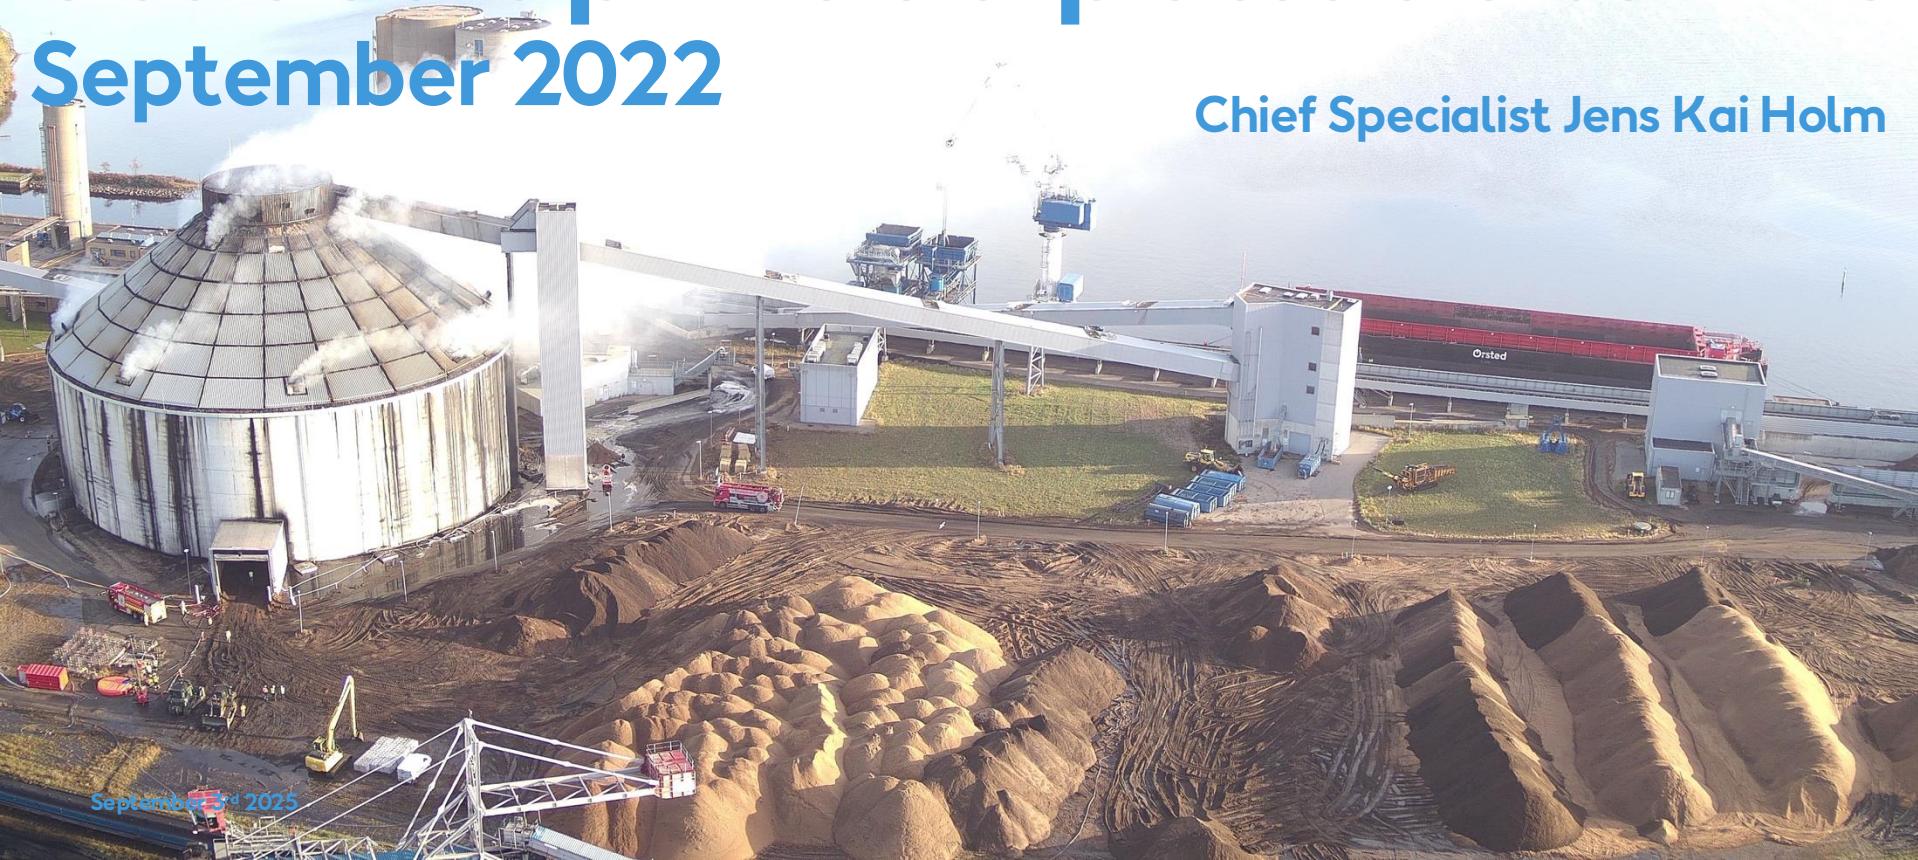
# The Studstrup wood pellet silo before the fire

- Volume: 100.000 m<sup>3</sup>
- Wood pellet total capacity: 65.000 tons
- The silo was constructed in 2015 with detection systems according to best practice

## Primary Preventive barriers

- 4 smouldering fire detectors in the headspace of the silo
- 4 IR-cameras for surface temperature monitoring
- 6 thermocouple cables for bulk temperature monitoring
- Spark detection system in transfer point beneath the silo

## Primary mitigating barriers

- Nitrogen purging system based on liquid nitrogen
- Fire foam system for surface fire fighting
- One primary gate and two secondary smaller gates for emergency extraction of the wood pellets

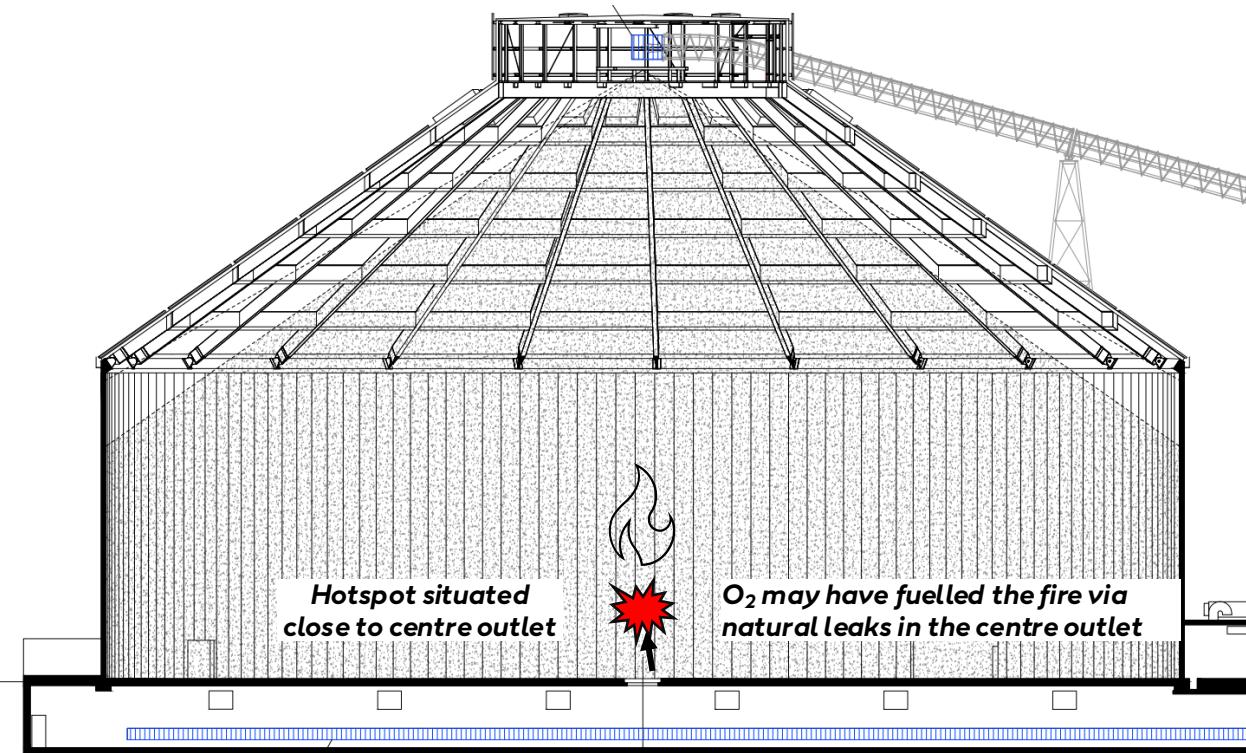
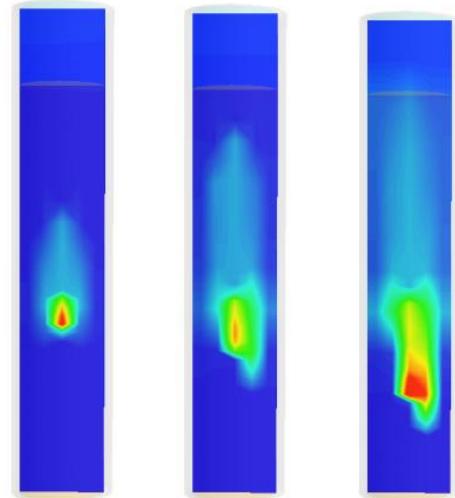
# Root cause conclusion: Late detection of a deeply buried smouldering hotspot resulting from critical self-heating

Time : 10h   Time : 20h   Time : 30h

[Source: Henry Persson, Fire extinguishing and preventive and preparatory measures](#)

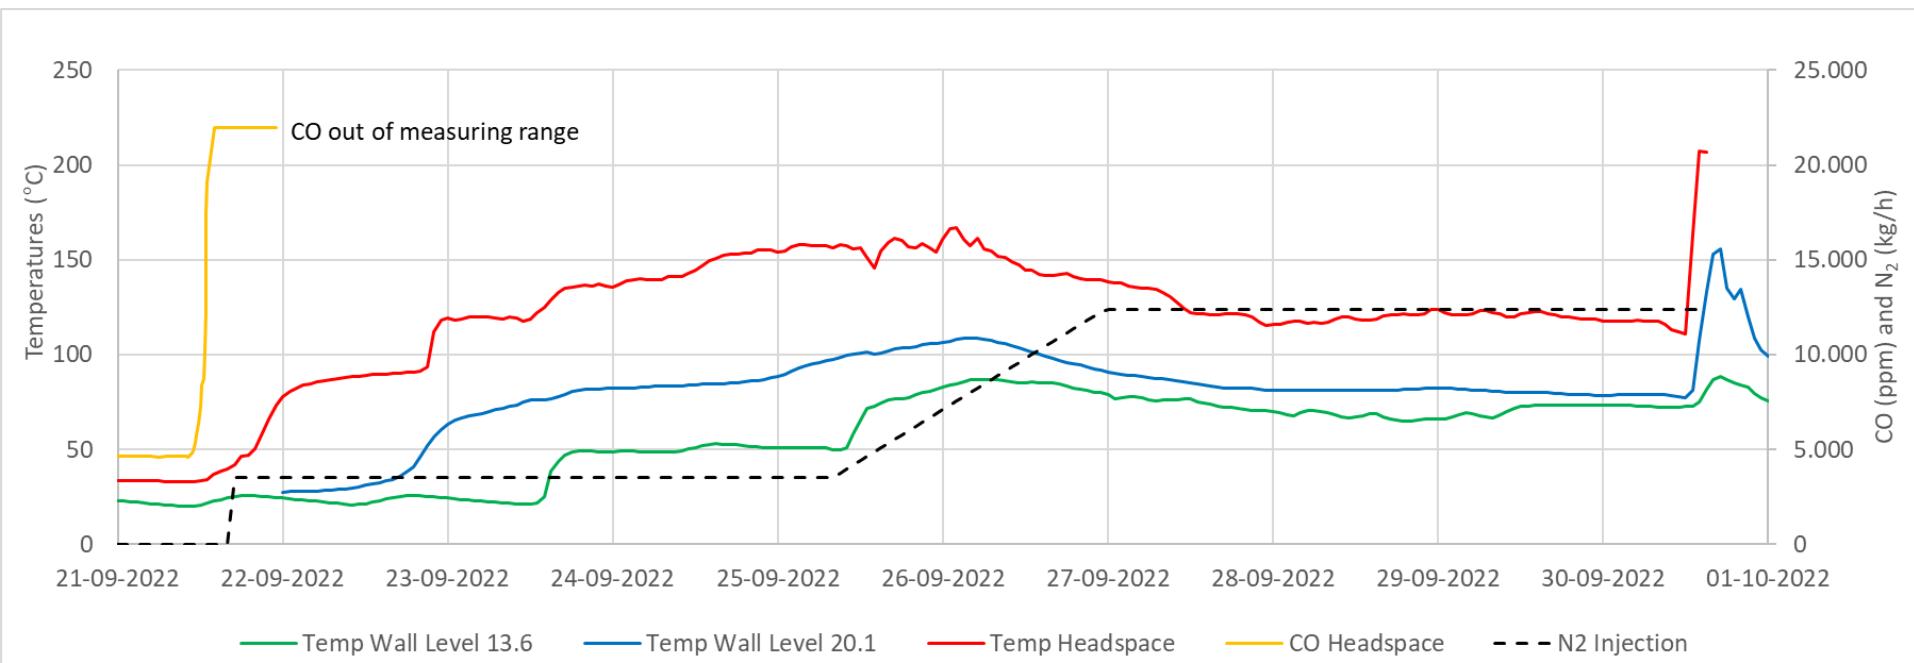
# The first indication of critical self-heating was a rapid rise in CO concentration in the silo headspace

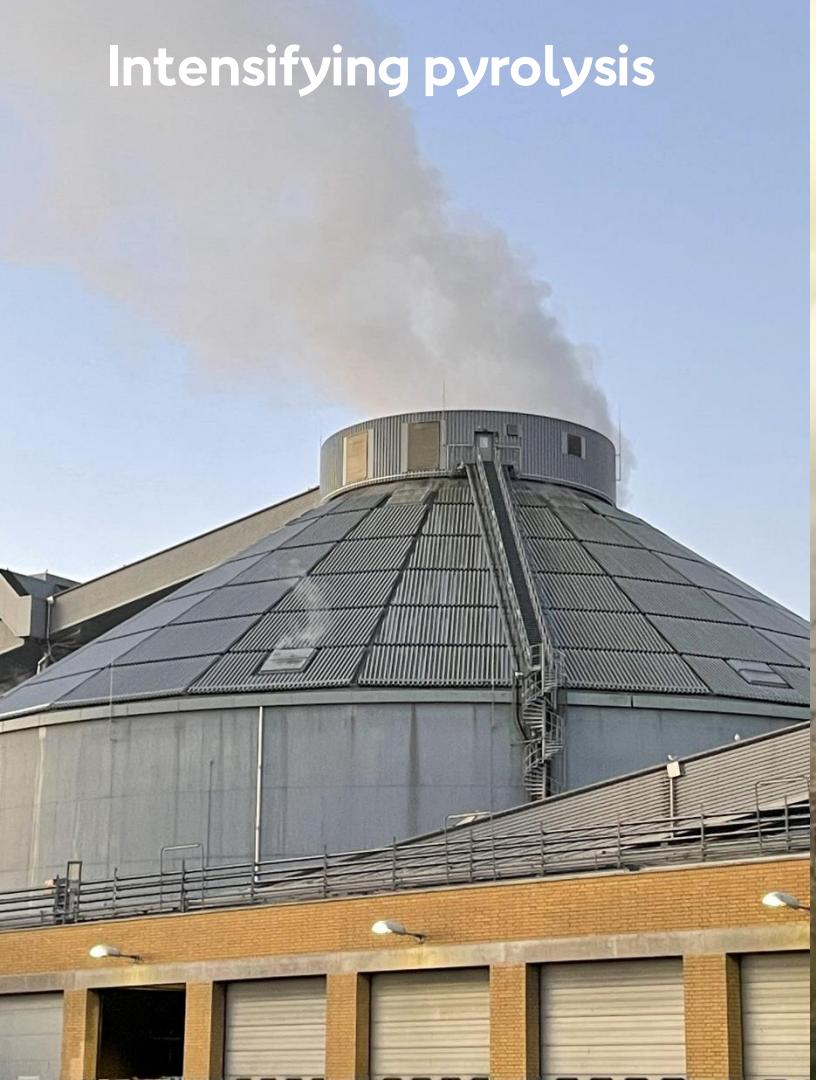
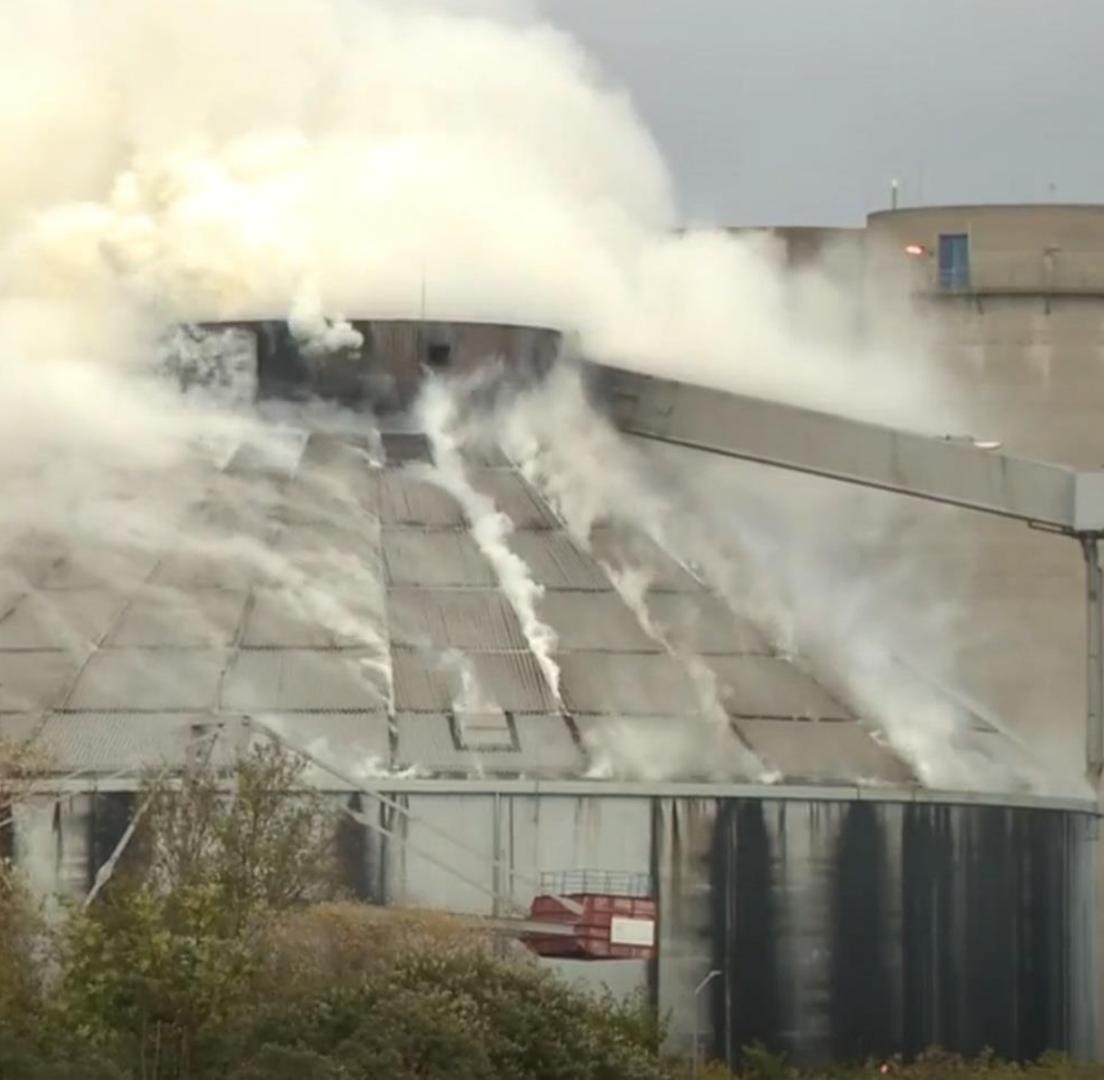
# Intensifying pyrolysis

**Flames visible in the penthouse from the surface fire**

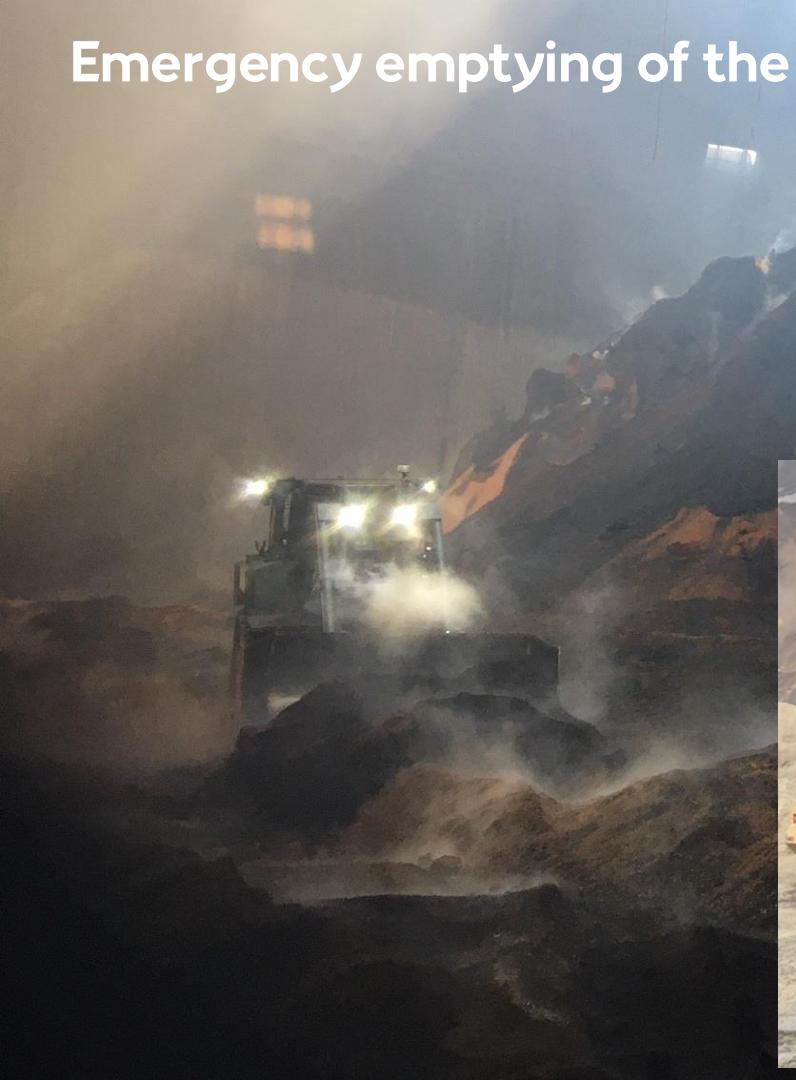
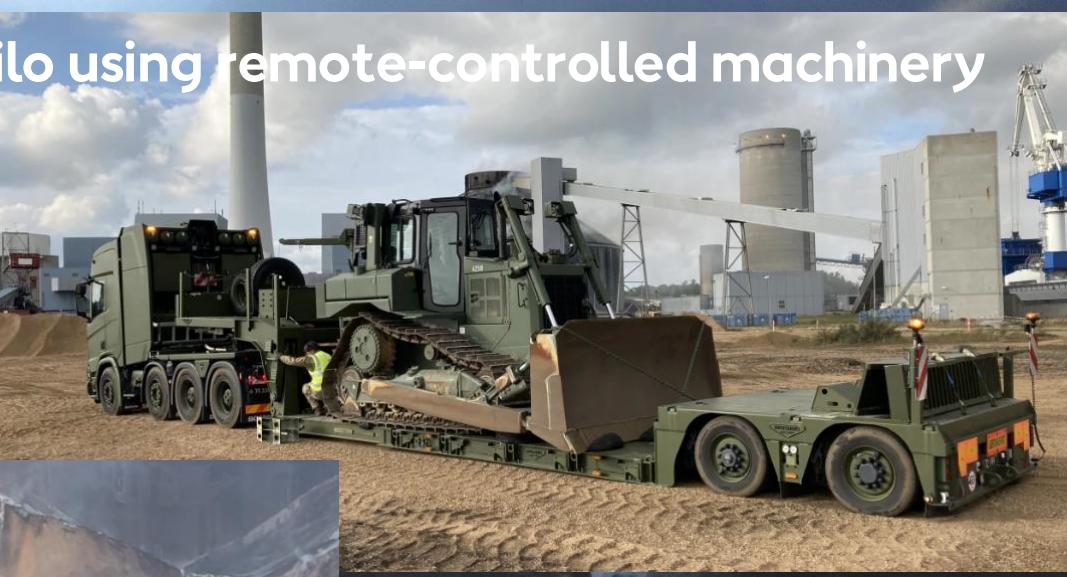
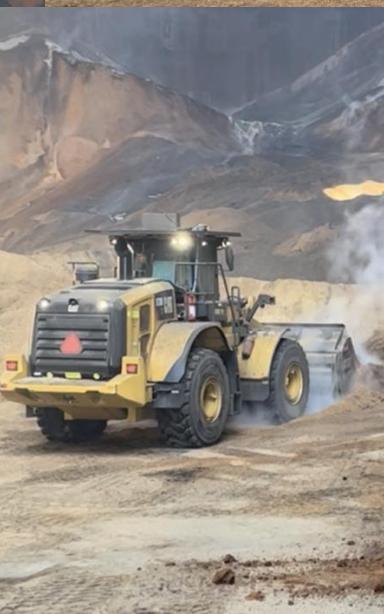
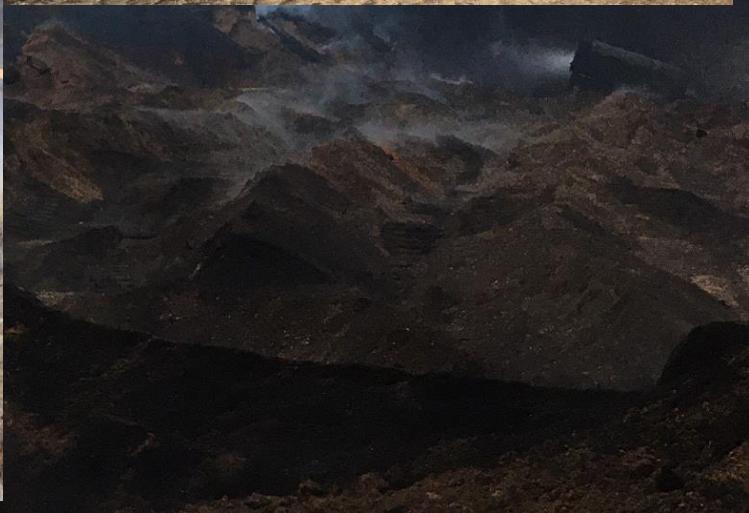
# Emergency emptying of the silo using remote-controlled machinery

- The fire was detected too late to be managed in a controlled way
- Temperature measurement system in the bulk of the pellets was not sufficient – no runaway temperatures were registered
- Smouldering gas detection system did not give a clear and unambiguous alarm at a sufficiently early point in time
- Insufficient system installed to control the temperature of the headspace and roof construction
- Fire foam not effective in extinguishing a surface fire on an uneven surface
- Only one gate for wheel loader access
- Challenge to maintain a high nitrogen purging capacity partly due to delivery bottlenecks

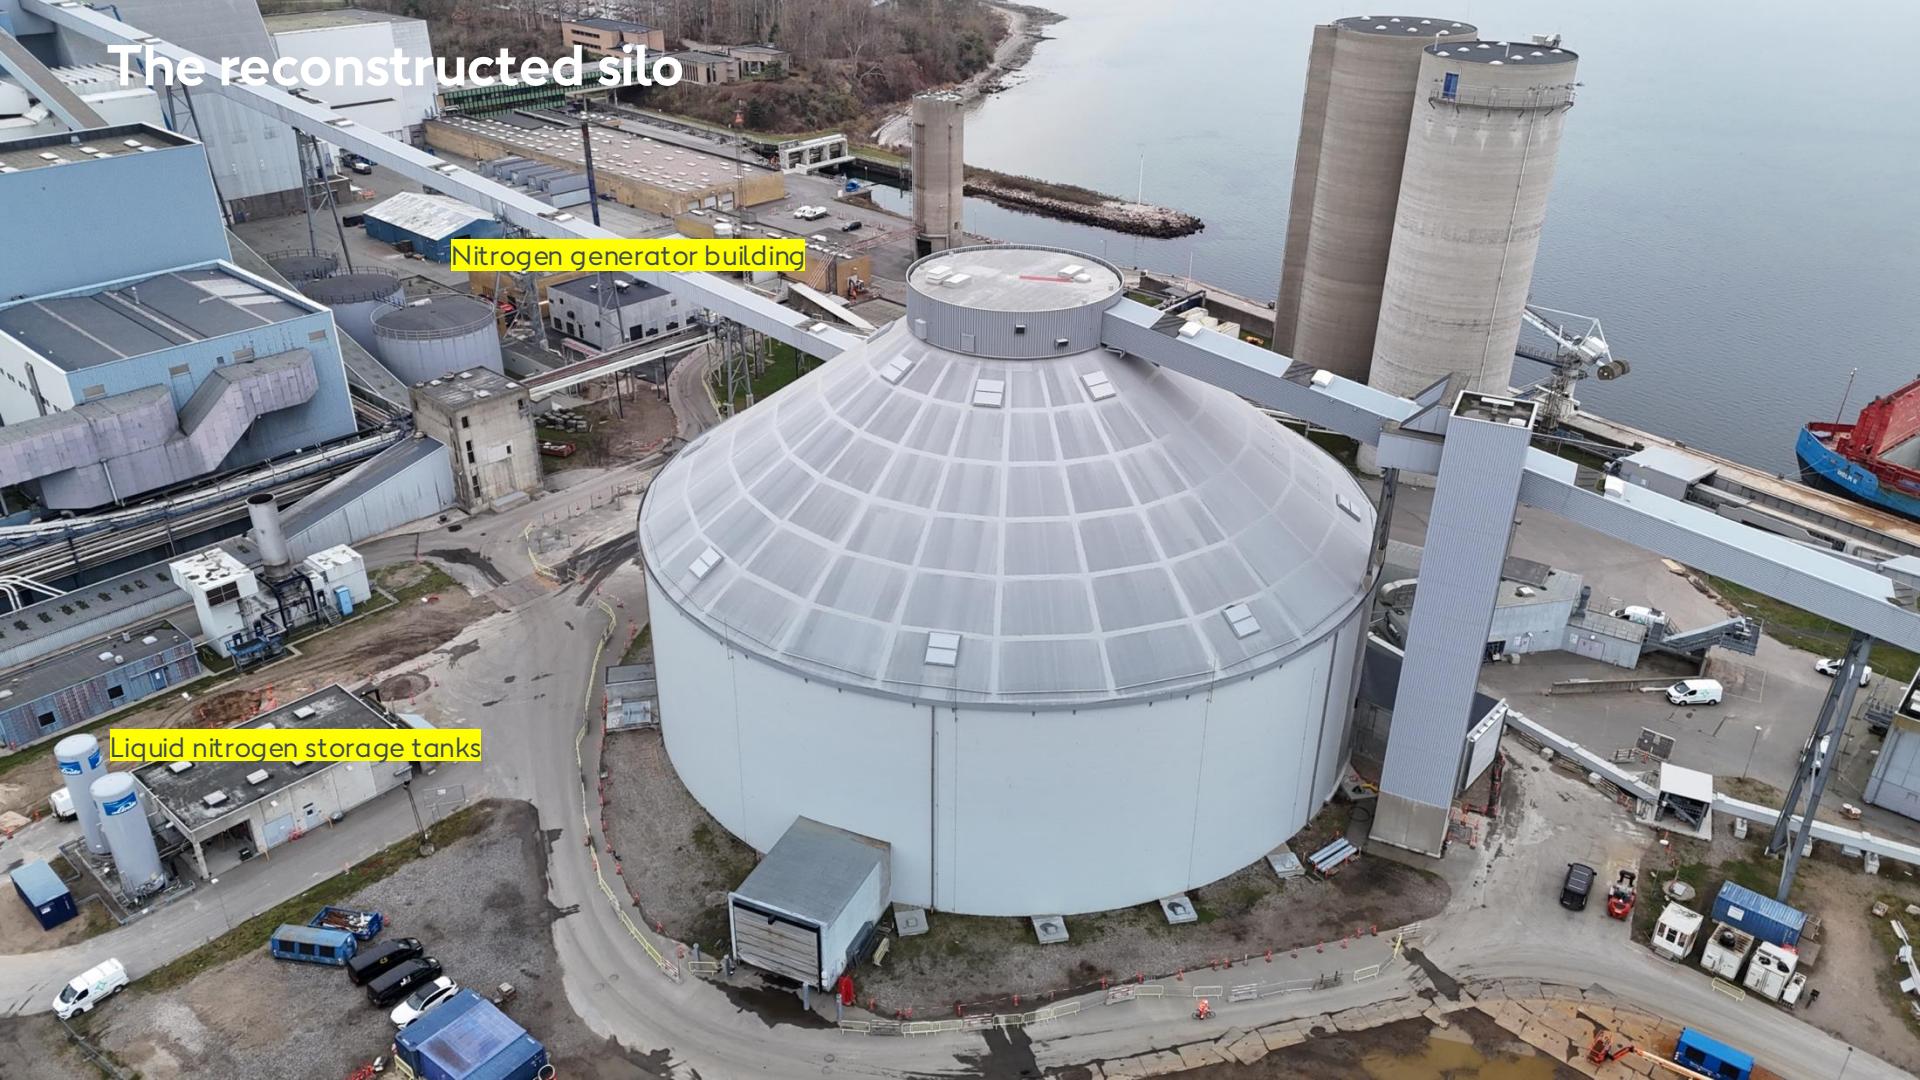
# The reconstructed silo

Nitrogen generator building

Liquid nitrogen storage tanks

- **Temperature monitoring:** Increased from 6 (free hanging) to 65 (fixed) thermocouples cables (~2.000 measurements)
- **Gas monitoring:** CO, CO<sub>2</sub>, and O<sub>2</sub> probes extract gases from the headspace (replacing smouldering detectors)
- **Nitrogen purging:** Continuous purging lowers oxygen; also increases gas diffusion to headspace
- **Water mist (headspace):** Sectionalized system to control headspace temperature (not for extinguishing)
- **Conveyor upgrades:** Central and side conveyors equipped with water mist and temperature sensors
- **Access:** Added two extra gates for efficient emergency emptying with wheel loaders
- **Wheel loaders:** Three remote-controlled, ATEX-approved wheel loaders shared across Ørsted sites
- **Roof monitoring:** High-temperature sensors installed on roof construction

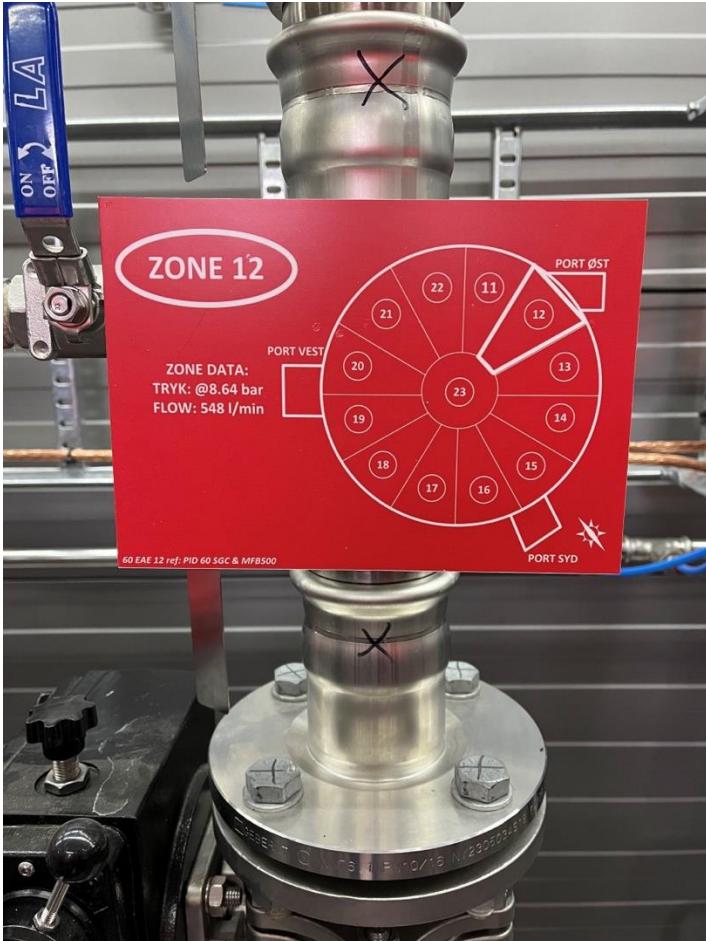
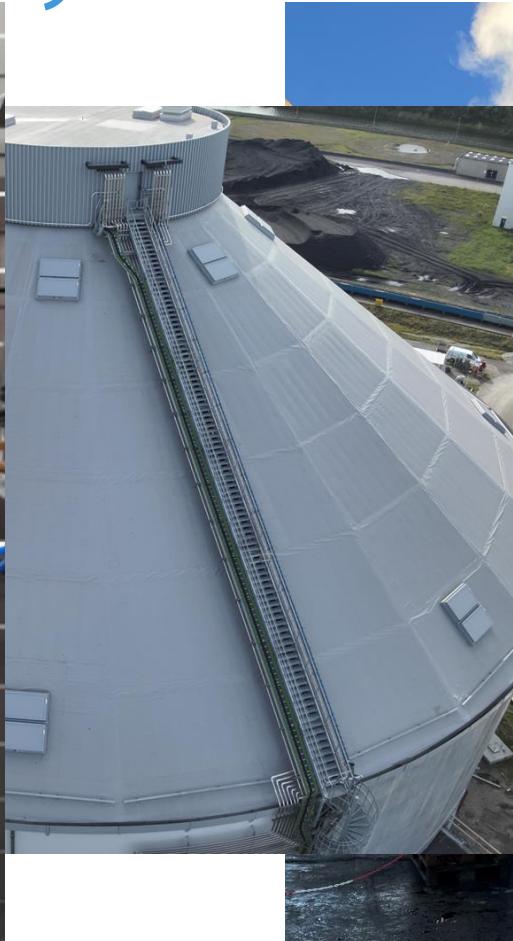
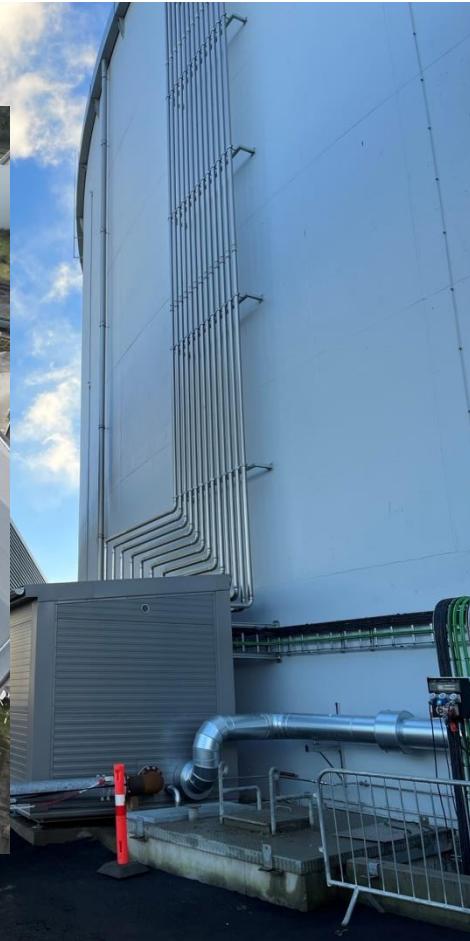
## **Sectionalized water mist system installation**

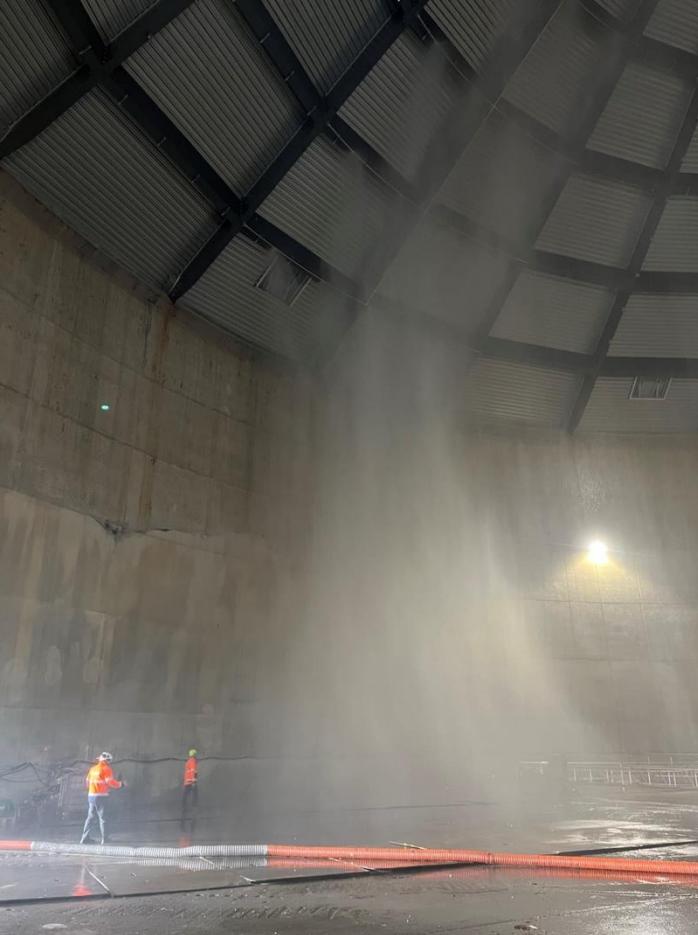
# Test of water mist system in one section

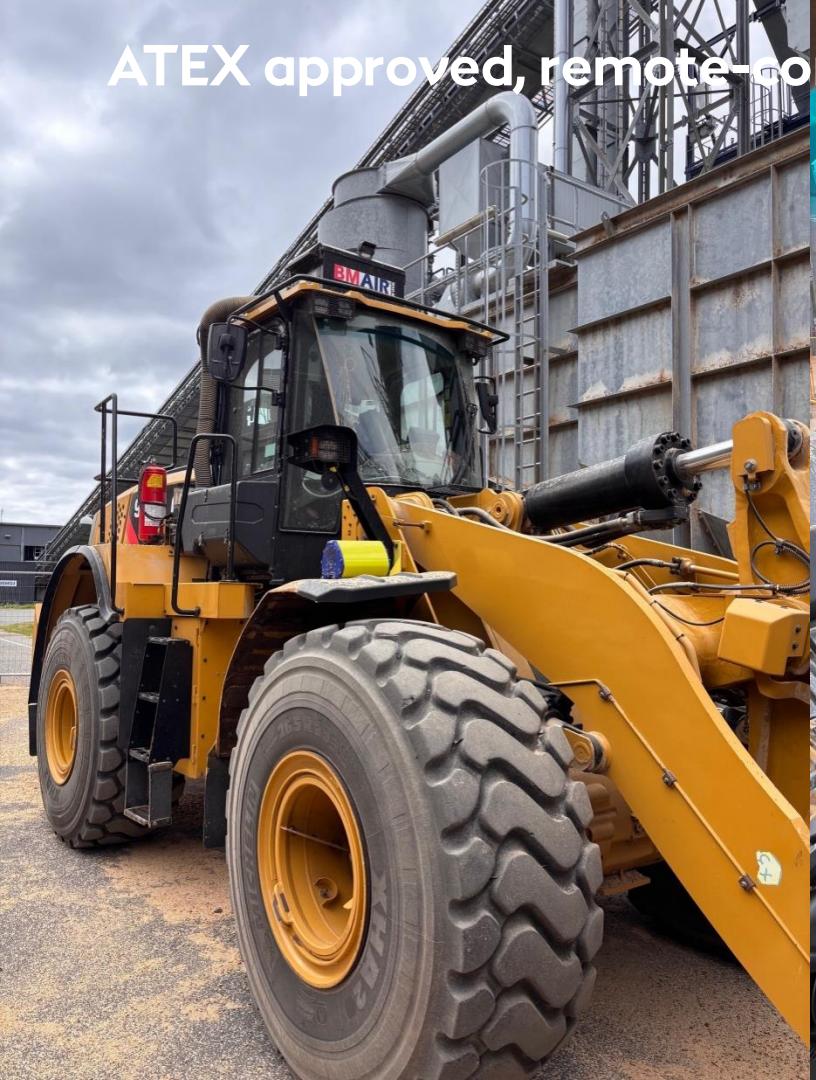
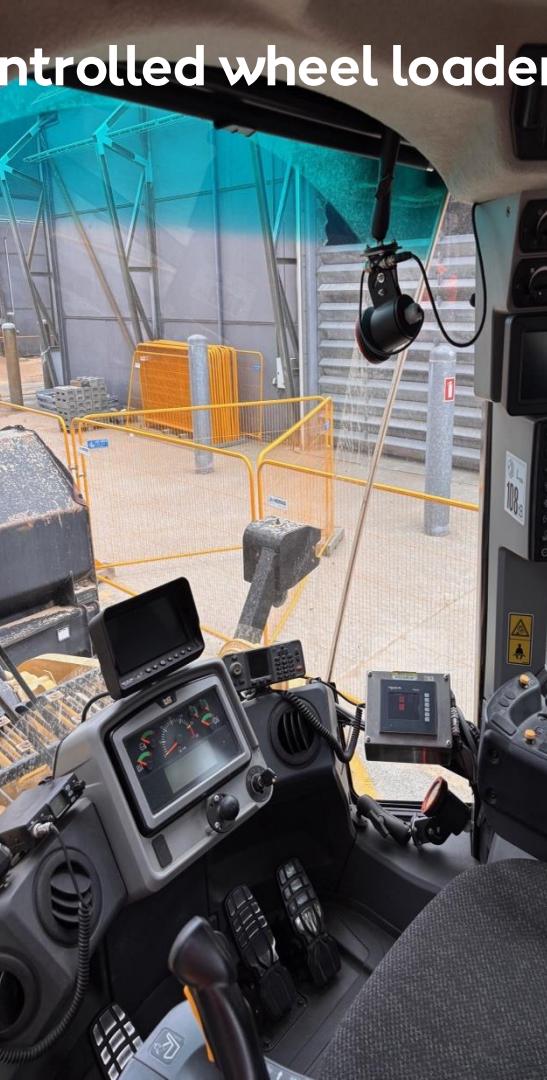
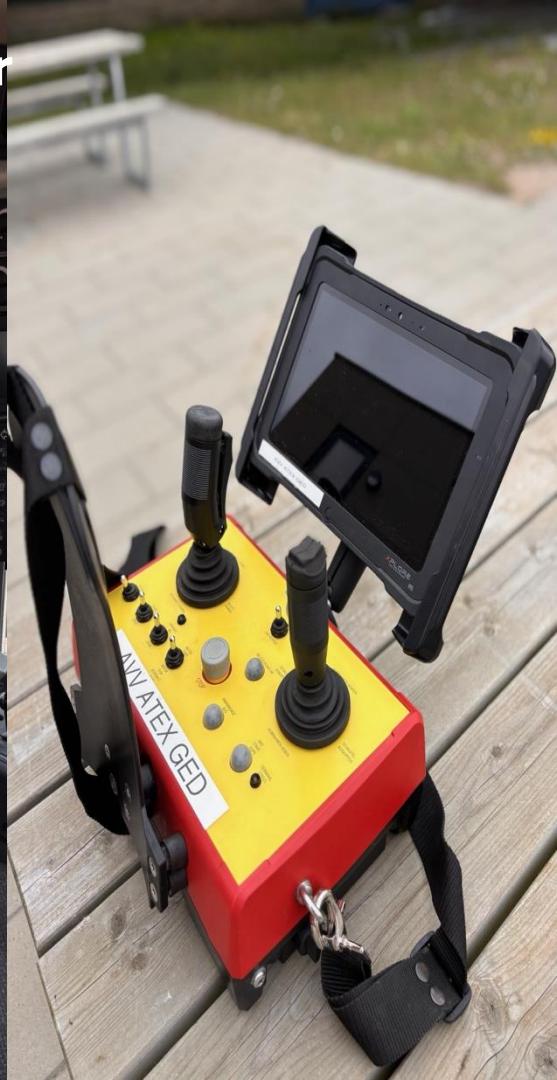
# ATEX approved, remote-controlled wheel loader

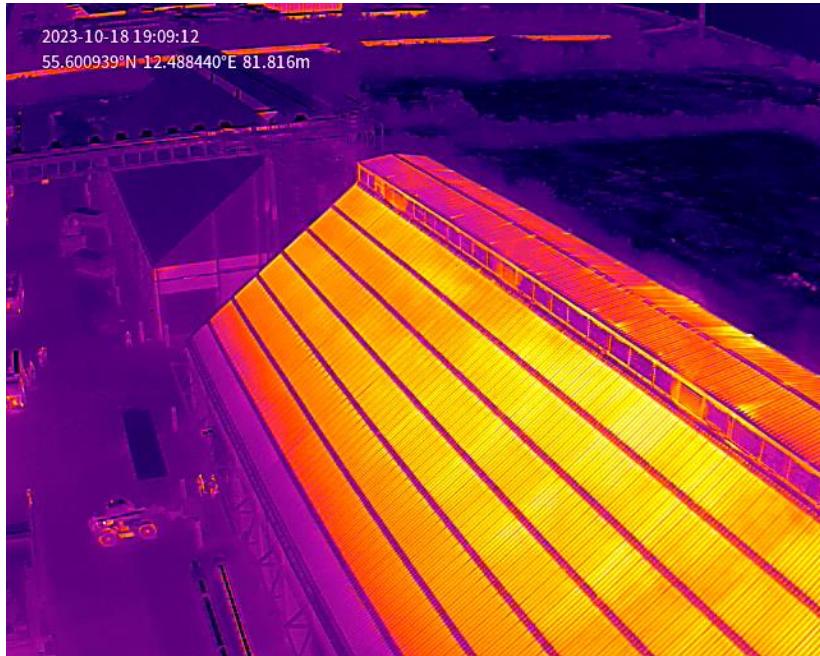
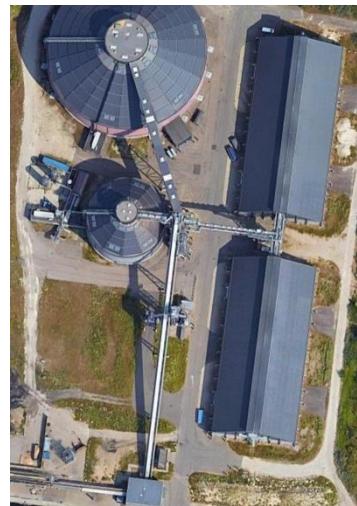
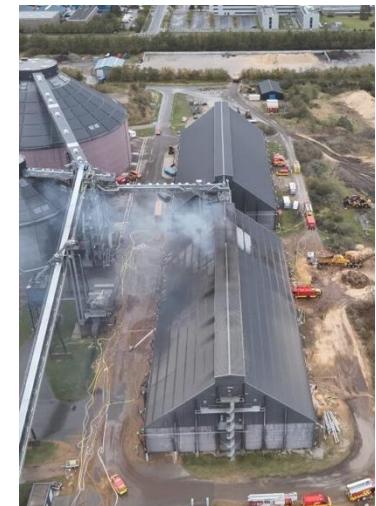
# Smouldering fire in flat storage was first realized when white smoke was seen from the roof top

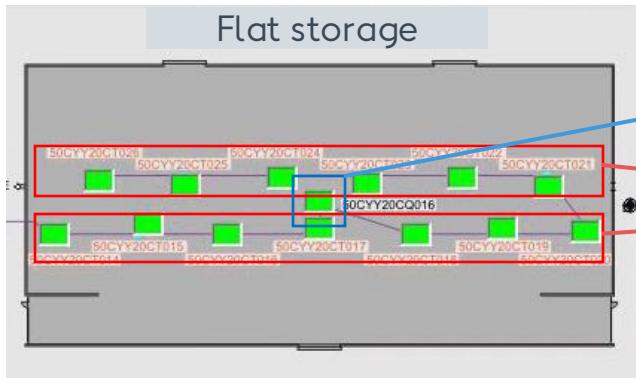
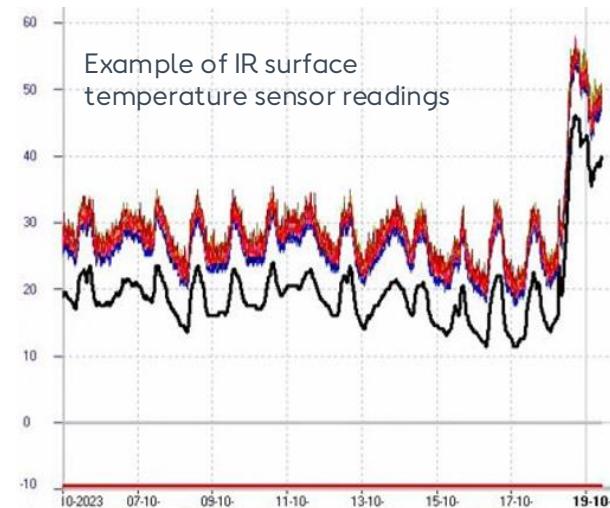
# Root cause conclusion: The monitoring systems failed to detect the smouldering fire in time to allow a controlled response

Primary barriers	Remarks
smouldering gas detector	No clear alarms and insufficient data on absolute gas concentrations
IR surface temperature sensors	No temperatures above 45 °C was measured before Oct 19, 2023
Bi-weekly inspection with mobile IR camera	No temperatures above 45 °C was measured before Oct 19, 2023

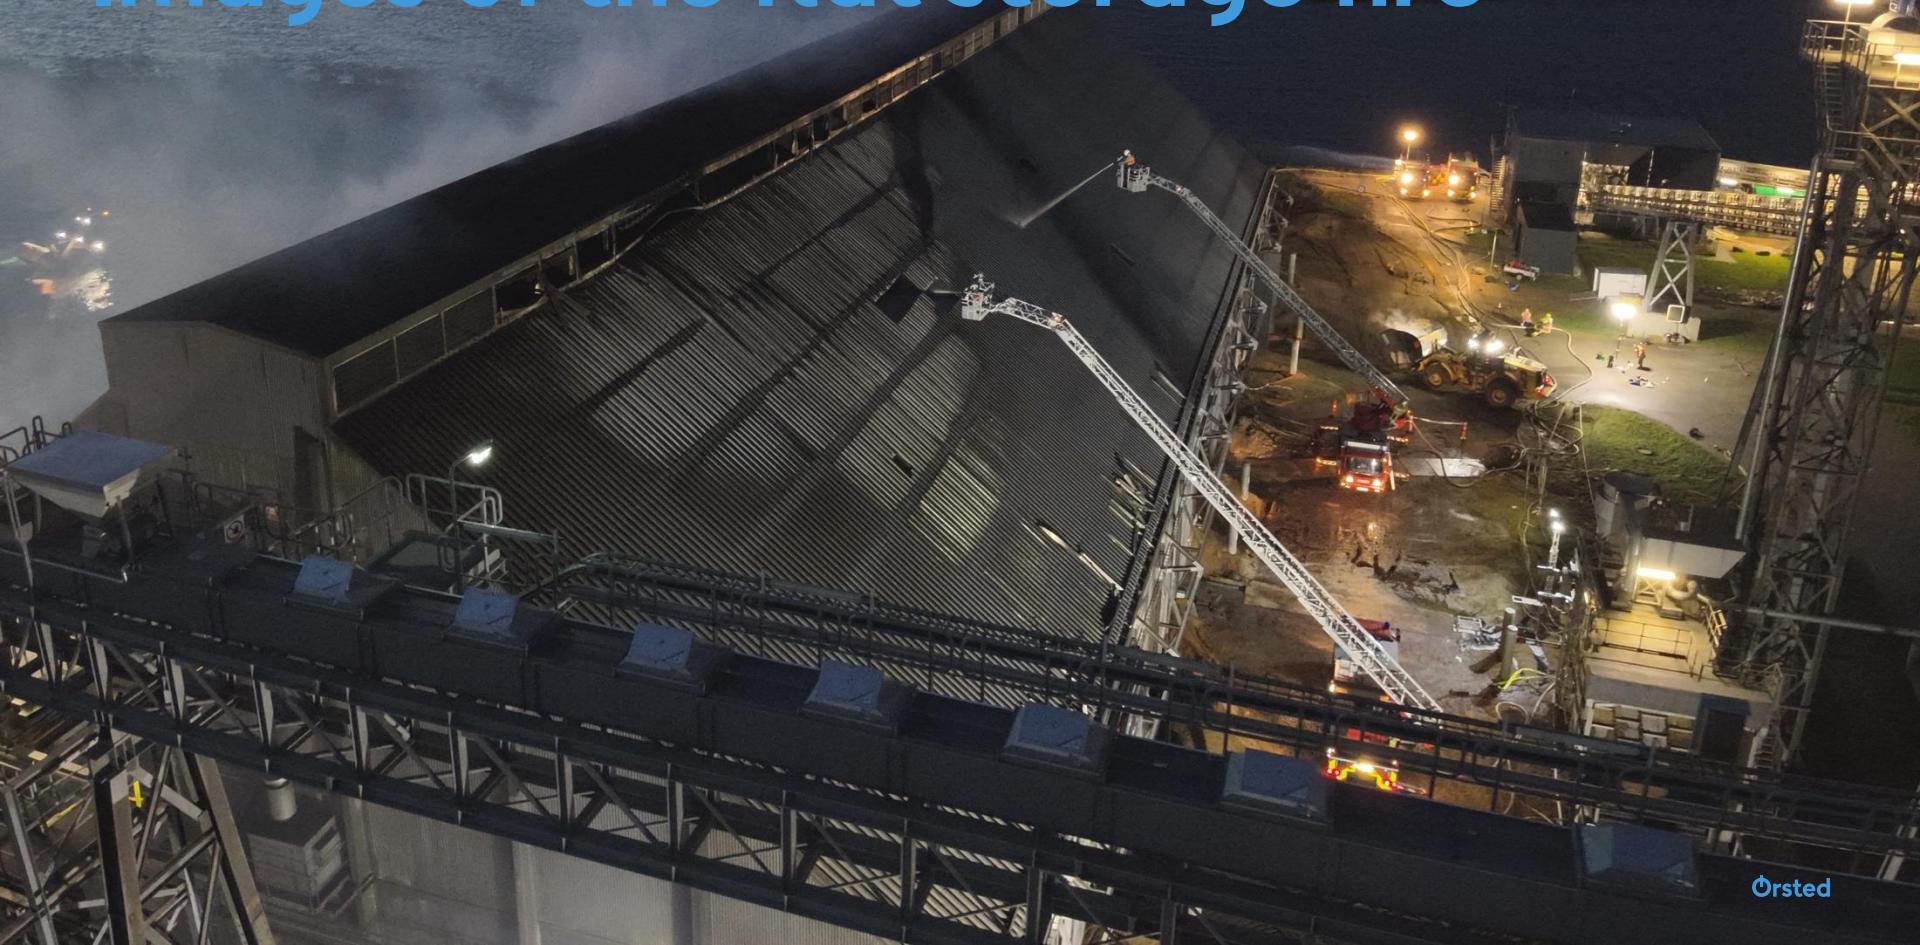
# Images of the flat storage fire

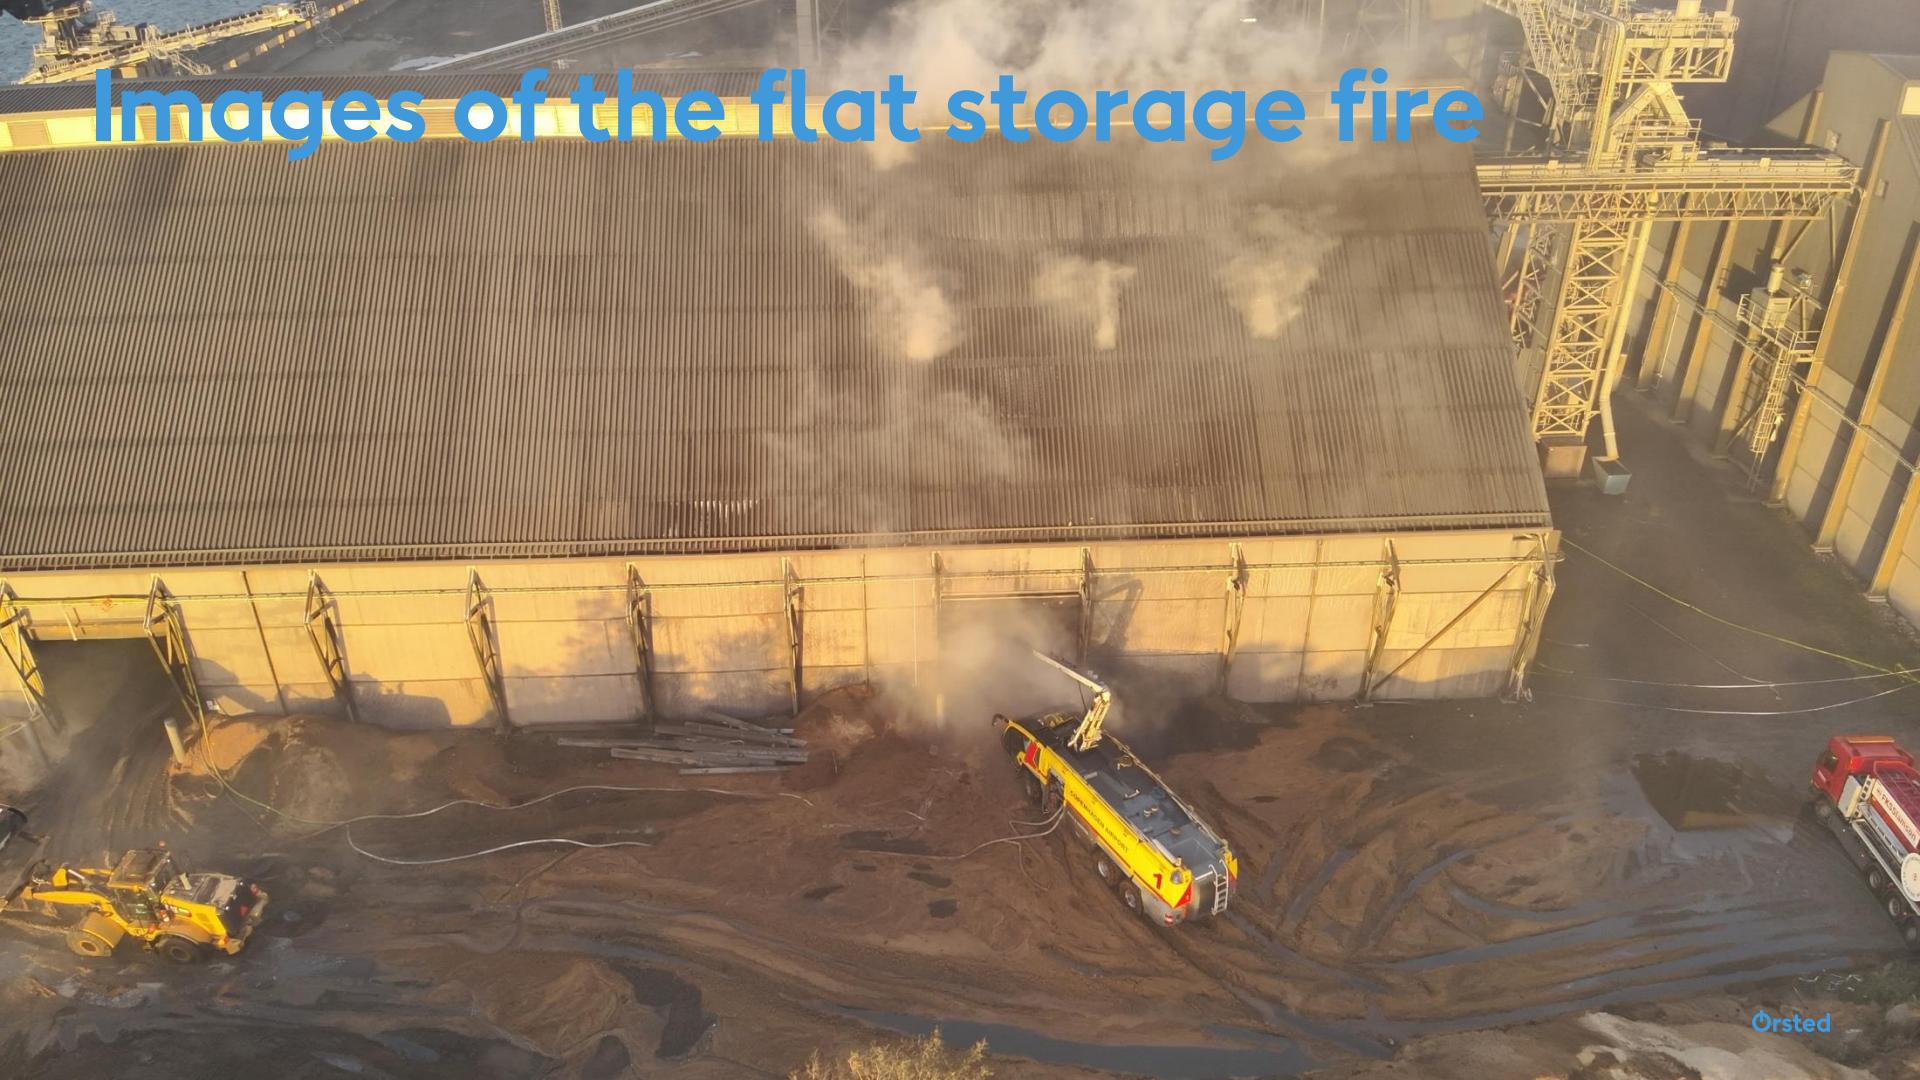
# Images of the flat storage fire

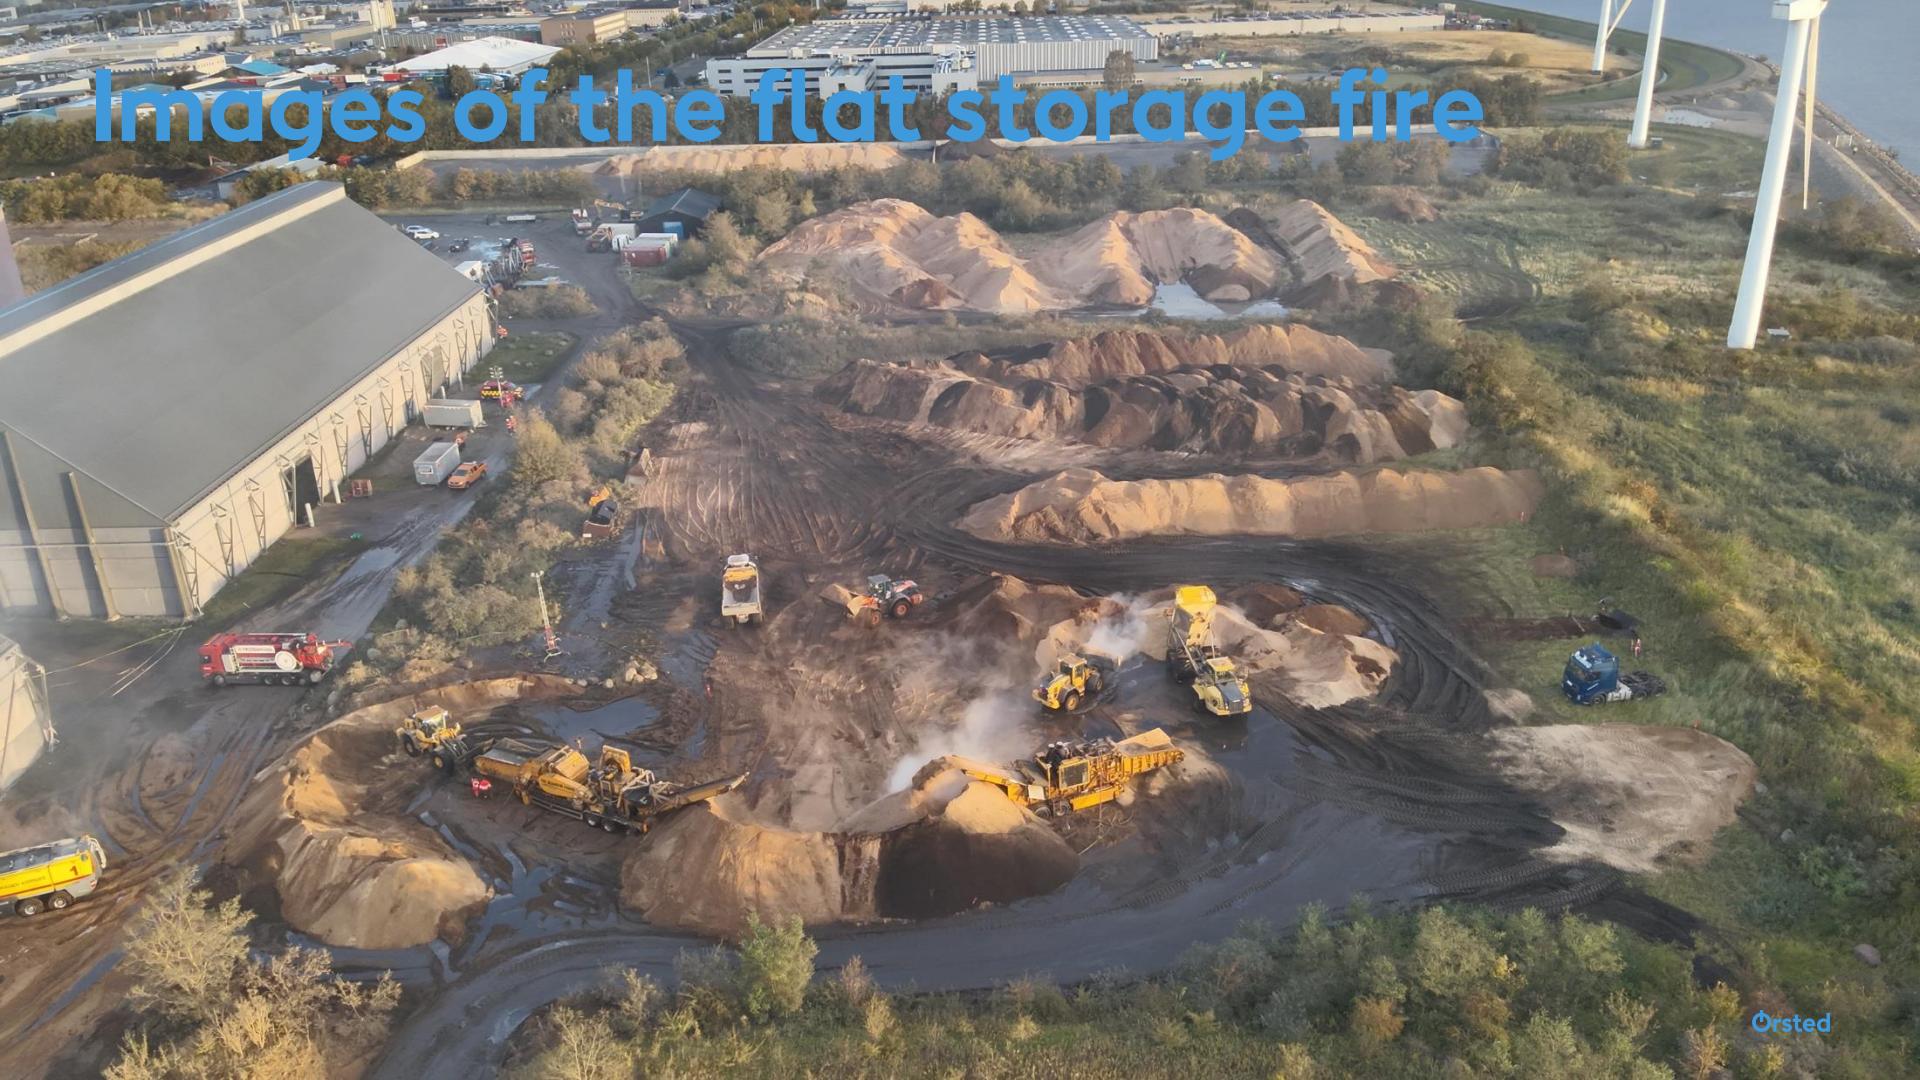
# Images of the flat storage fire
