SAFE WOOD PELLET STORAGE

Preventing, Detecting and Managing Self-Heating Incidents

Case Studies on Major Incidents that Resulted from Runaway Self-Heating Consequences and Lessons Learnt

Daigas Case Study:
Silo Fire at Sodegaura Biomass Power Plant

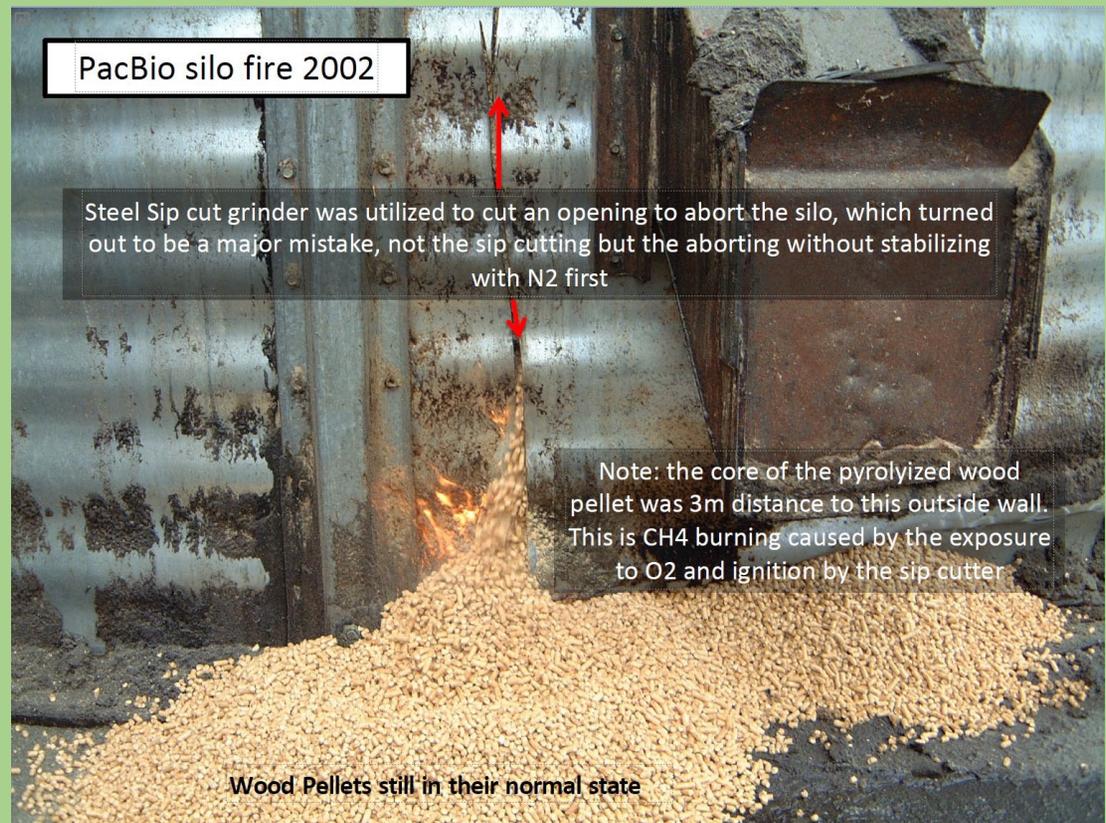
CAUSE OF THE FIRE – EXTERNAL HOT MATERIAL

” So what caused the explosion ???

- Pyrolysis of the smoldering pellet generate CH_4 , CO , CO_2 , H_2 combustible gases.
- Lowering (aborting) the level of wood pellets in silo down to the smoldering pellets allowed O_2 to make contact with the smoldering pellets releasing CH_4 causing the ignition and subsequent explosion.
- Smoldering pellets glue together and become clumps that cause bridging and blockage when aborting the silo

- Wood Pellet Fire incidents MUST be stabilized before aborting a silo and/or warehouse

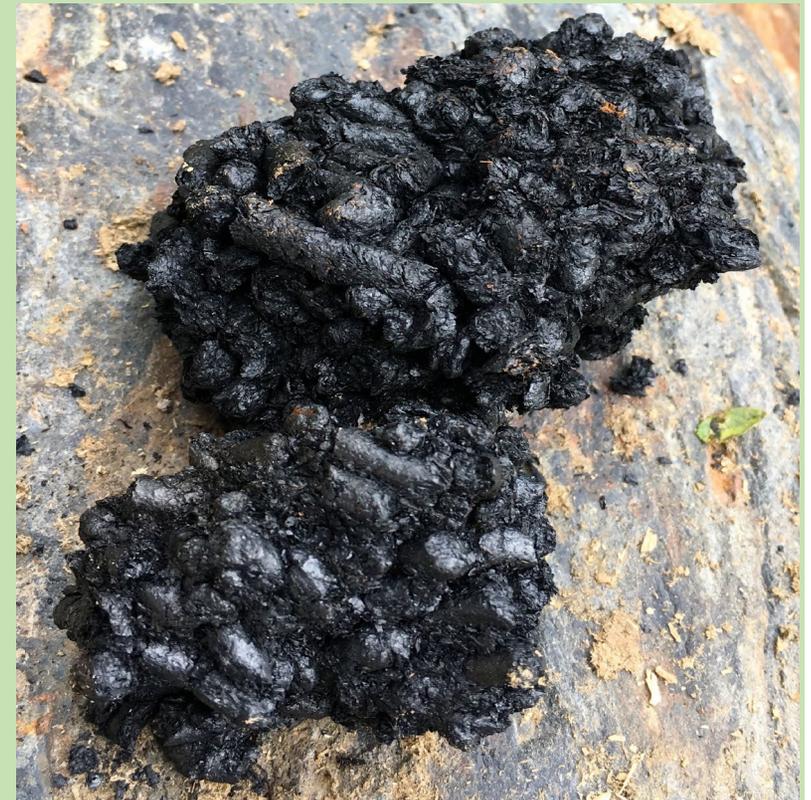
“CONSEQUENCES OF ABORTING BEFORE THE SMOLDERING WOOD PELLETS ARE NOT STABILIZED”

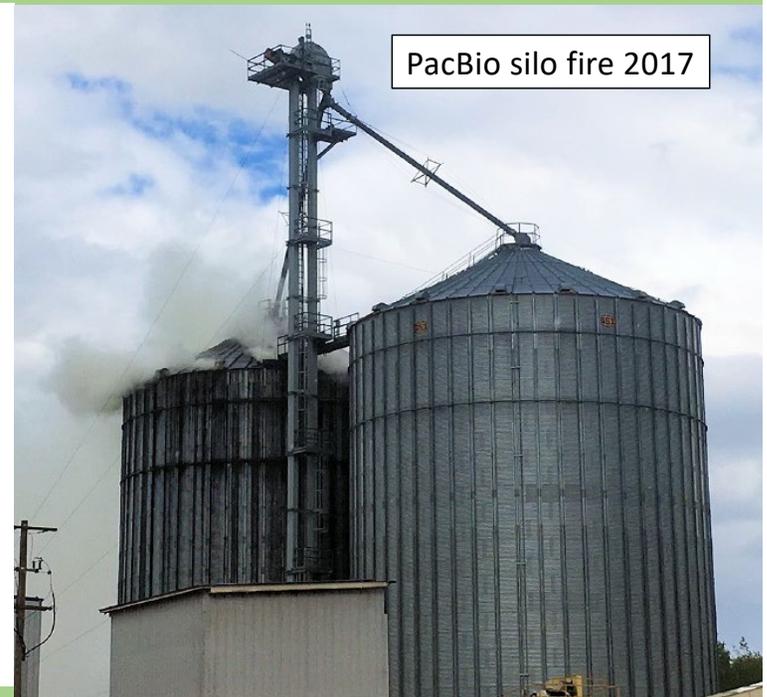
- Best practices for dealing with wood pellet fire incidents found N₂ injection to be the most effective to stabilize the smoldering pyrolysis of the pellets before safely discharging silo's, minimizing personnel danger and damage to the silo(s) and/or surrounding facilities.
- Volume and flow rates for N₂ injection where also calculated and verified.
- Restricting O₂ and injecting N₂ into the silos head space proved to have positive results, although utilizing medium or high density foam spray was identified as an option to assist with N₂ losses from the top of the silo and potential fire.

CAUSE OF FIRE – BELIEVED TO BE SELF-HEATING

Concluding results of the Swedish Research were followed and a safe outcome was the result. NO injury's or loss of life and NO loss of assets.

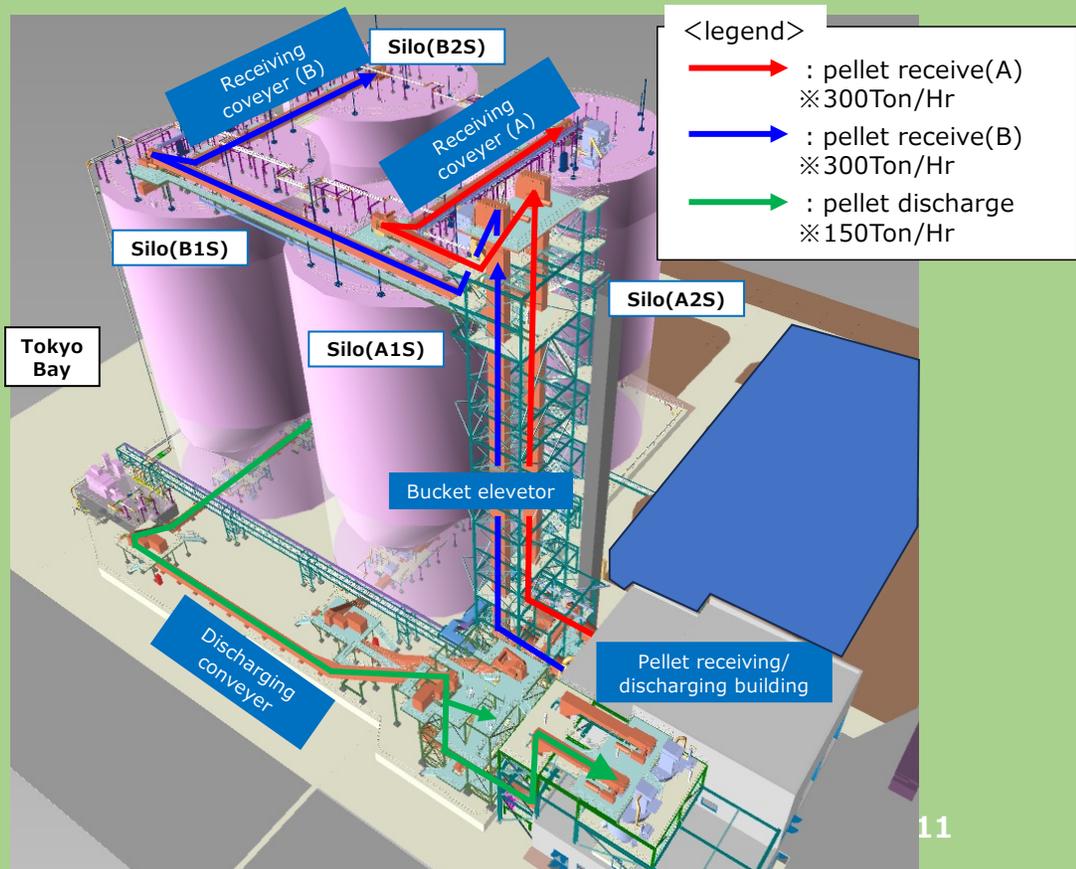
Storage Site Outline

SBP Storage site outline	
Operation start	Jul. 2022
Stored fuel	White wood pellets
Silo Spec.	Concrete silo : 4 silos Capacity : 10,000Ton(approx.15,000m³)/silo Diameter : 25.1m, Height : 46.5m
Conveyer spec.	①receiving; 2 series (Max. 300 t/h) ②discharging; 2 series (Max. 150 t/h)
Other facilities	Pellet Receiving/Discharging building N ₂ supplying Nozzle(For pellet fire counter) Fire extinguishing facility (Water Spray, Outdoor Hydrant)

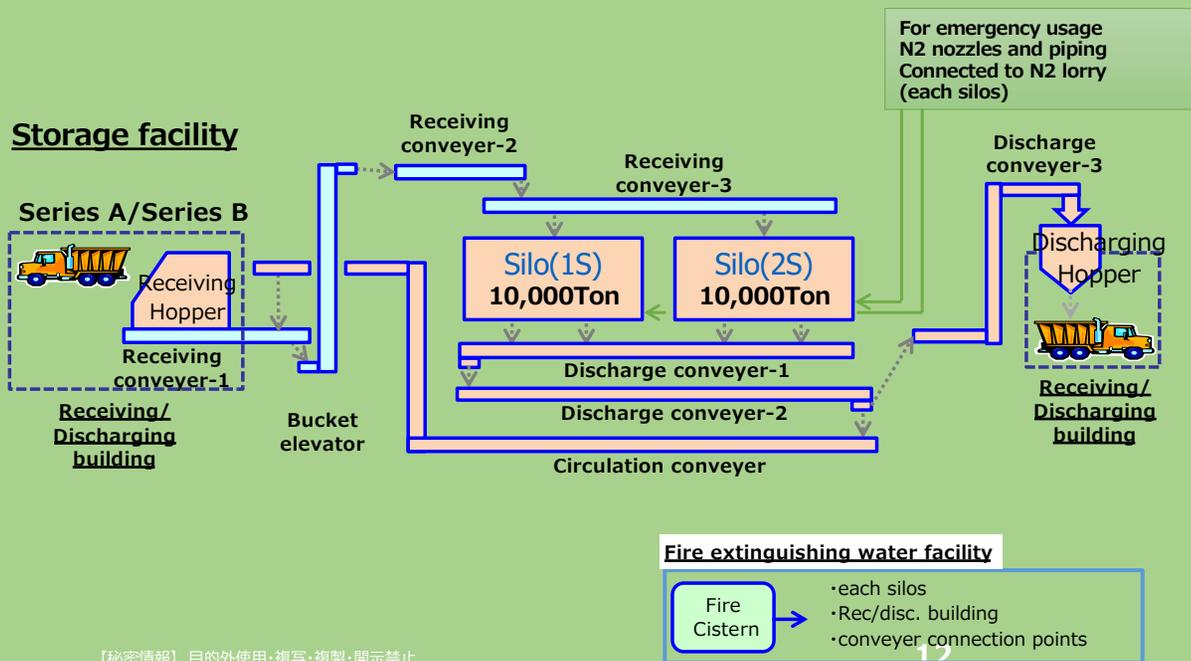
Equipment Configuration

- A nitrogen lorry line is permanently installed to supply nitrogen to each silo in case of emergency.
- Fire extinguishing system capable of spraying water on each silo, conveyor transfer area, and warehouse building.
- Fuel circulation operation is possible when an abnormality is detected in stored fuel.
- The silos are monitoring the condition of stored fuel with gas concentration and thermometers.

Specification of silo	capacity : 10,000Ton ×4 Dia : 25m, Height : 46.5m
Instruments, Prevention equipments	Thermometer Gas concentration monitor N2 injection nozzles Sprinkler (silo, etc)

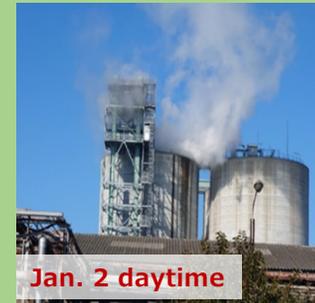
White smoke was observed from A1 and B1 silos of the 4 silos.

Date	Time	Events
Dec.31, 2022	8:58 night	The abnormal gas concentration in A1 silo was detected. Steam smoke from A1 silo was observed.
Jan.1, 2023	AM	A nitrogen lorry was arranged.
	12:30	N2 injection in A1 silo was started.
	22:00	N2 injection was stopped.
	22:12	White smoke was observed from A1 silo.
	22:31	Notify the fire department.
Jan.2, 2023	midnight	Water was sprayed inside A1 silo.
	morning	Nitrogen had been injected in A1 silo.
Jan.4, 2023	15:10	White smoke was observed from B1 silo. Nitrogen had been injected in each silos to calm down the situation.

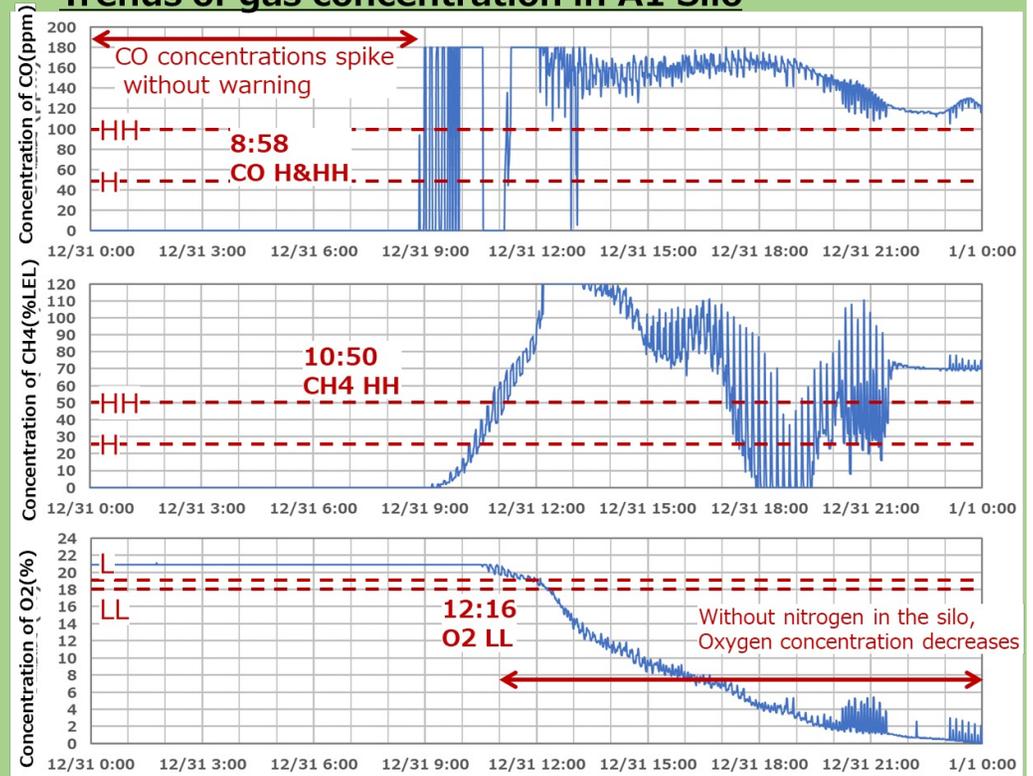
Trends of gas concentration in A1 Silo

- Suddenly the gas concentration increased on 31st Dec. 2022.
- Temperature in the silos had been showing normal temp.

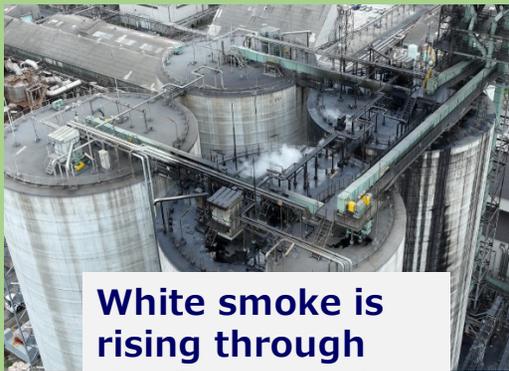
- White smoke was generated from the tops of the A1 & B1 silos, and tar adhered to the tops and walls of the silos and the surrounding area, causing an odor. In addition, the area around the silos became a high CO concentration environment, which greatly hindered firefighting activities.

White smoke is rising through the flapper valve, etc.

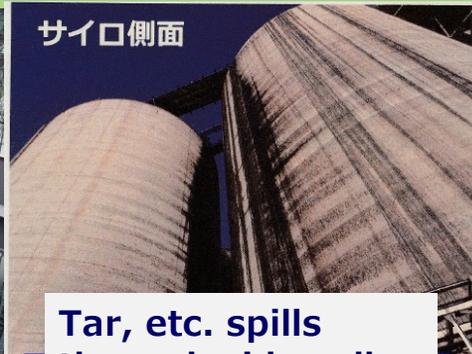
Tar, etc. spills through sidewalls

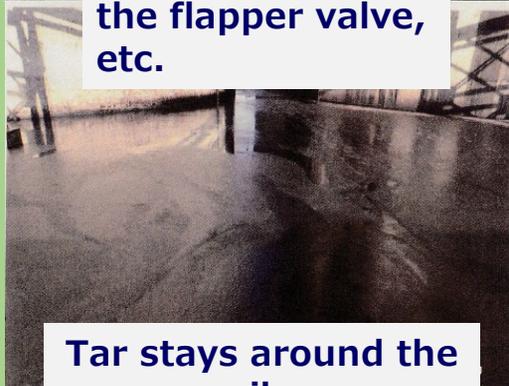
Tar stays around the silo

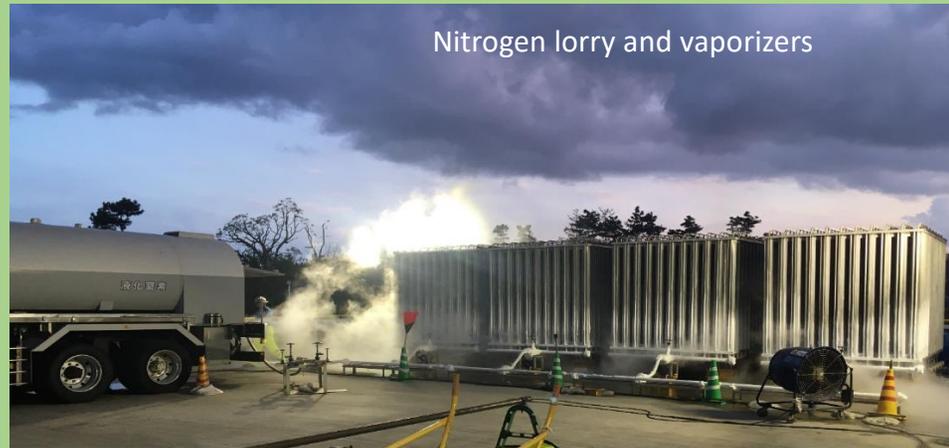
Nitrogen lorry and vaporizers

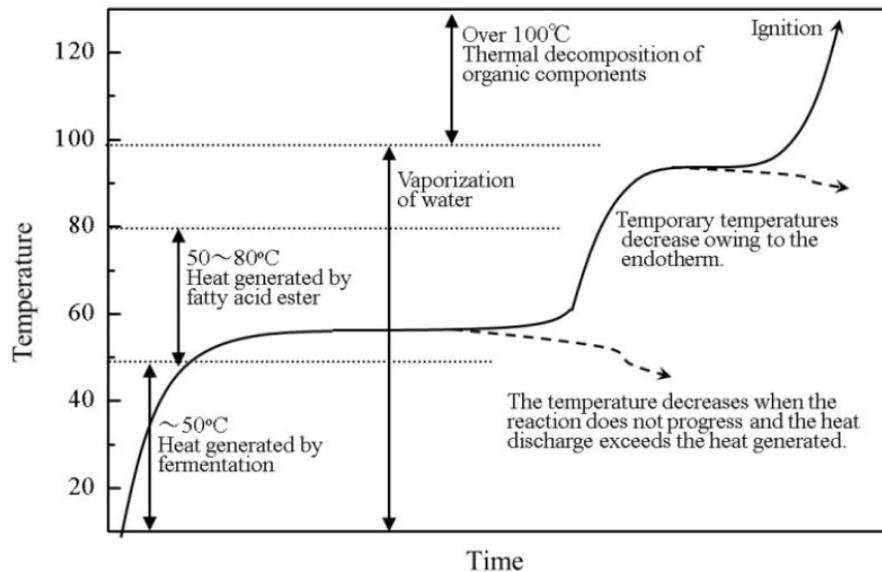
Figure 16. Combustion mechanism of biomass fuels.

When local moisture concentration occurs during wood pellet storage due to moist air inflow or condensation, heat of fermentation by microorganisms is generated, which, when stored, further generates heat through spontaneous oxidation and is considered to lead to ignition.

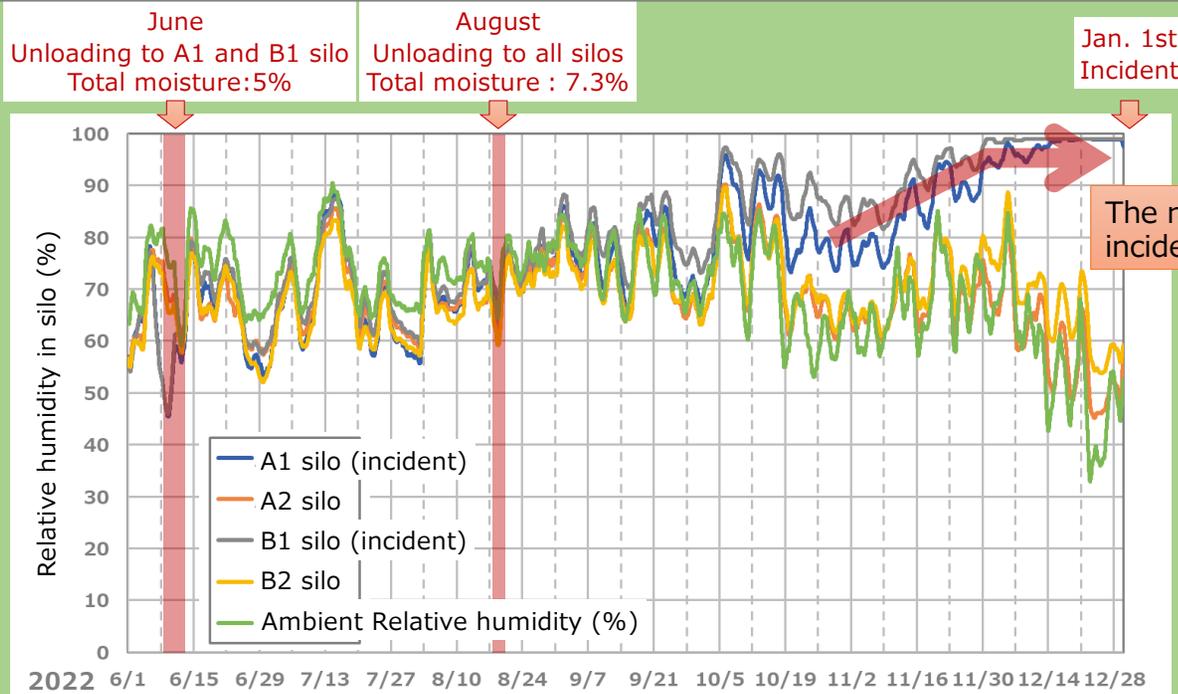
Humidity History in Silos

No signs of moisture entering from the outside → humidity increased caused by self-heating of wood pellets in the silo.

The relative humidity only increased in the incident silos.

Note : The gas concentration and bulk temp. did not detect any abnormal values until the incident occurred.

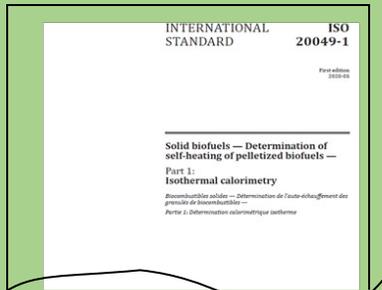
ISO 20049-1 Solid biofuels
- Determination of self-heating of pelletized biofuels -

Experimental equipment
(Isothermal calorimetry)

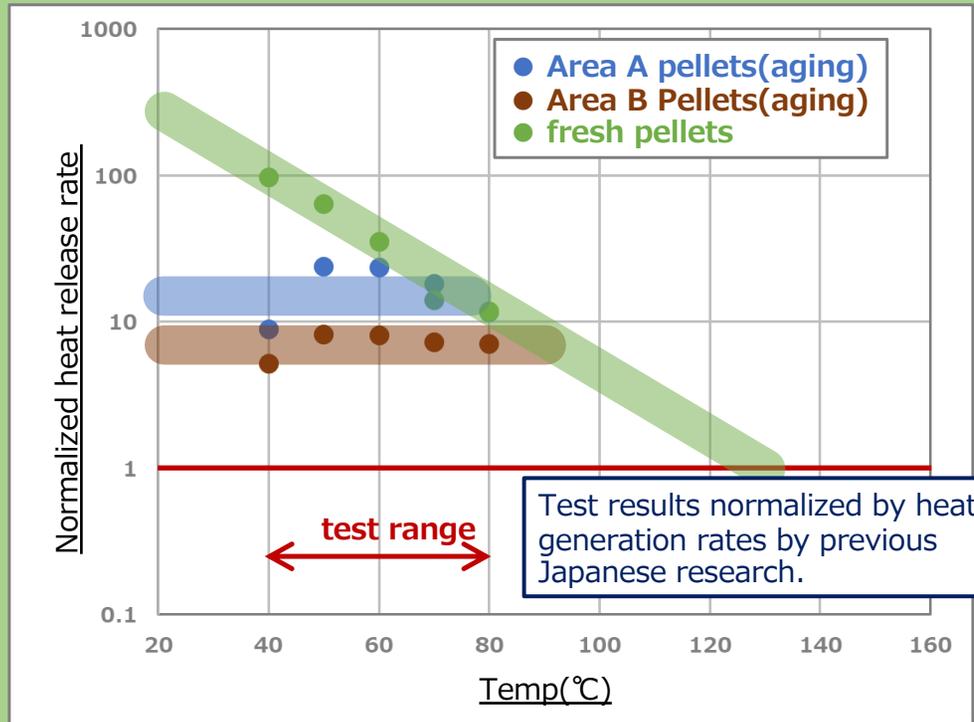
Test Results : Self-heating characteristics of wood pellets

- Evaluated the self-heating characteristics of wood pellets based on ISO, and confirmed that the self-heating characteristics are 1~2 orders of magnitude higher than the previous findings in the low temperature range.
- Also, the self-heating property of **fresh** wood pellets was confirmed to be higher than that of stored pellets(**aging pellets**).
