Studstrup wood pellet silo fire

September 2022

Chief Specialist Jens Kai Holm

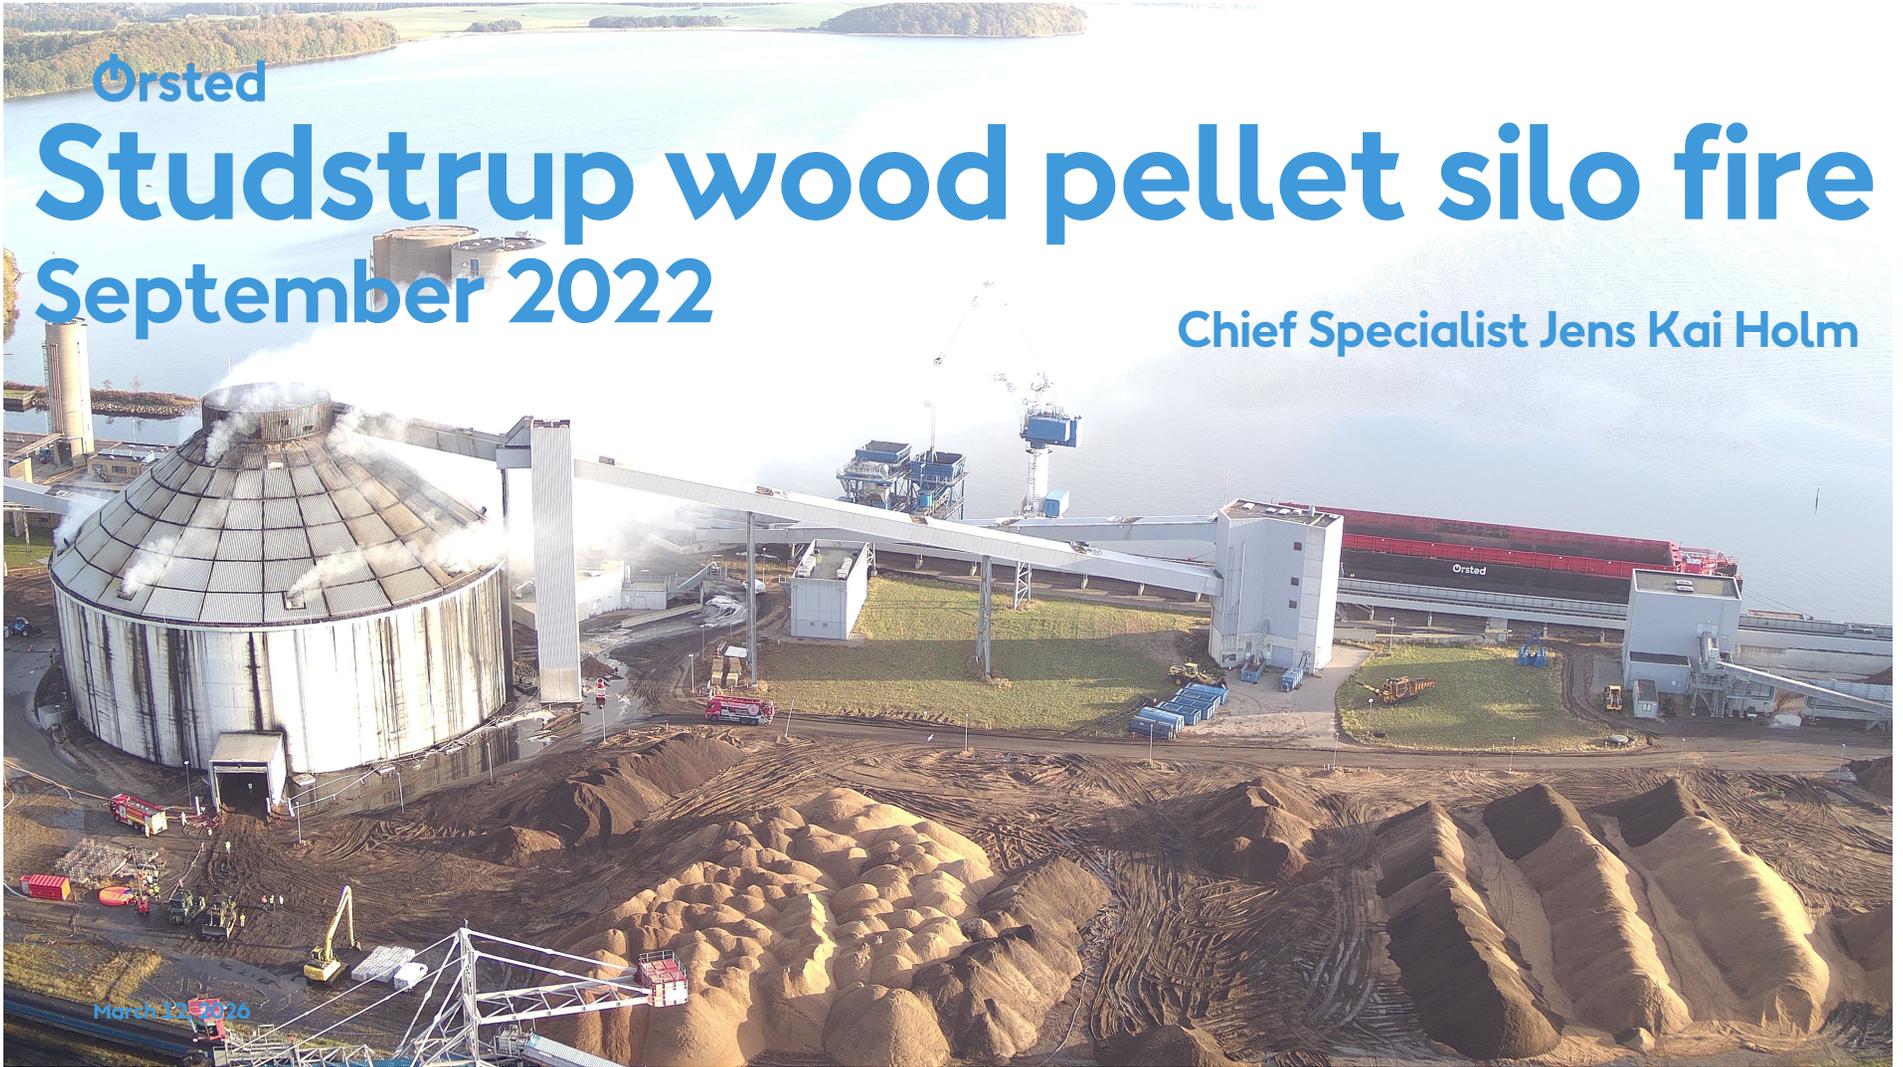
The Studstrup wood pellet silo before the fire

- Volume: 100.000 m³
- Wood pellet total capacity: 65.000 tons
- Constructed in 2015, the silo was fitted with detection systems in line with the consultants' best-practice recommendations

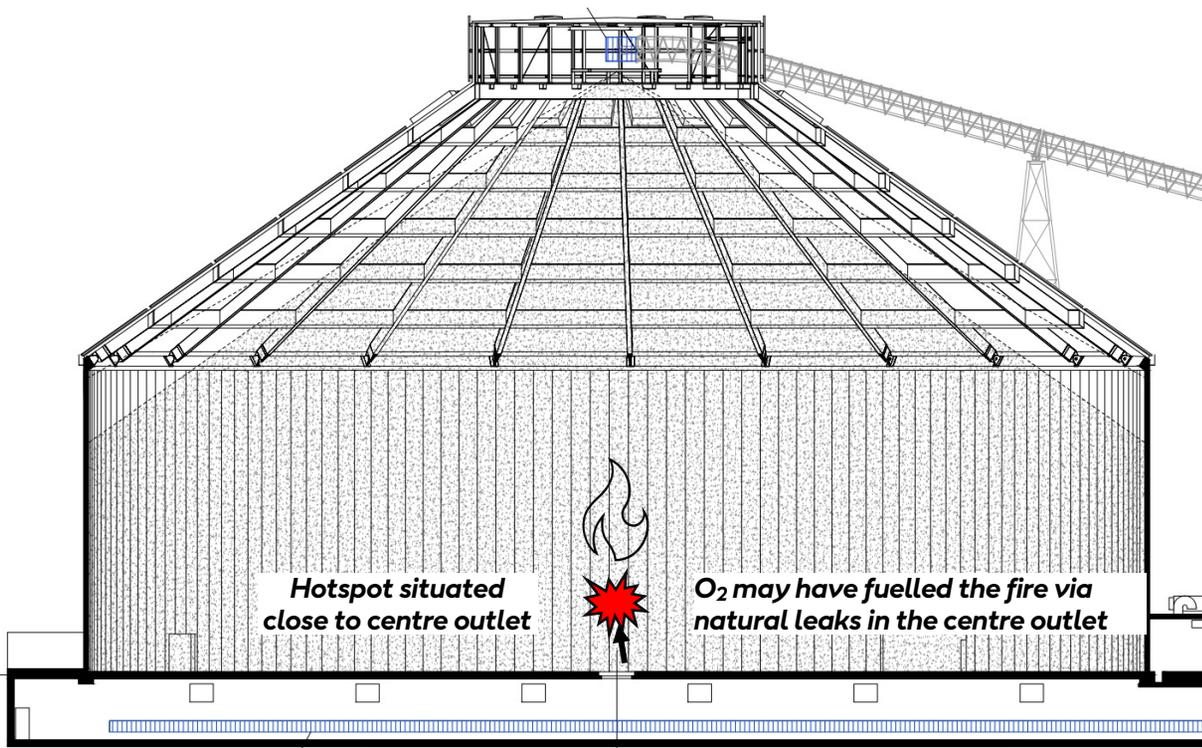
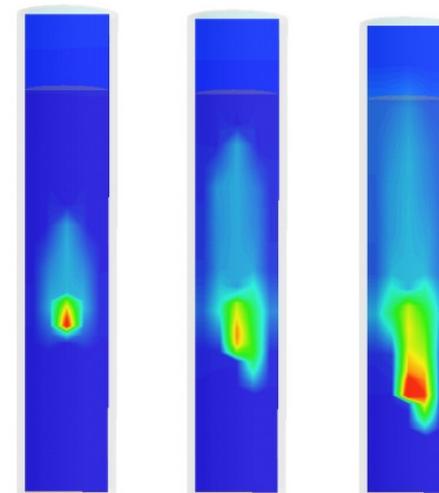
Root cause conclusion: Late detection of a deeply buried smouldering hotspot resulting from critical self-heating

Time : 10h Time : 20h Time : 30h
Silo Fires Report* (Henry Persson)

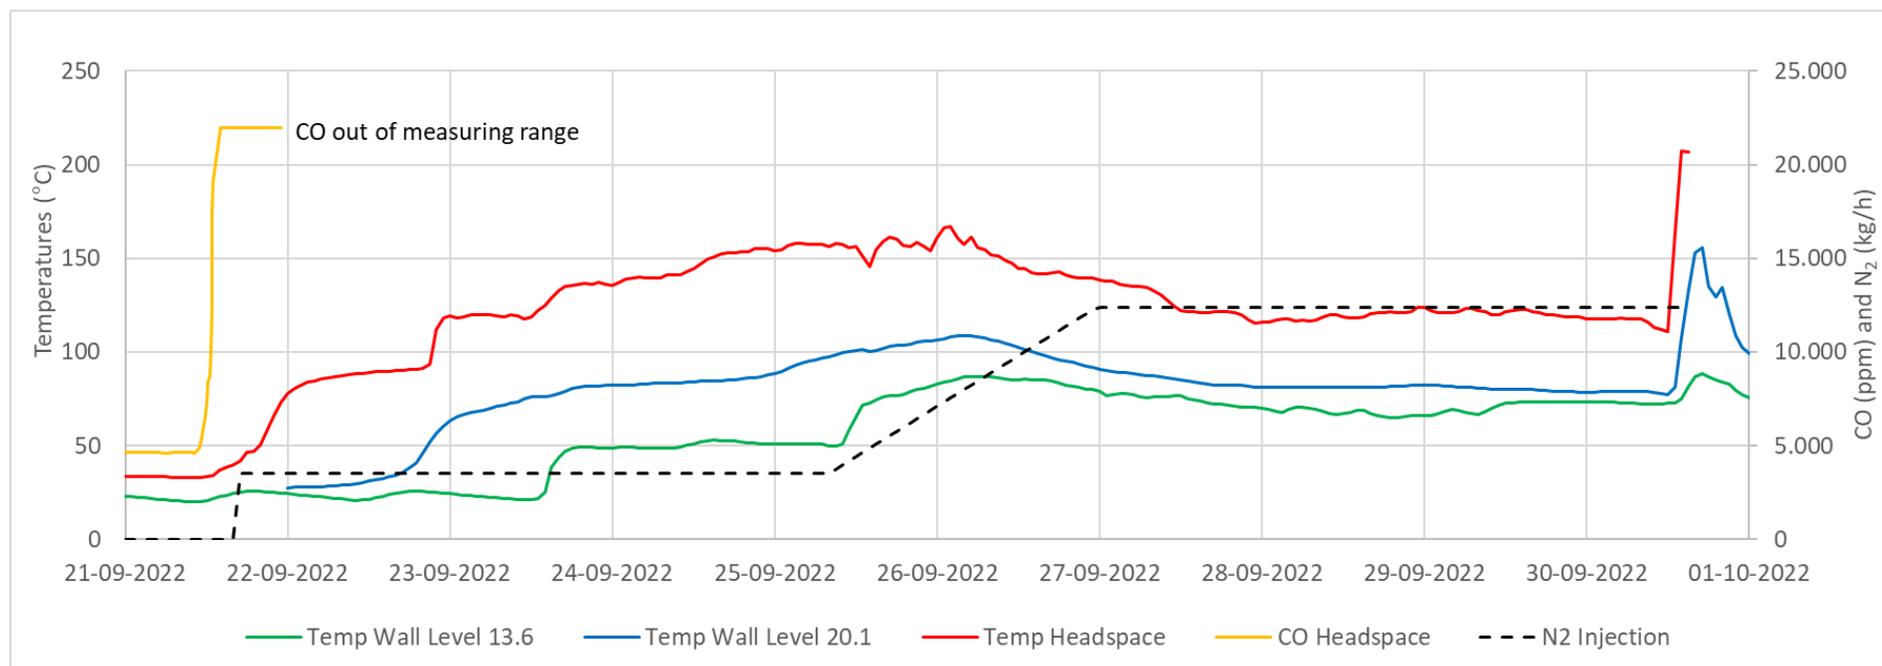
The first indication of critical self-heating was a rapid rise in CO concentration in the silo headspace

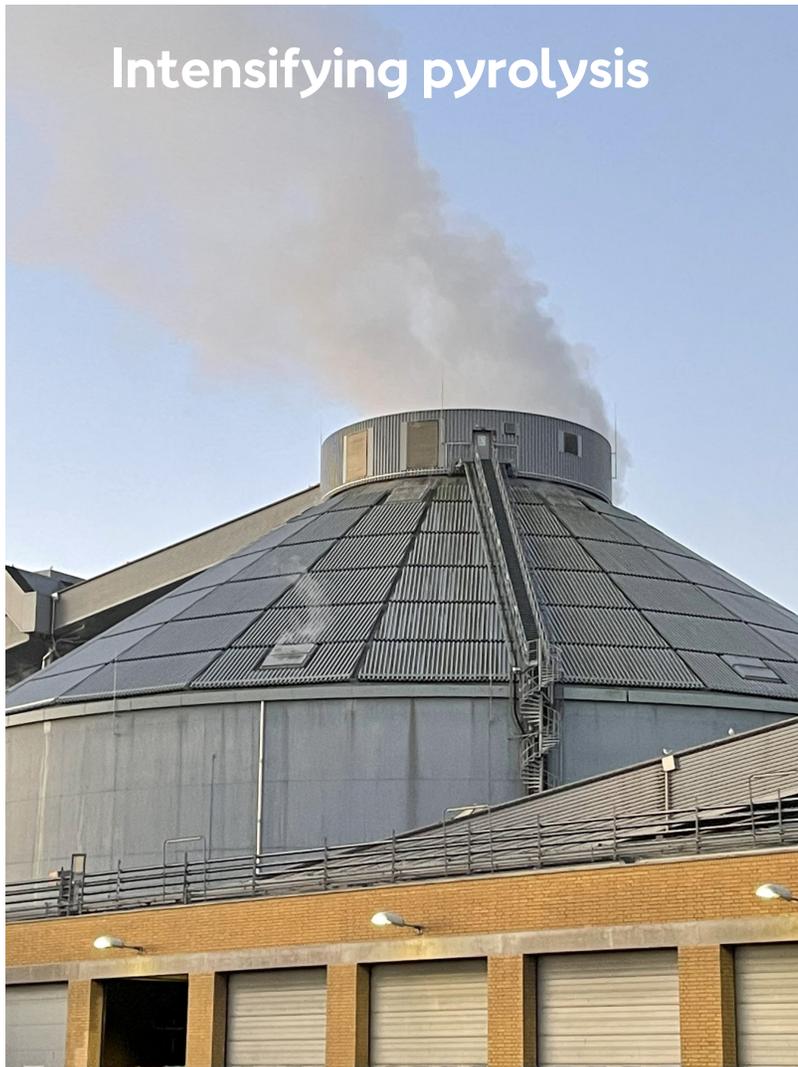
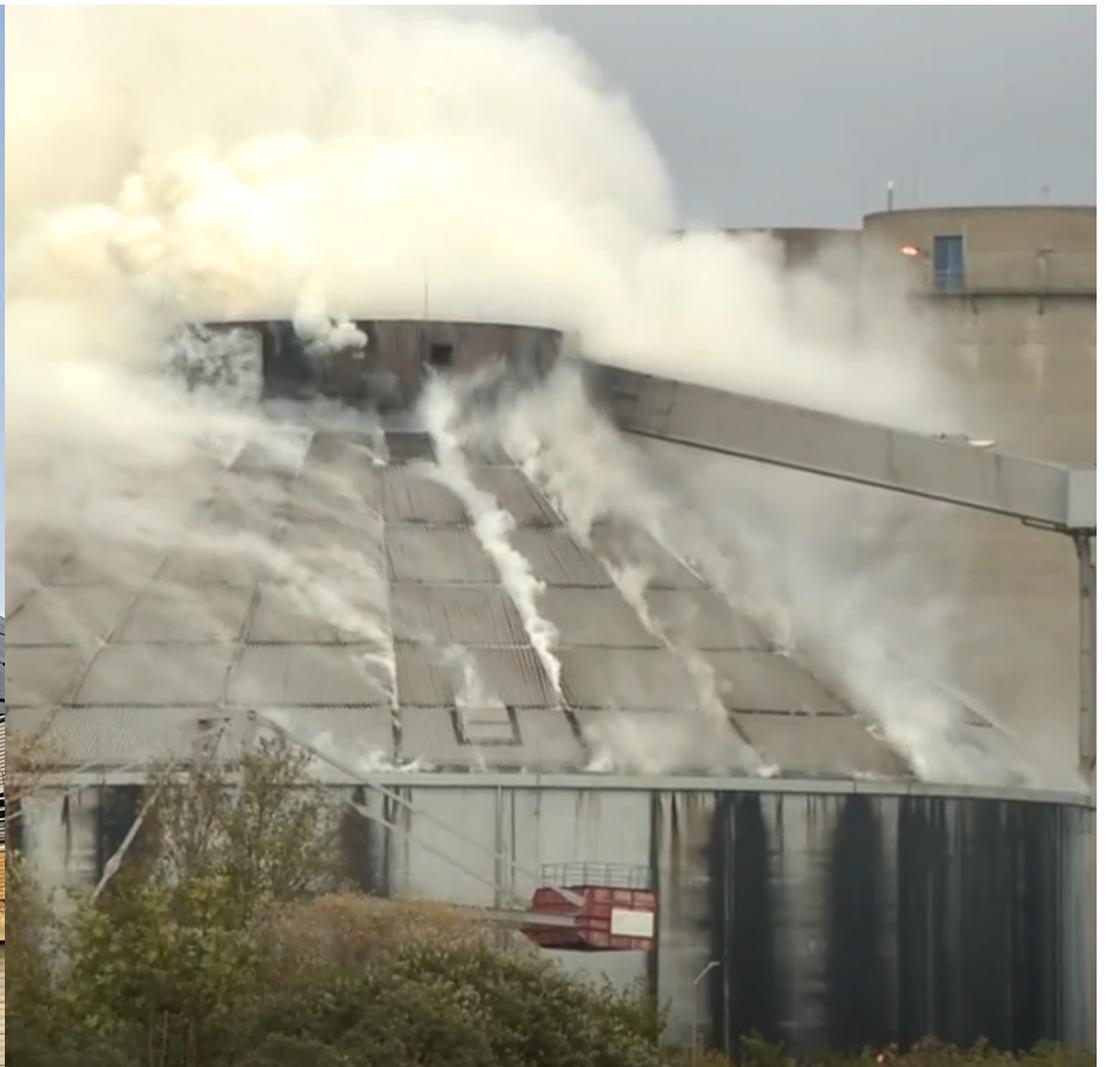
Intensifying pyrolysis

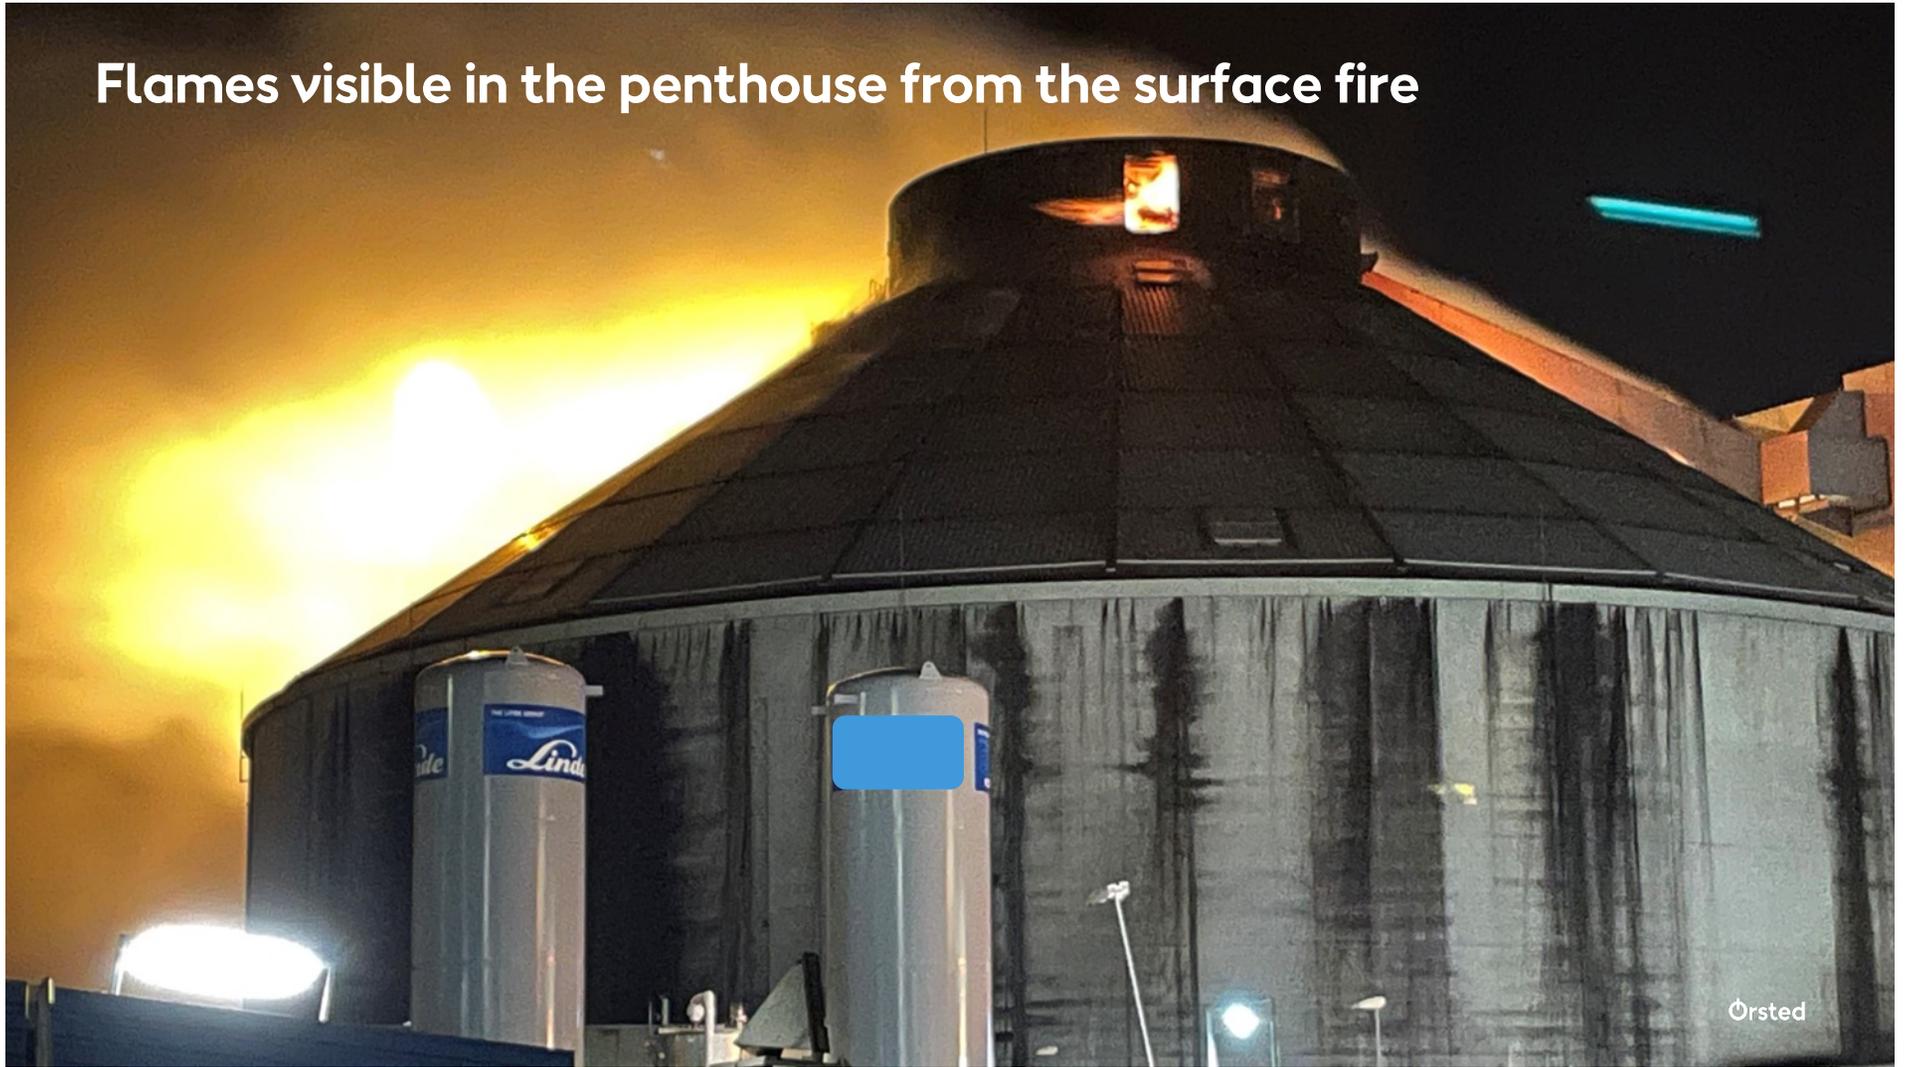
Flames visible in the penthouse from the surface fire

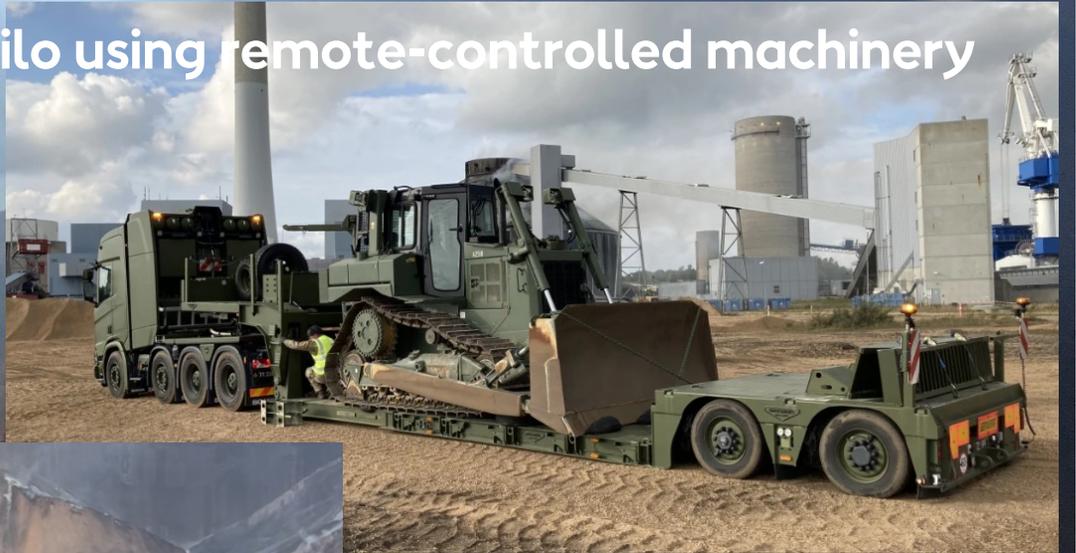
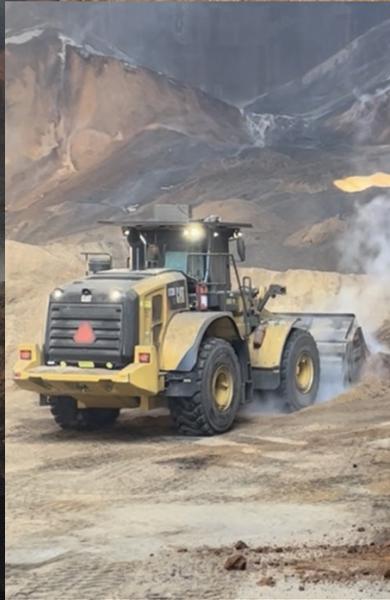
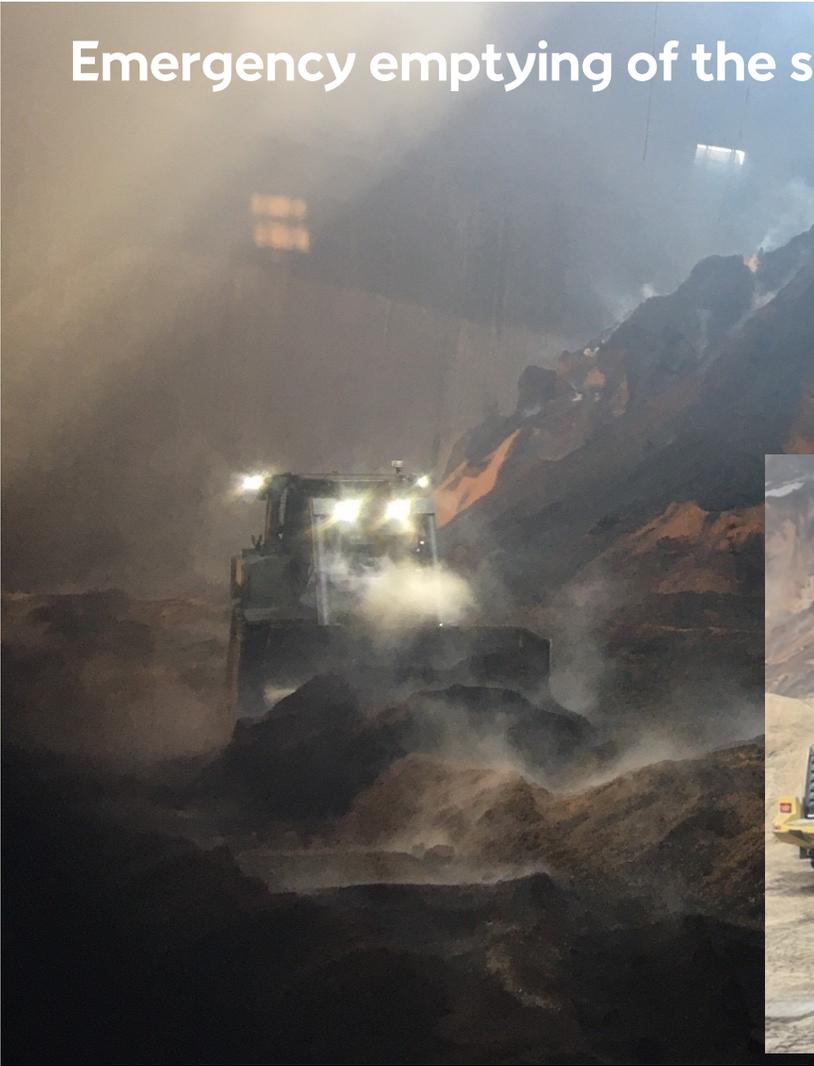
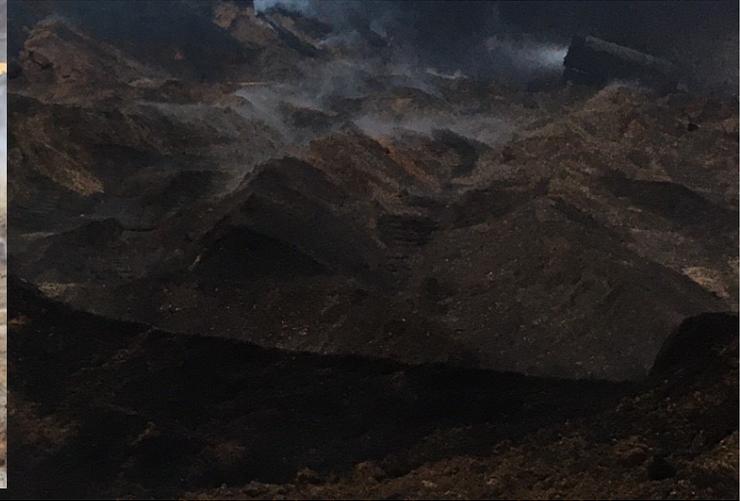
Emergency emptying of the silo using remote-controlled machinery

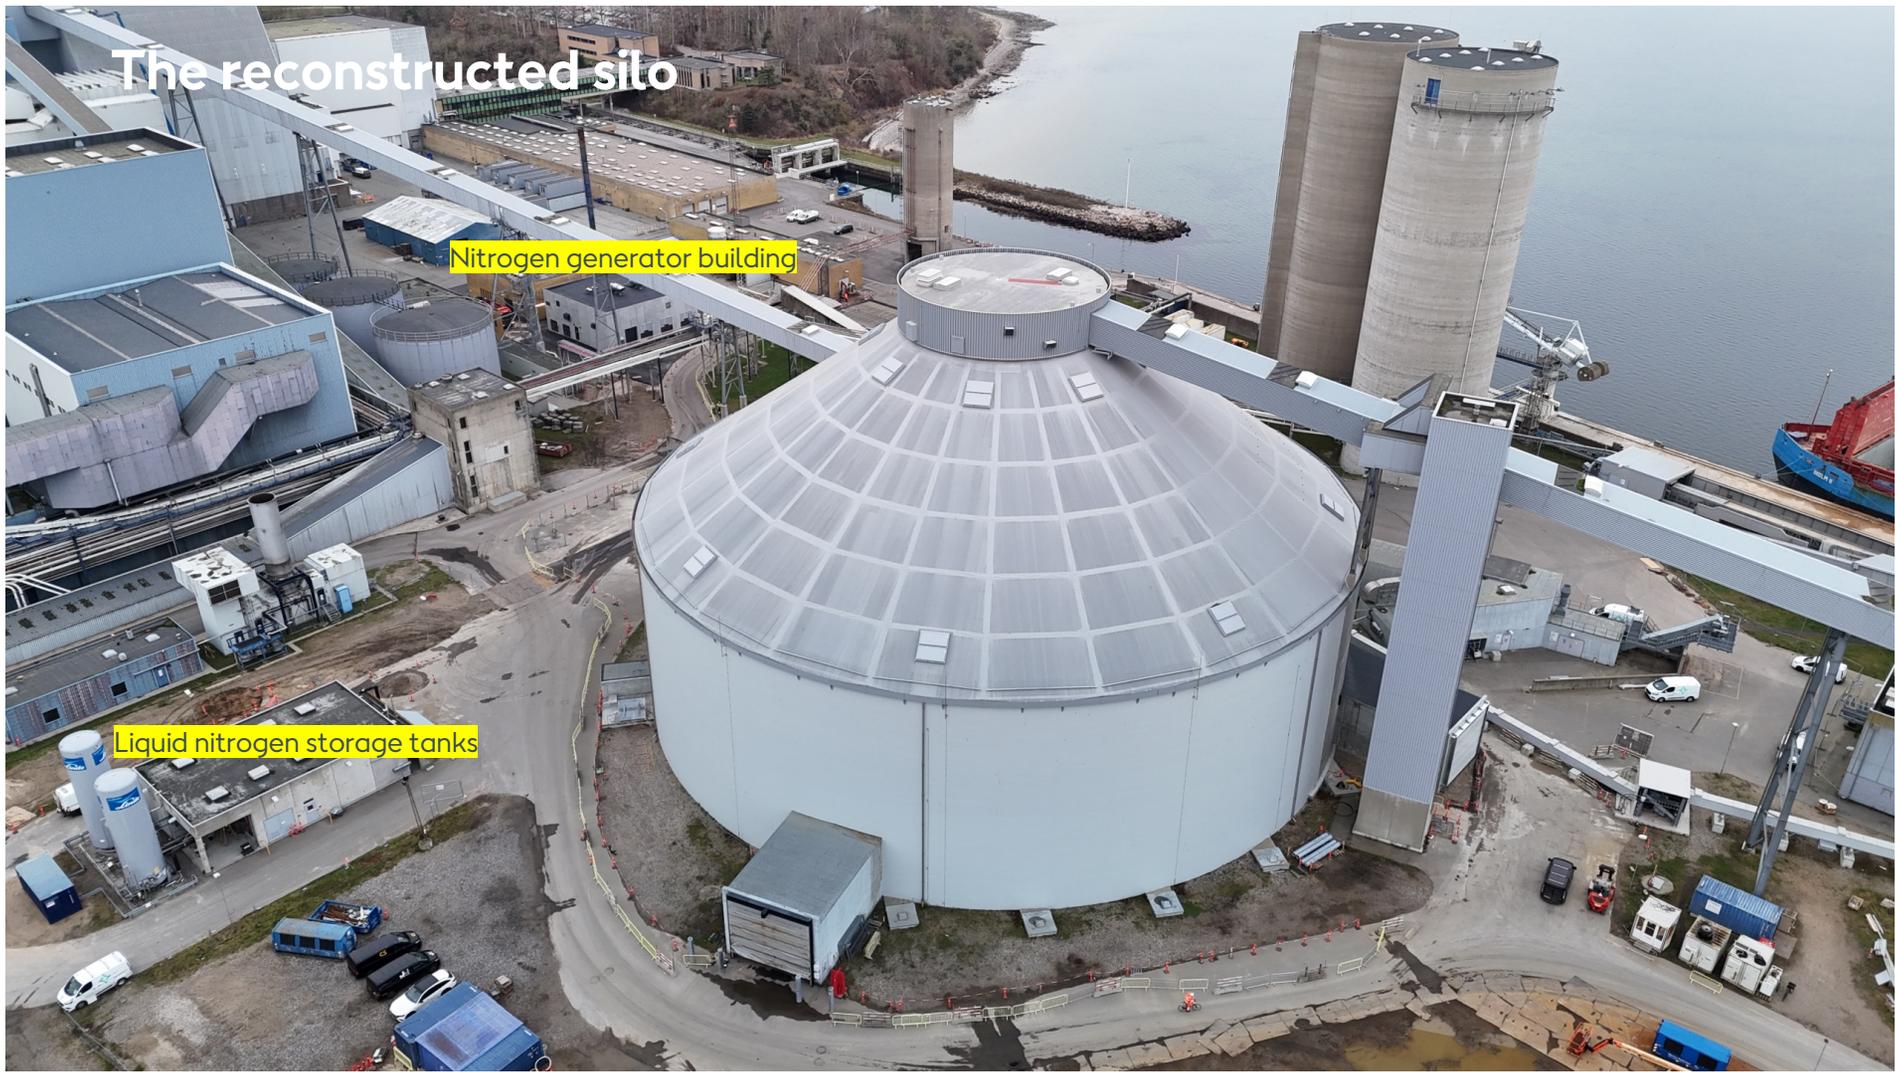
The reconstructed silo

Nitrogen generator building

Liquid nitrogen storage tanks

- **Temperature monitoring:** Increased from 6 (free hanging) to 65 (fixed) thermocouples cables (~2.000 measurements)
- **Gas monitoring:** CO, CO₂, and O₂ probes extract gases from the headspace (replacing smouldering detectors)
- **Nitrogen purging:** Continuous purging lowers oxygen; also increases gas diffusion to headspace
- **Water mist (headspace):** Sectionalized system to control headspace temperature (not for extinguishing)
- **Conveyor upgrades:** Central and side conveyors equipped with water mist and temperature sensors
- **Access:** Added two extra gates for efficient emergency emptying with wheel loaders
- **Wheel loaders:** Three remote-controlled, ATEX-approved wheel loaders shared across Ørsted sites
- **Roof monitoring:** High-temperature sensors installed on roof construction

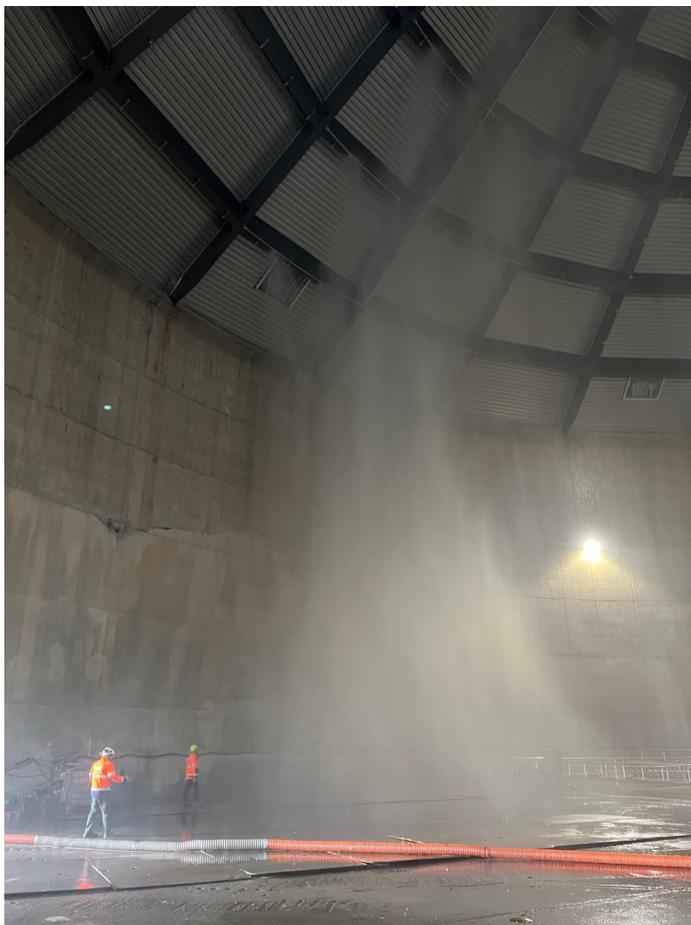
Test of water mist system in one section

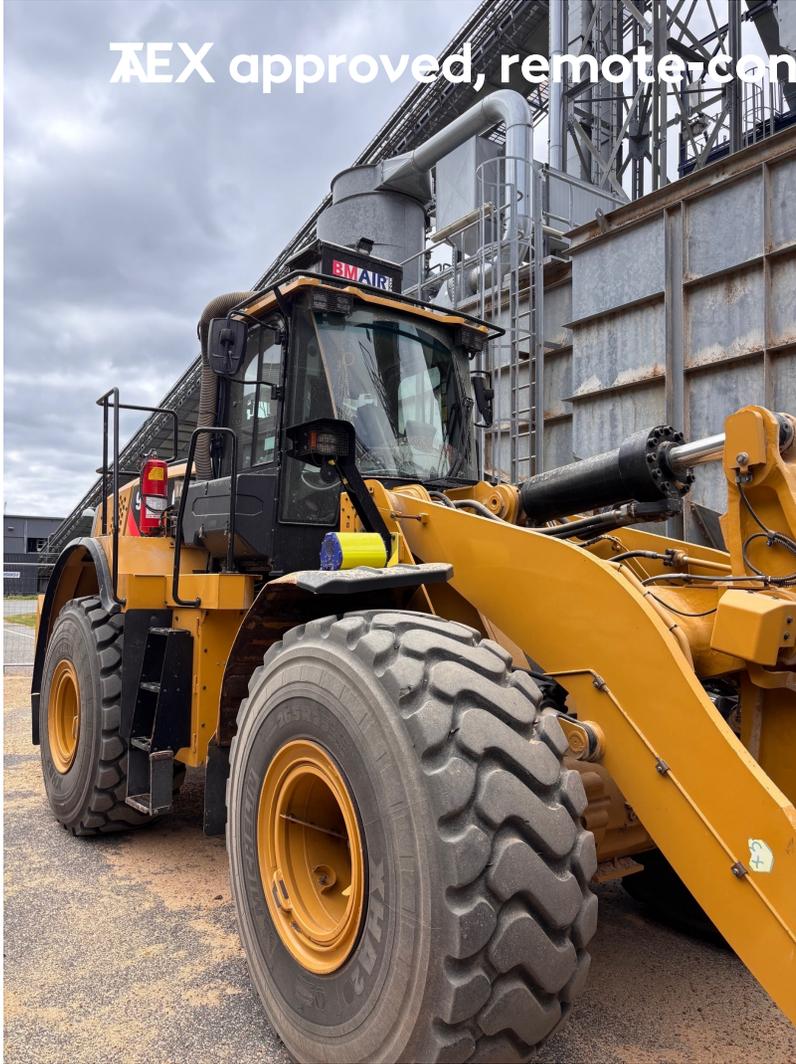
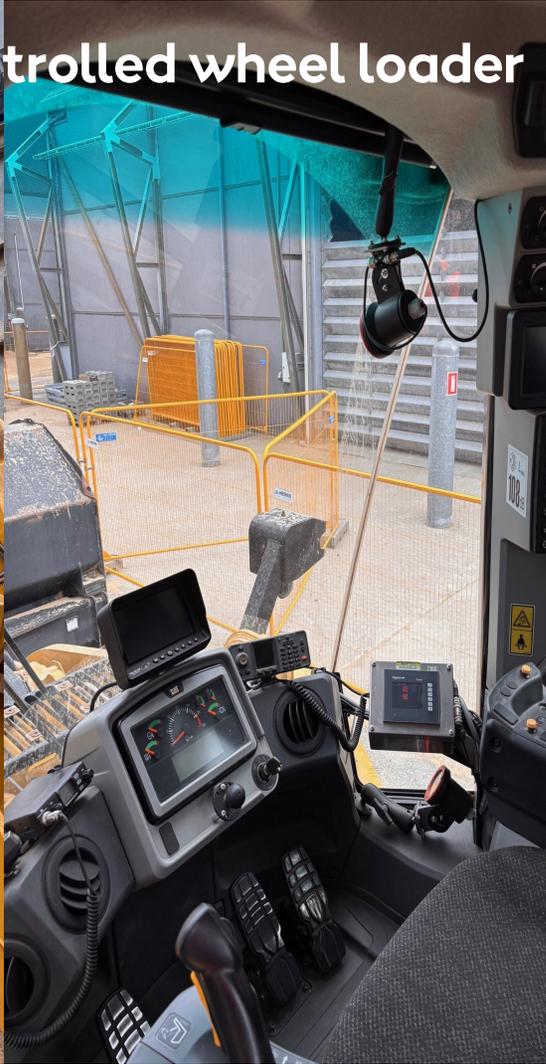
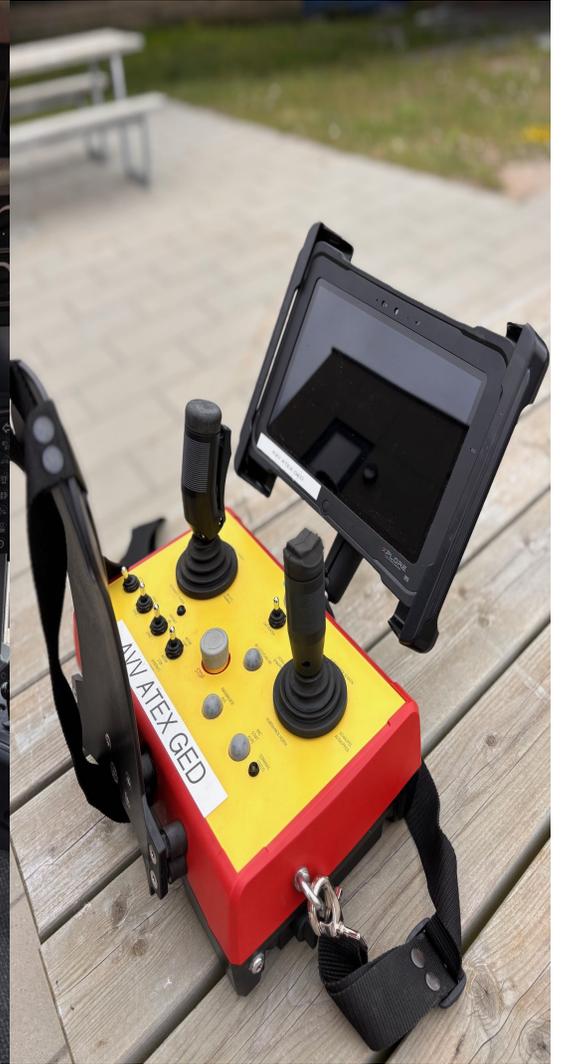
ÆX approved, remote-controlled wheel loader

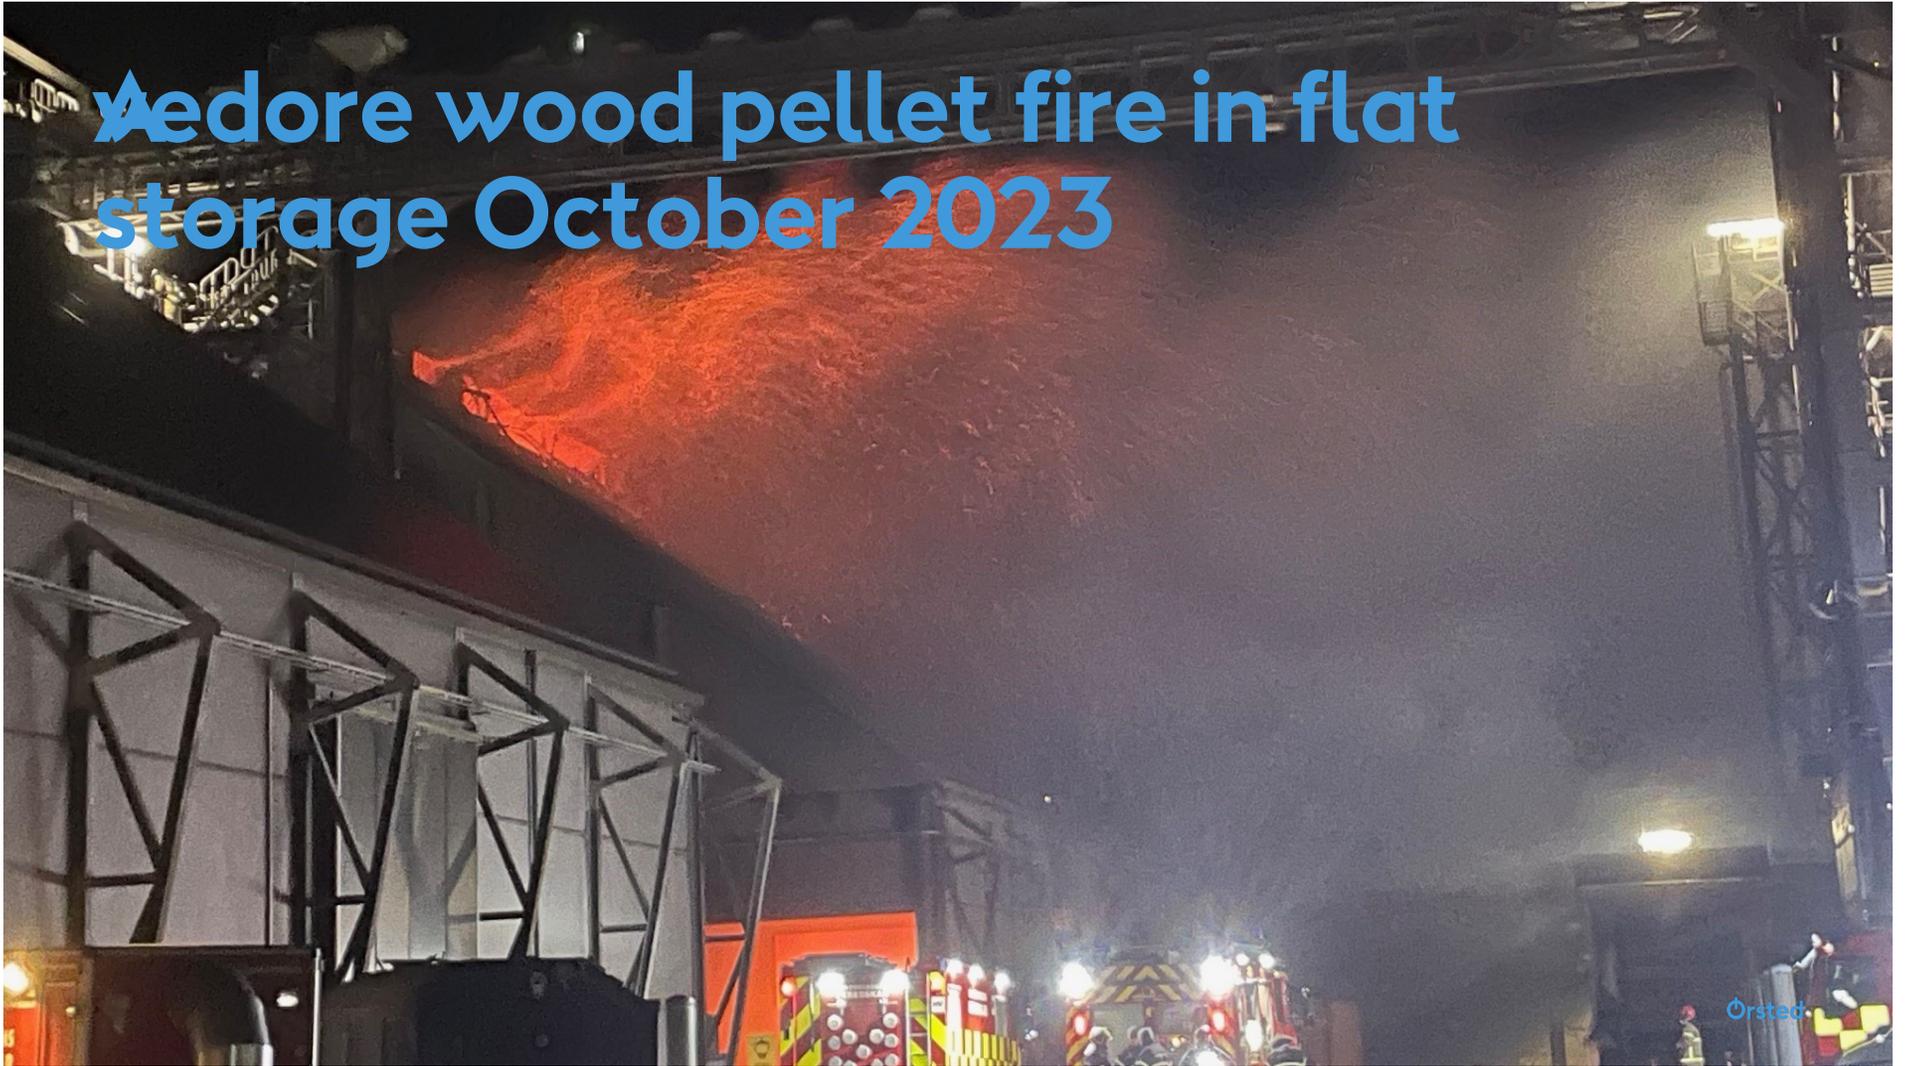
Aedore wood pellet fire in flat storage October 2023

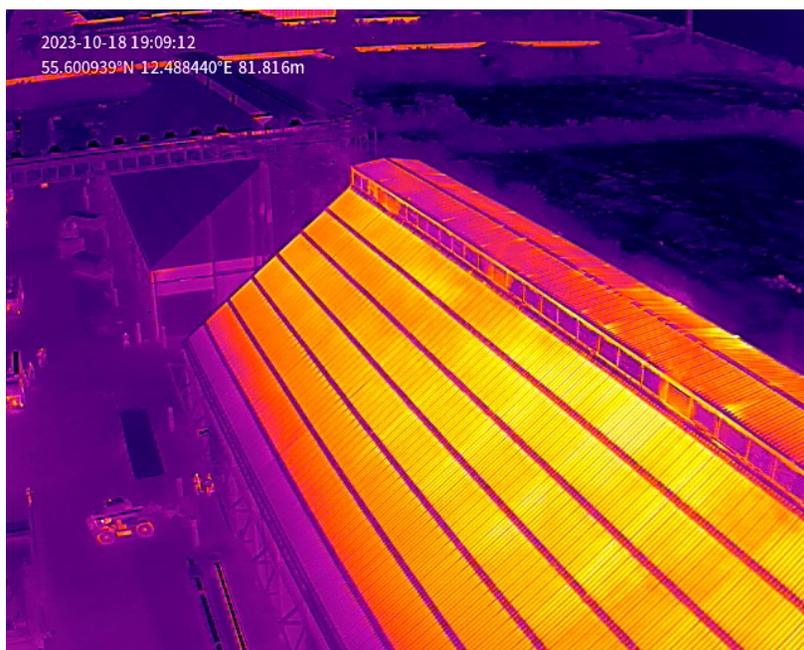
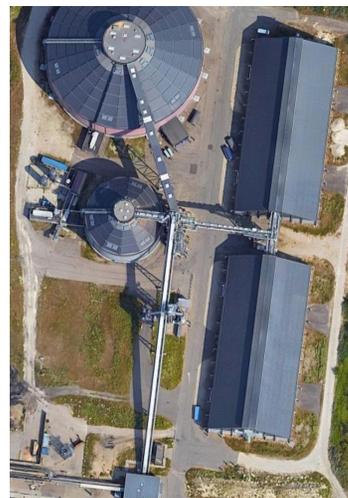
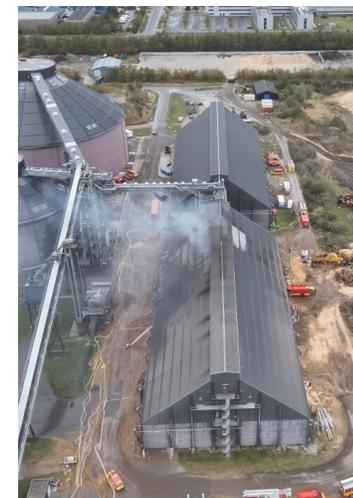
Smouldering fire in flat storage was first realized when white smoke was seen from the roof top

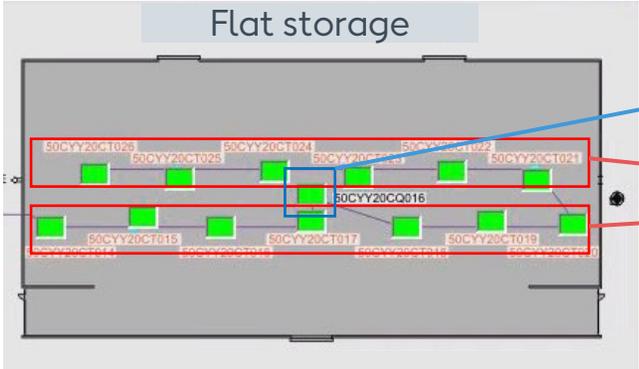
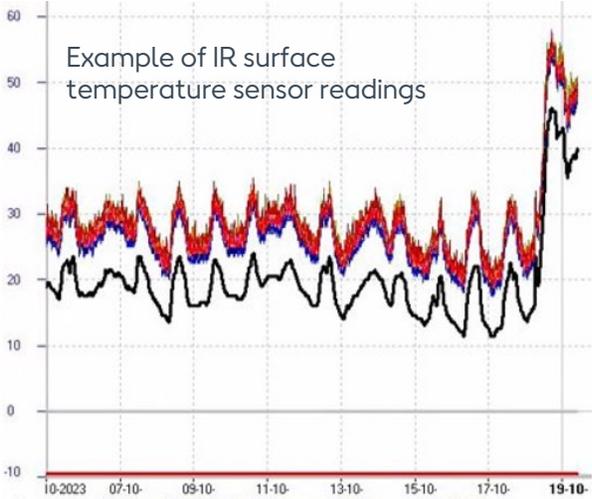
Root cause conclusion: The monitoring systems failed to detect the smouldering fire in time to allow a controlled response

Primary barriers	Remarks
Smouldering gas detector	No clear alarms and insufficient data on absolute gas concentrations
IR surface temperature sensors	No temperatures above 45 °C was measured before Oct 19, 2023
Bi-weekly inspection with mobile IR camera	No temperatures above 45 °C was measured before Oct 19, 2023

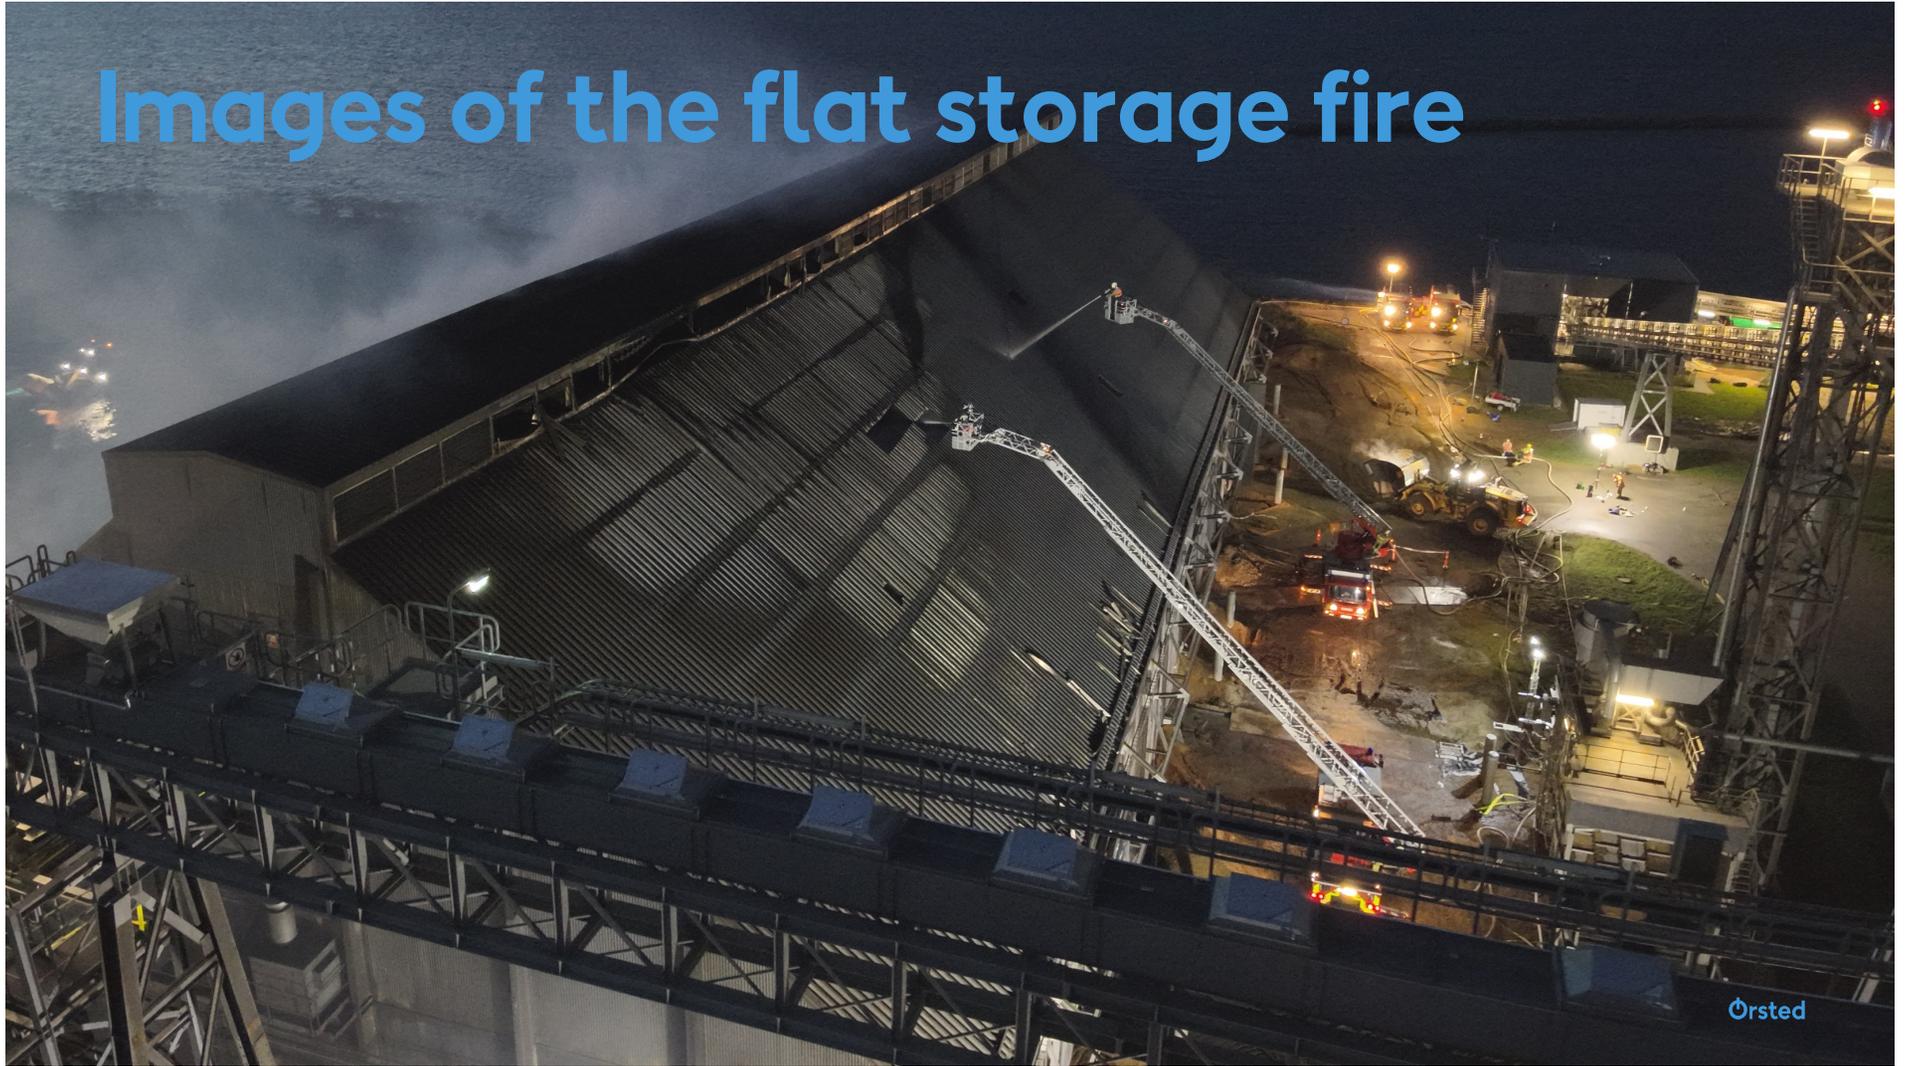
Images of the flat storage fire
