Studstrup wood pellet silo fire

September 2022

Chief Specialist Jens Kai Holm

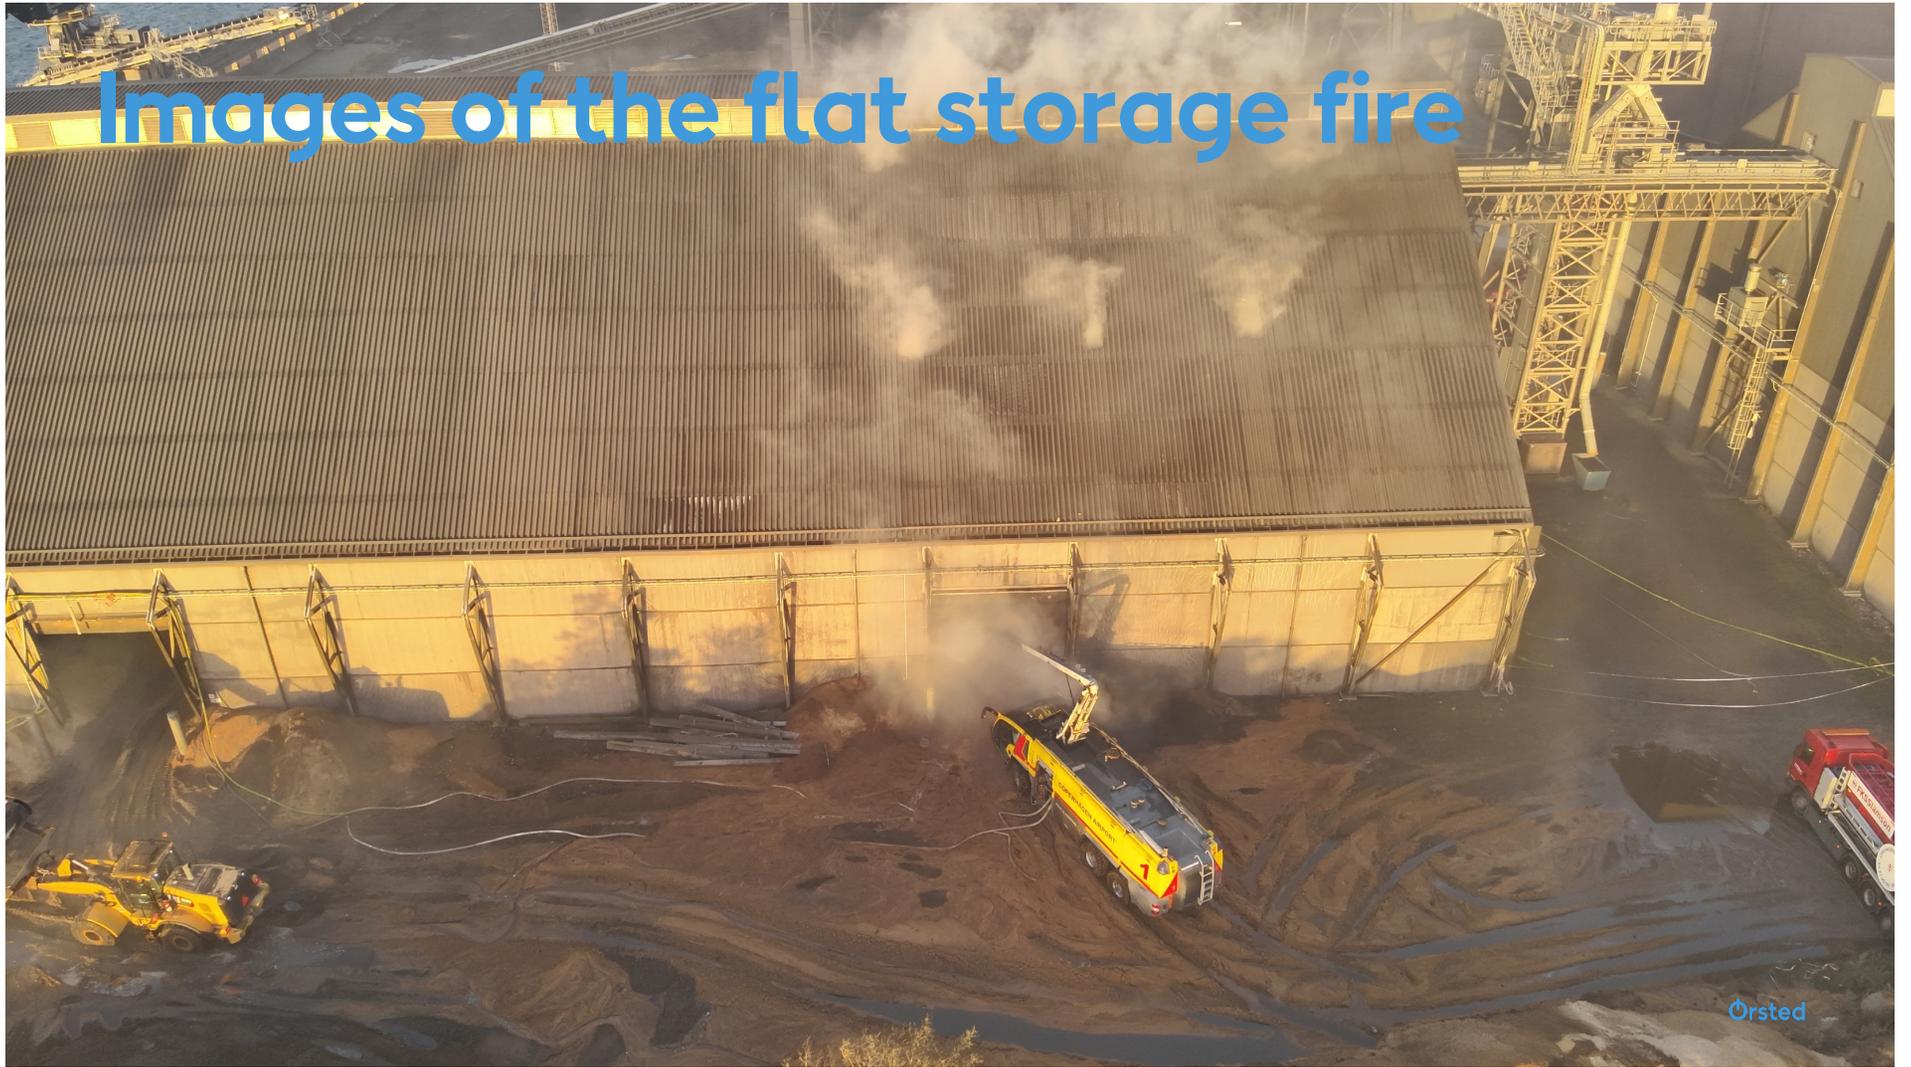
Images of the flat storage fire

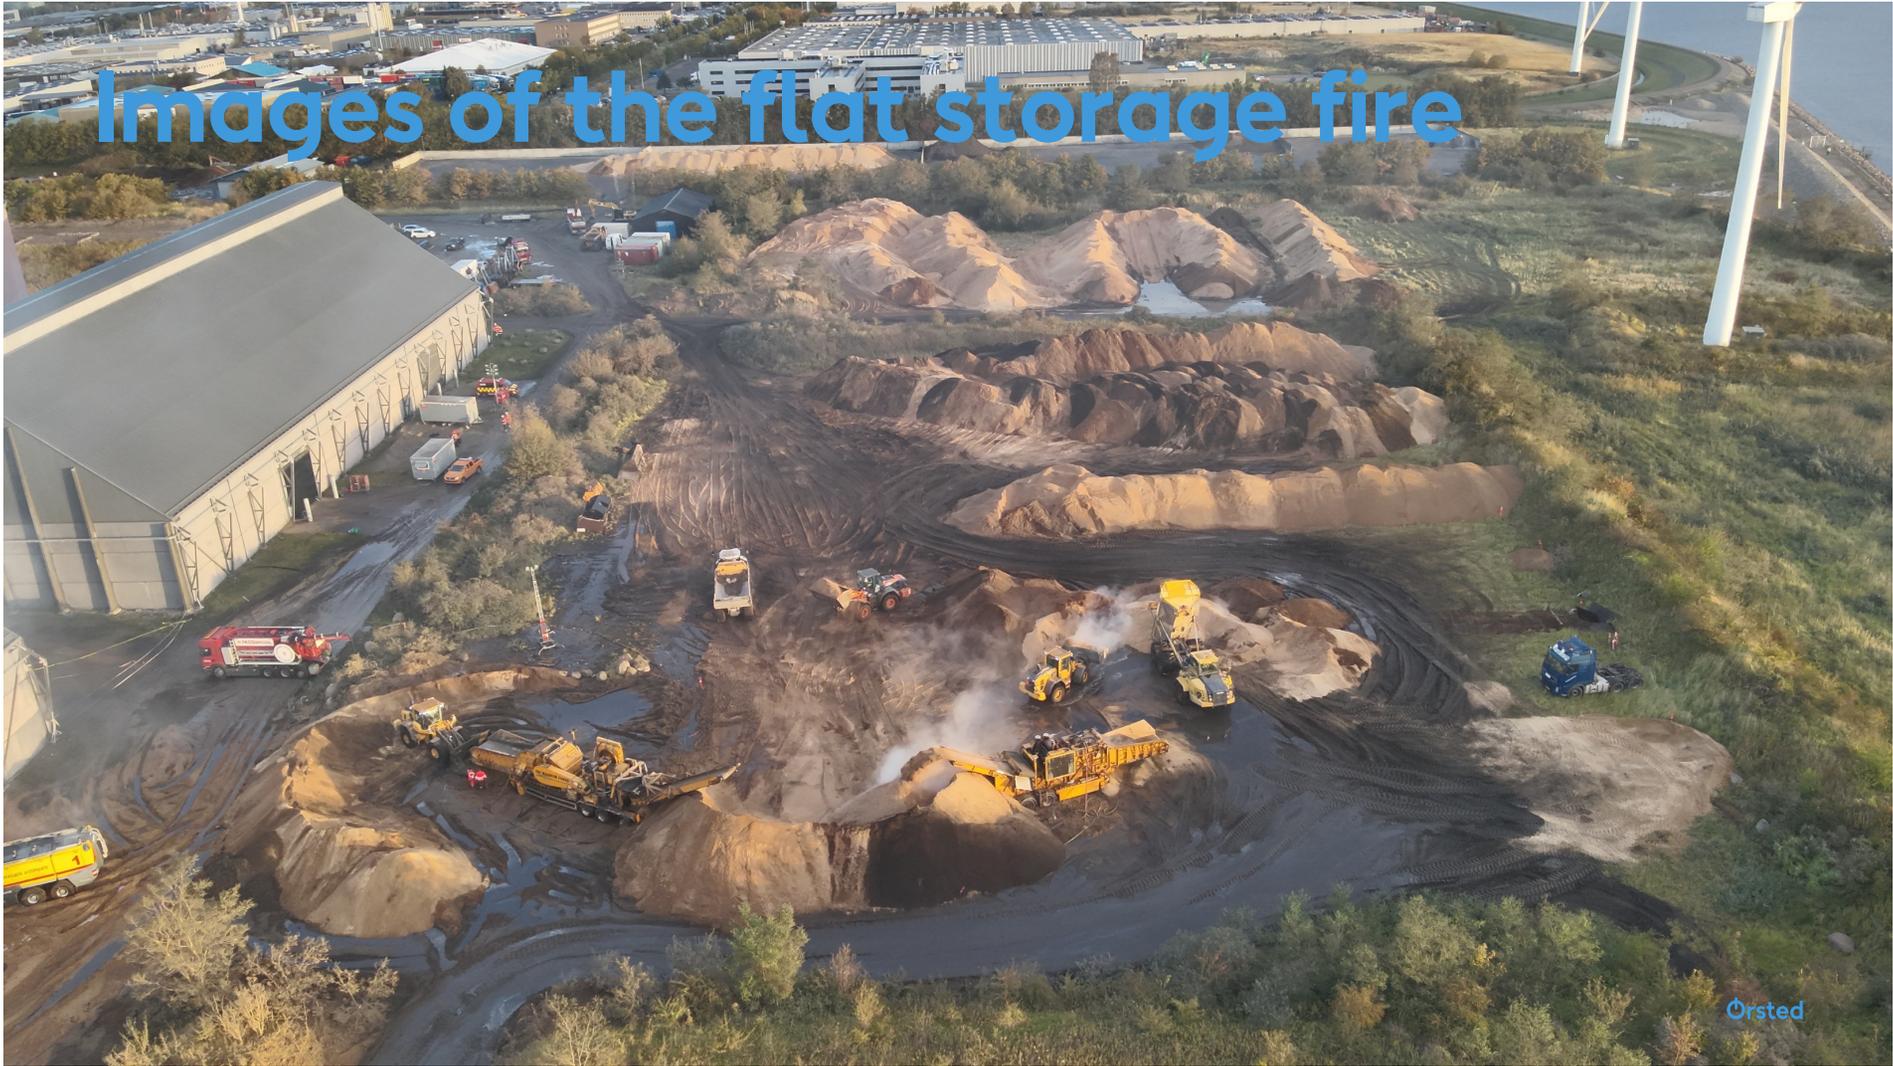
Images of the flat storage fire
