Pacific BioEnergy

SILO SMOULDER

WPAC OTTAWA

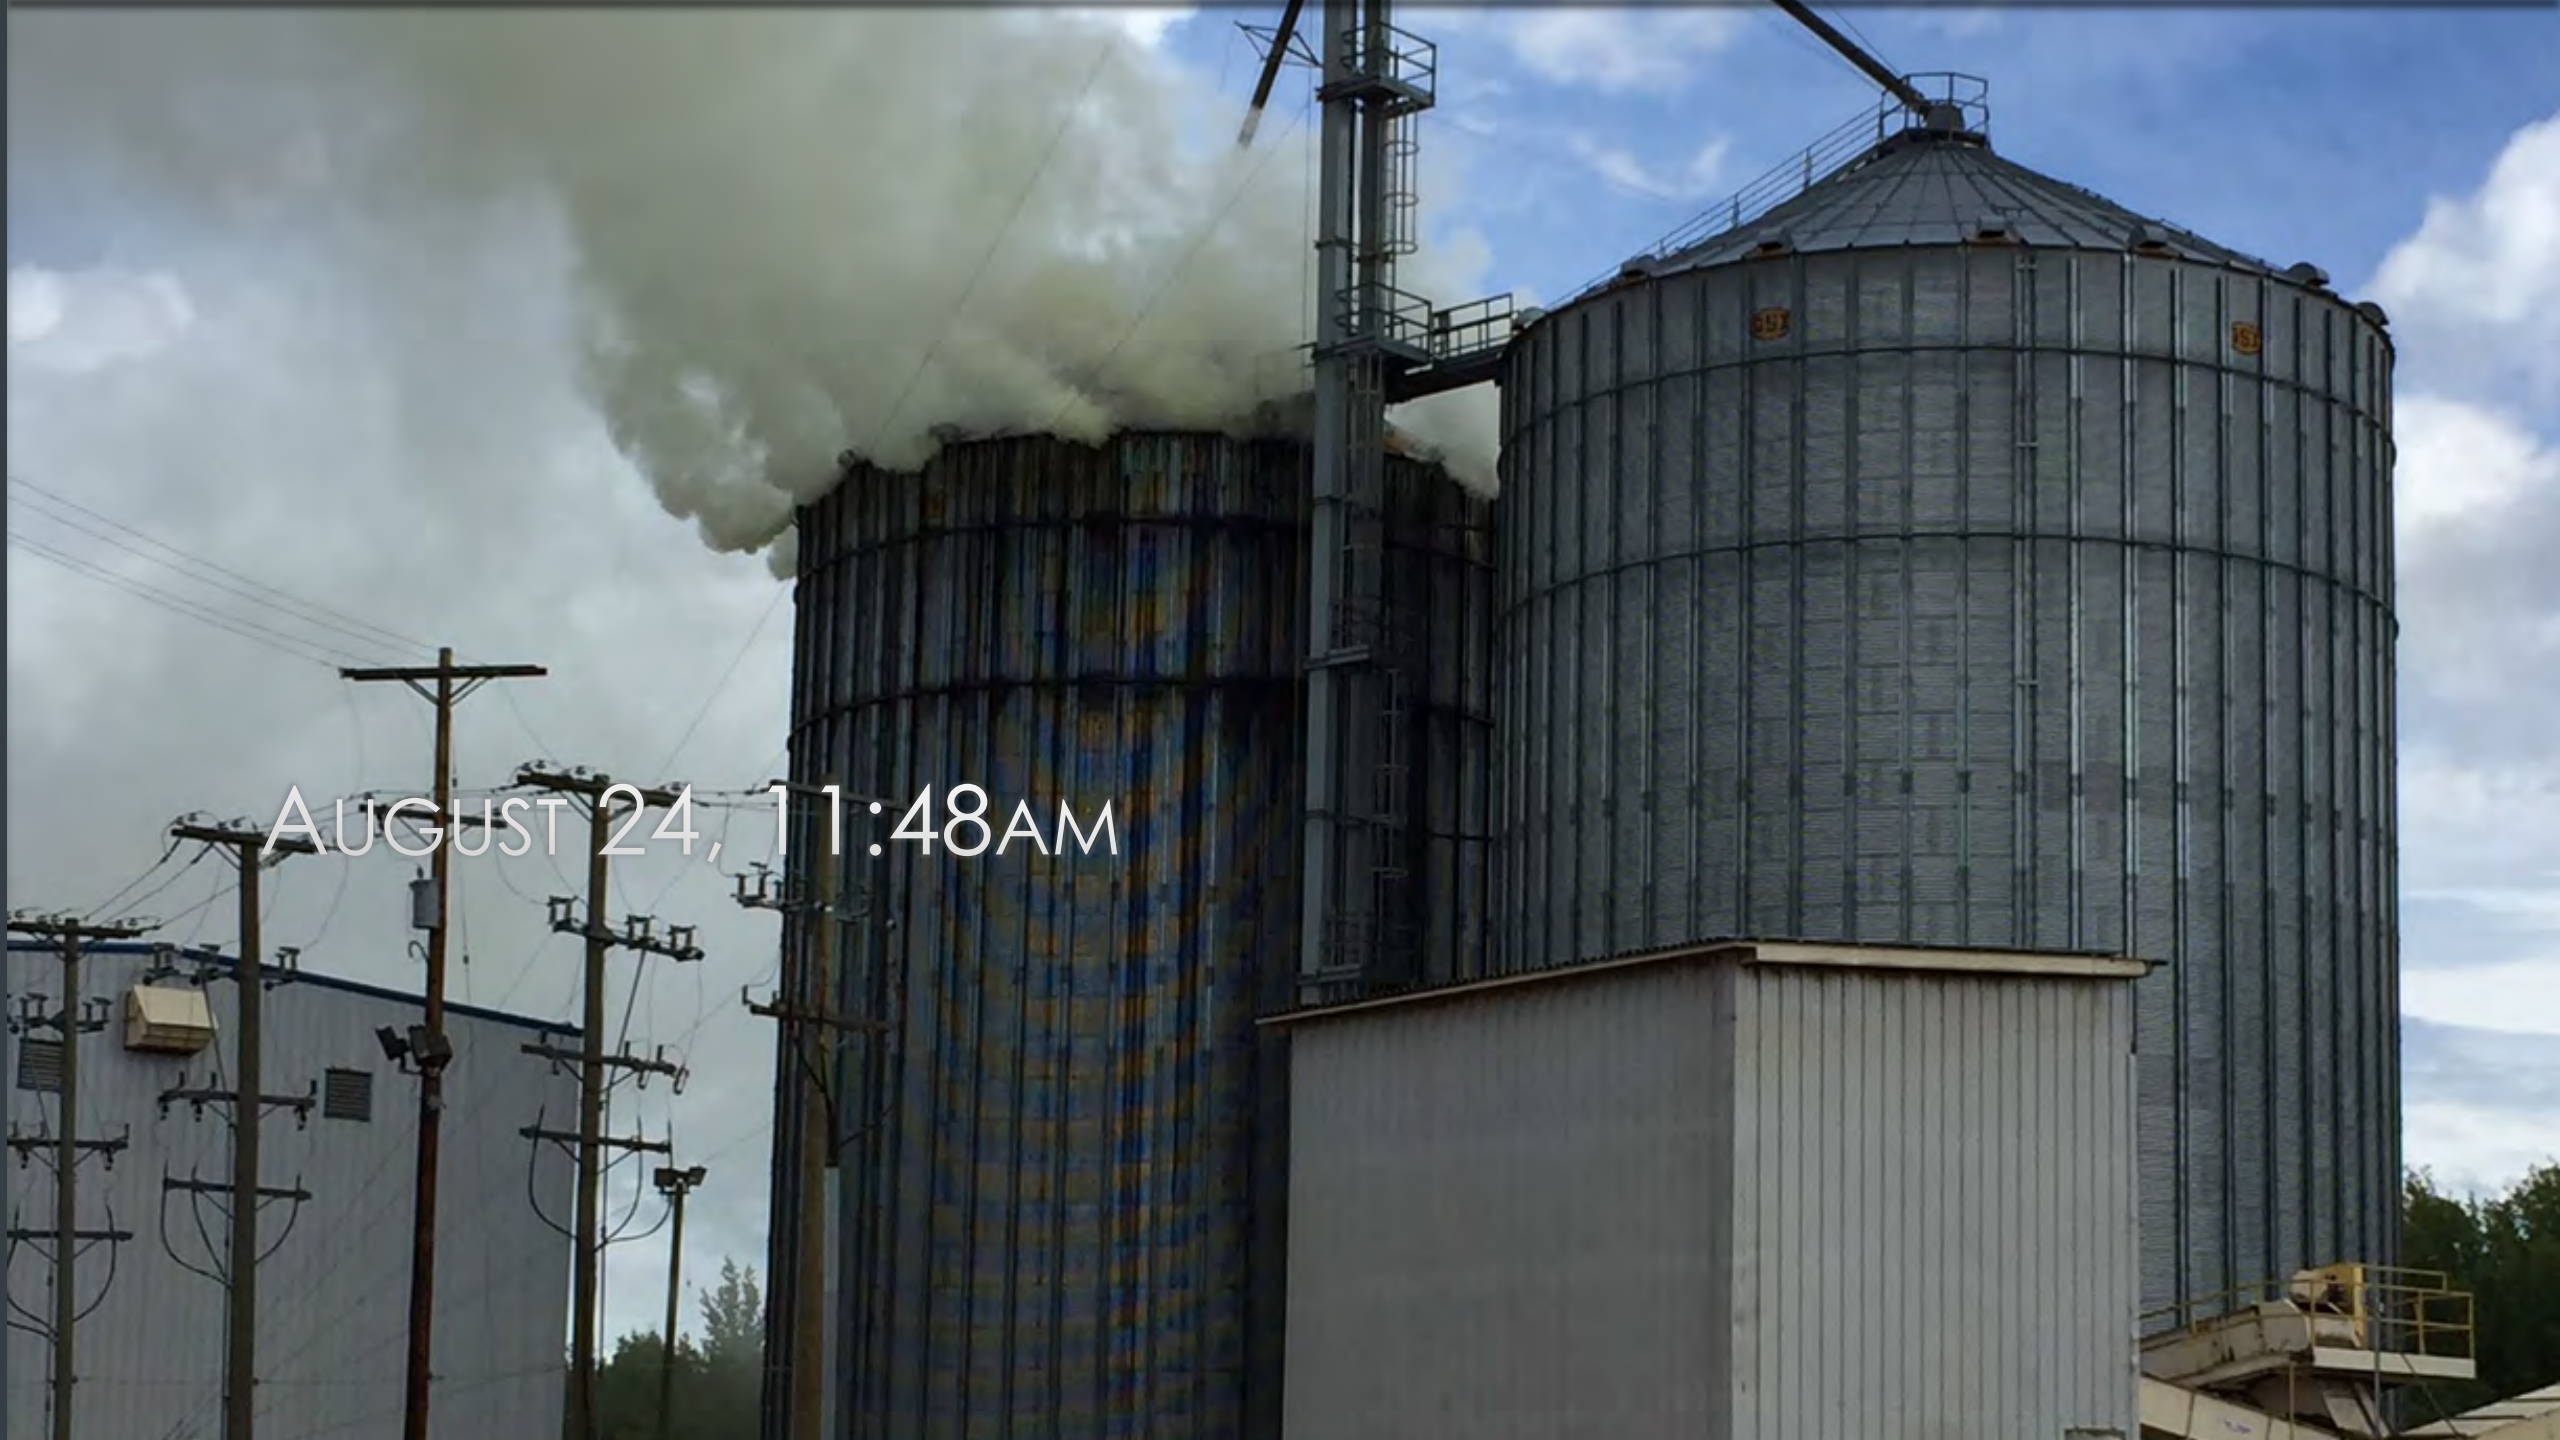
AUGUST 24, 6:52AM

The image shows two large, cylindrical industrial silos made of corrugated metal. They are situated outdoors under a cloudy sky. A tall metal structure with ladders and walkways is positioned between the two silos. In the foreground, there are utility poles with power lines. The date and time 'AUGUST 24, 6:52AM' are overlaid in white text on the left side of the image.

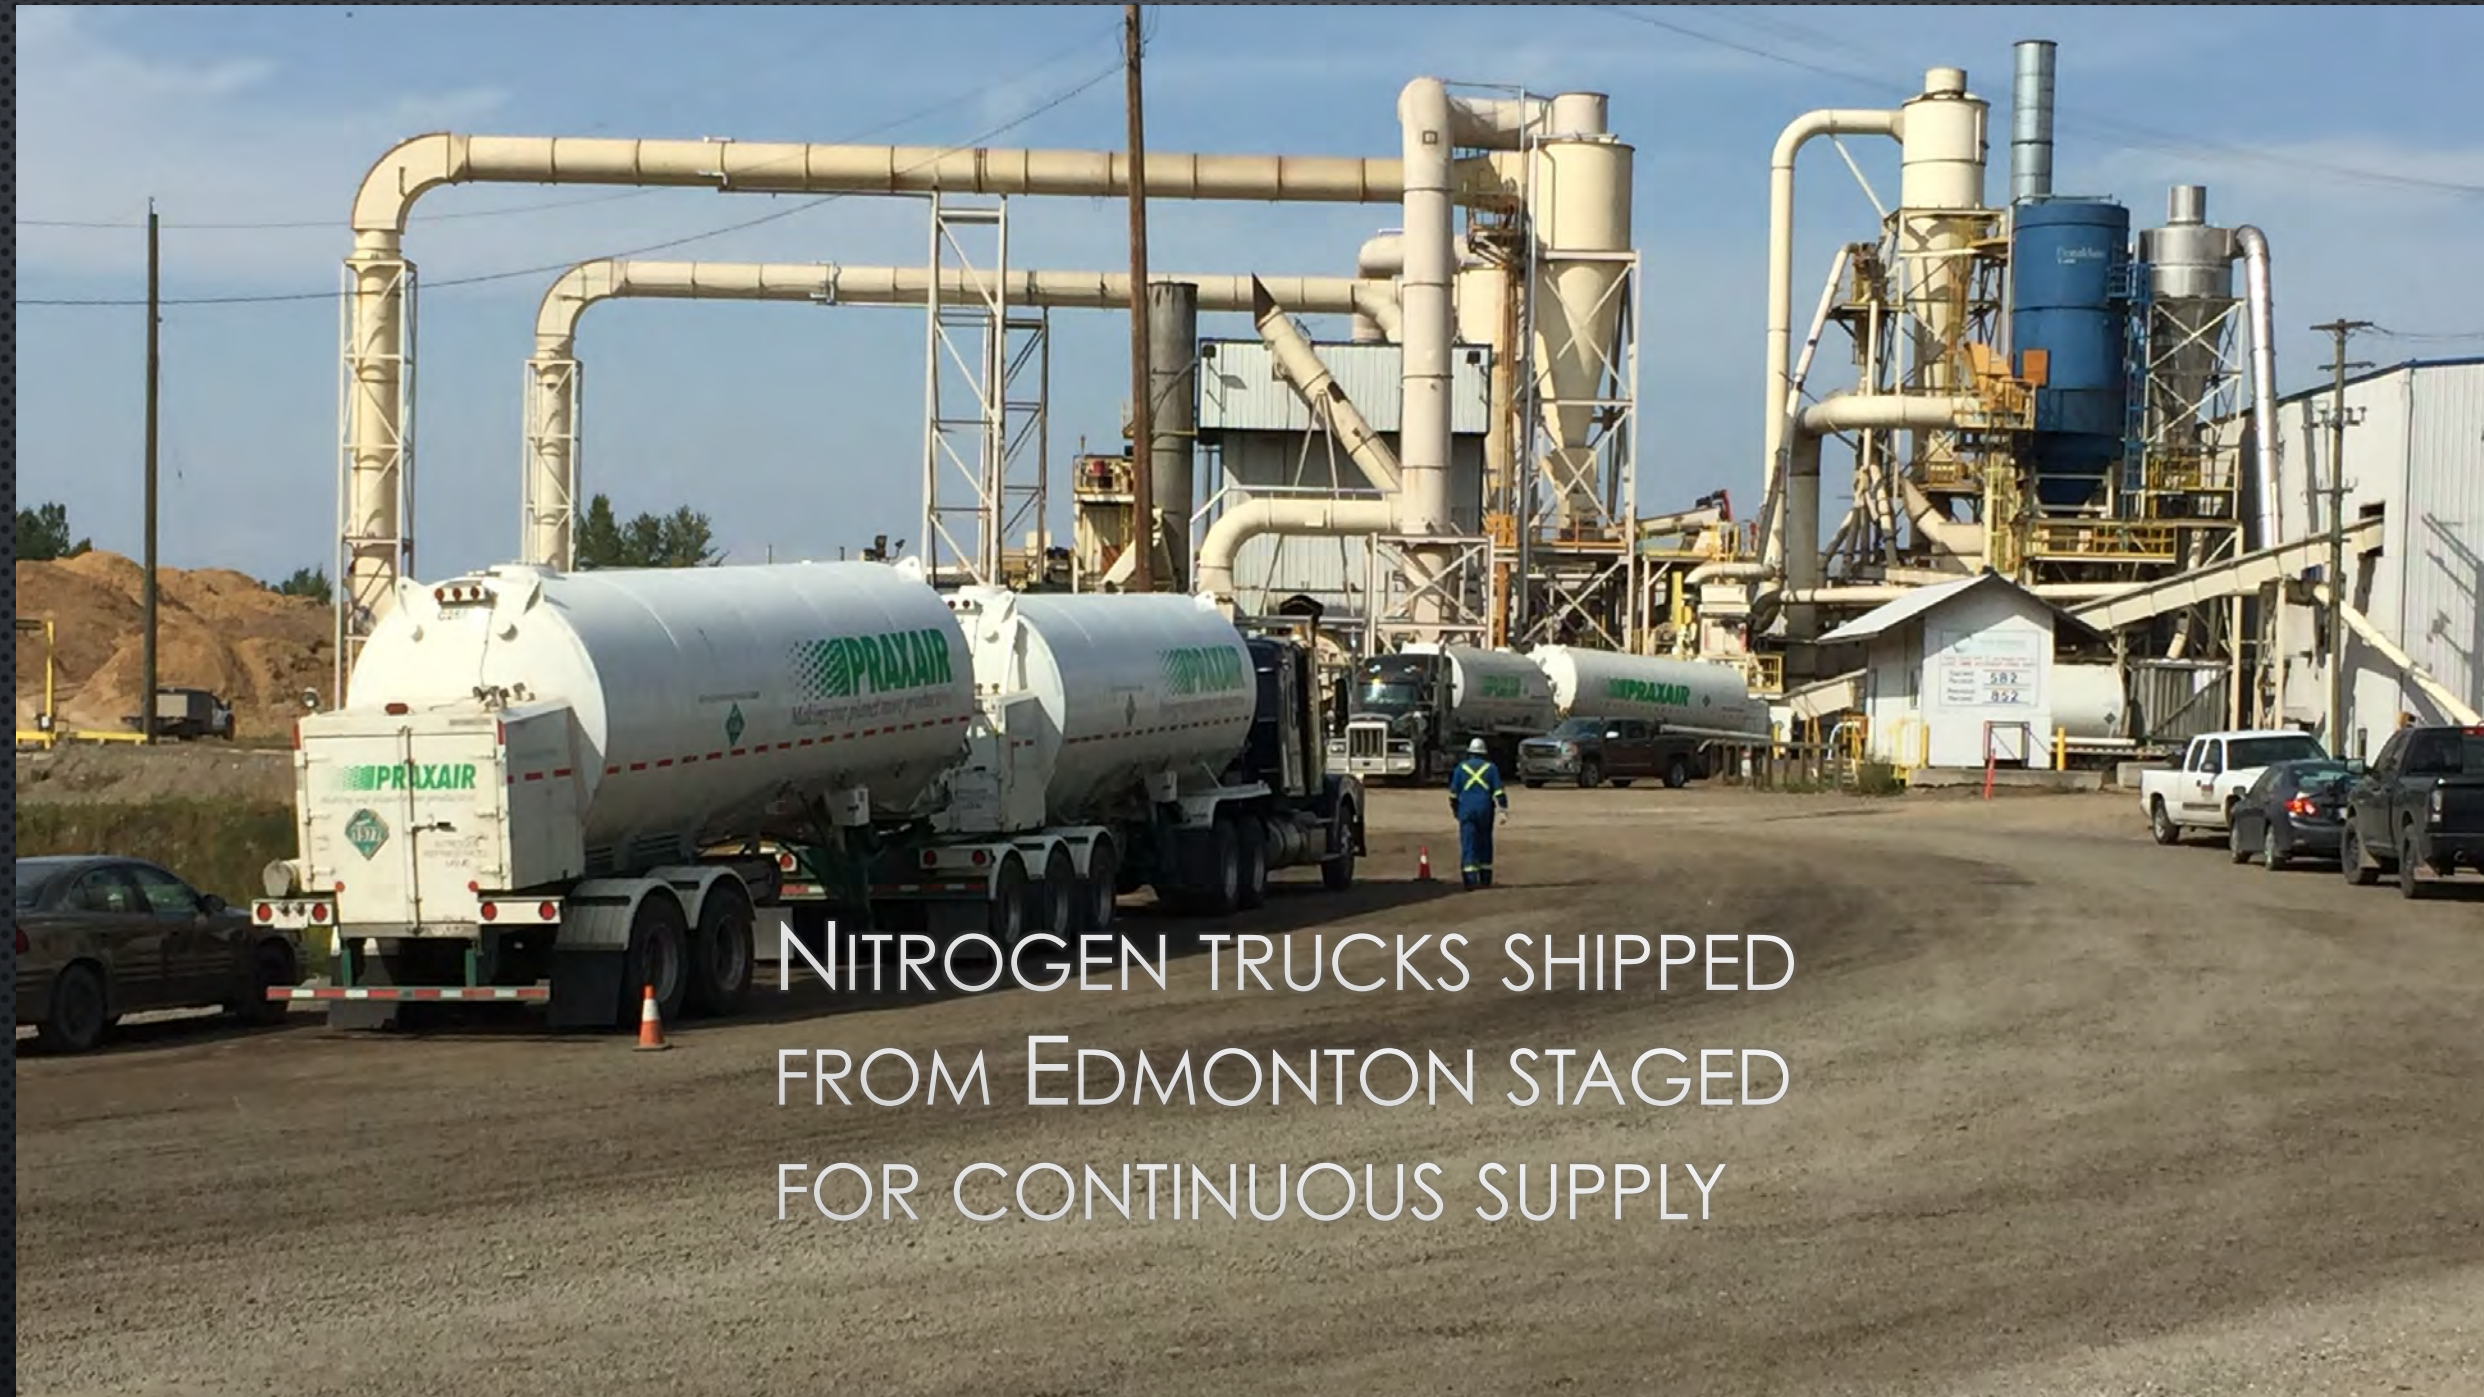
NITROGEN TRUCKS SHIPPED  
FROM EDMONTON STAGED  
FOR CONTINUOUS SUPPLY

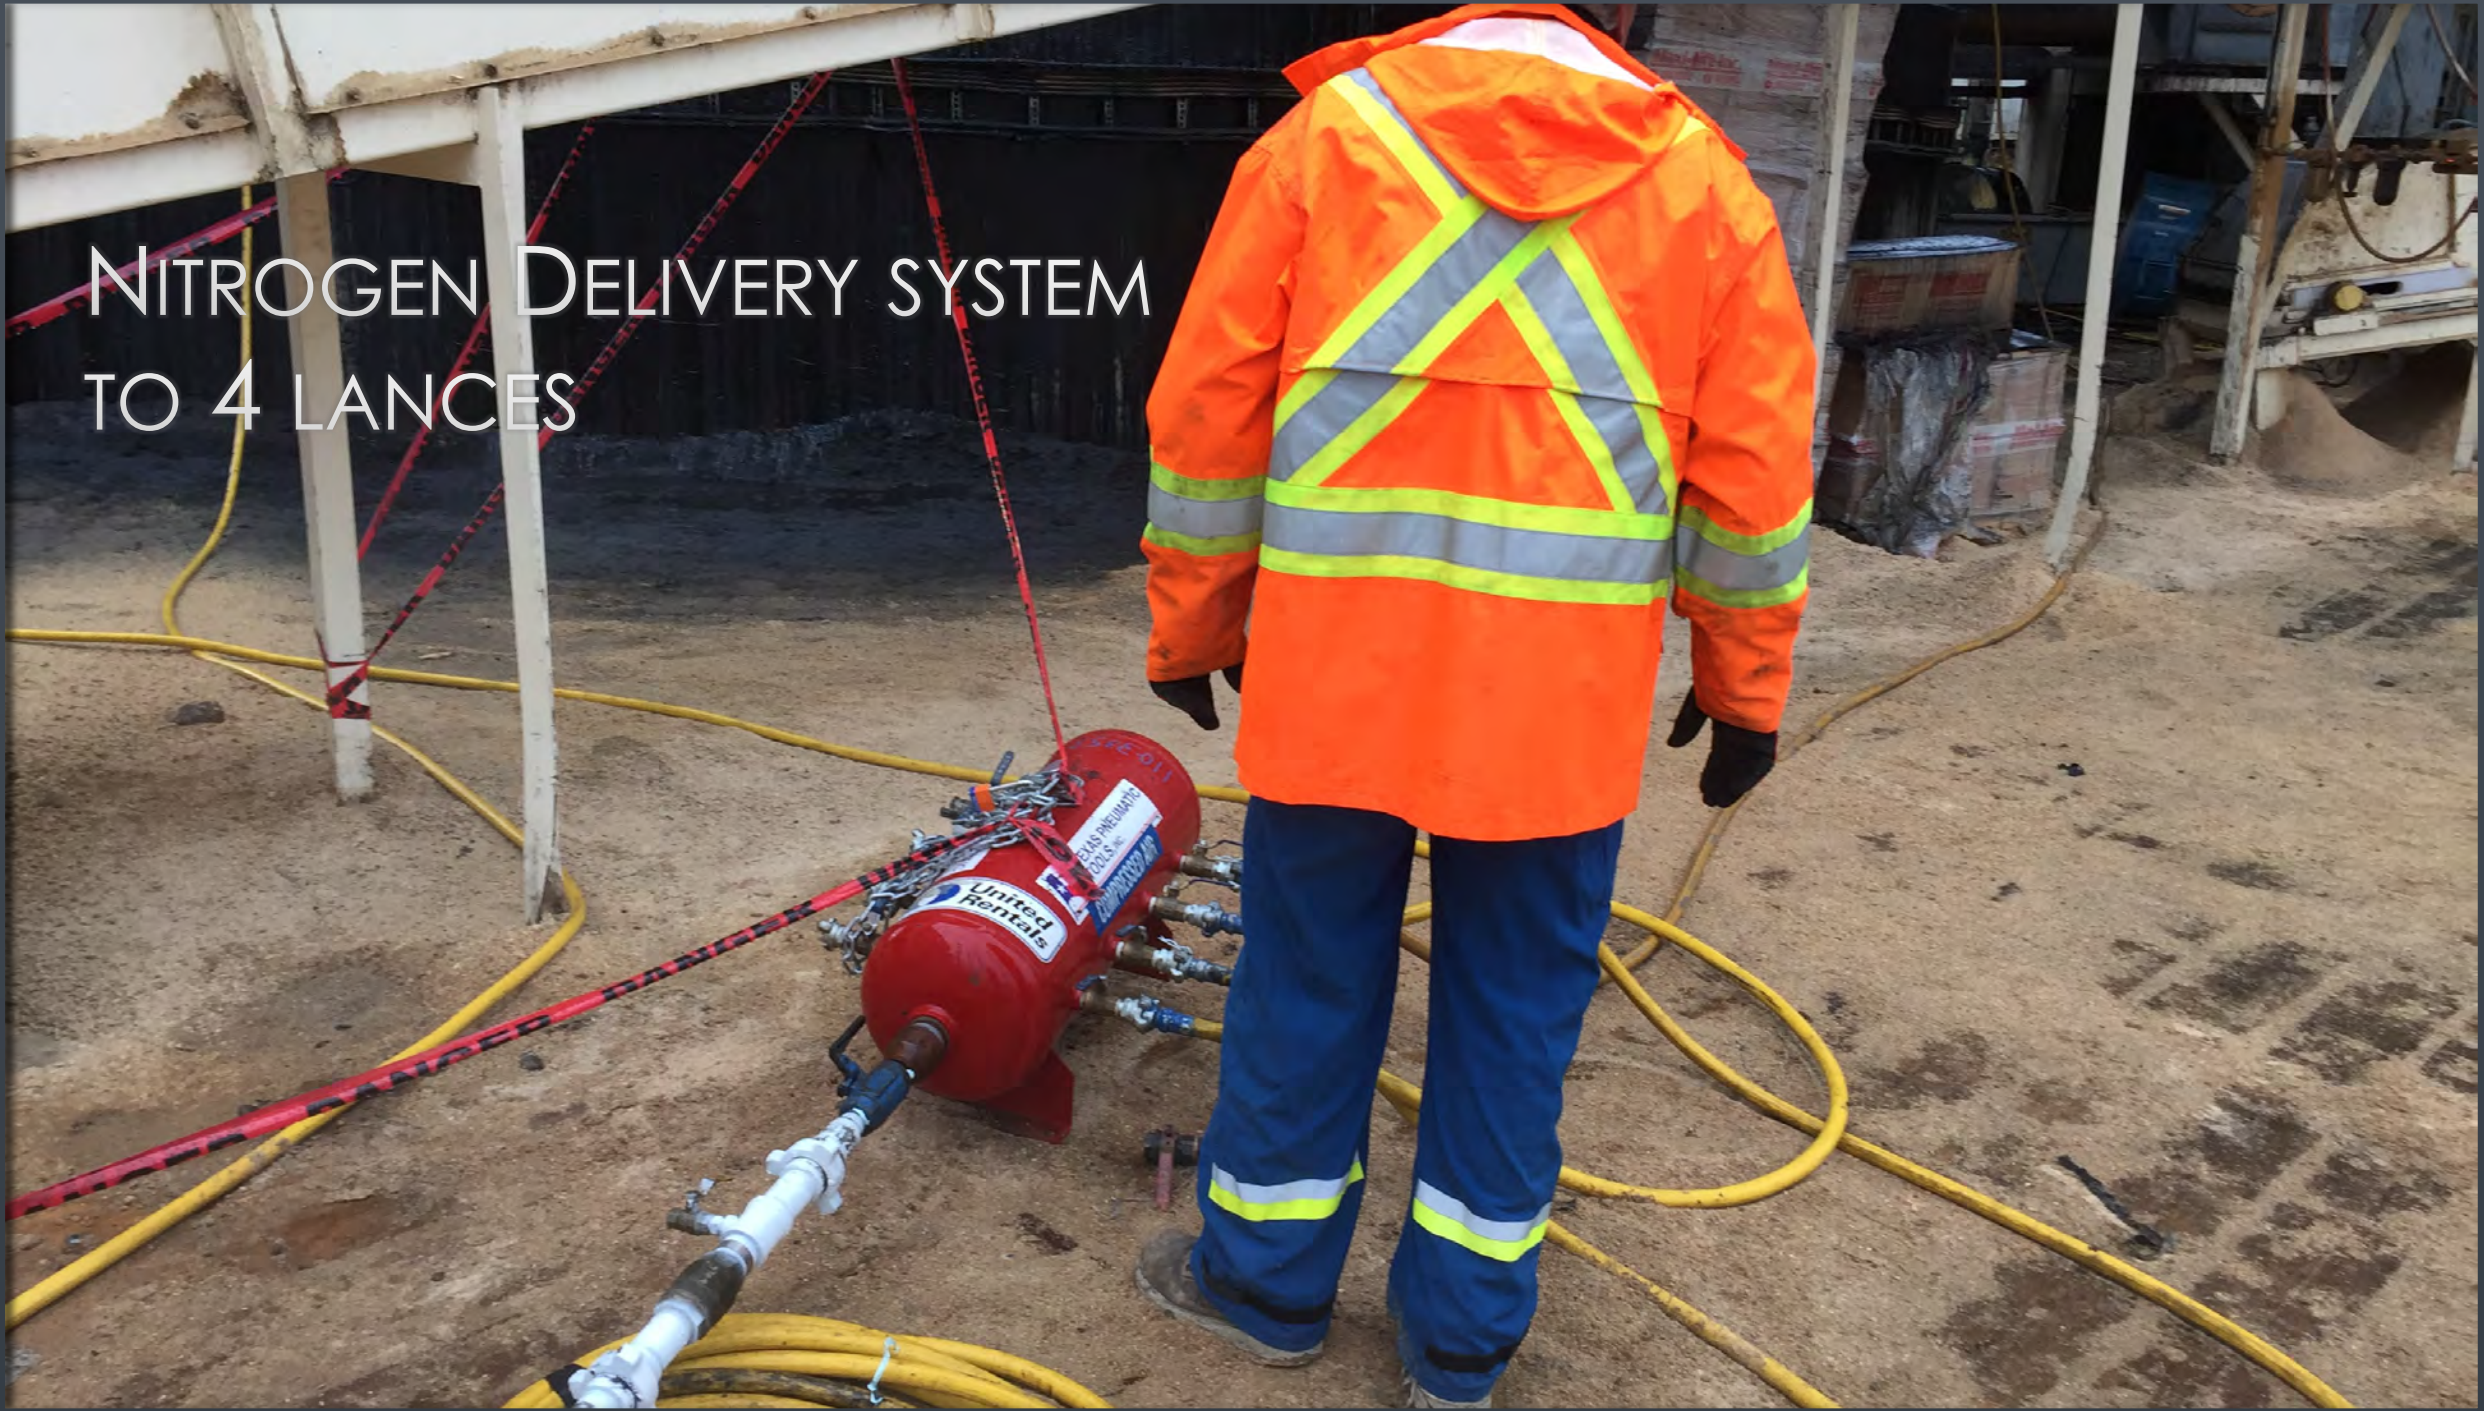
# NITROGEN DELIVERY SYSTEM TO 4 LANCES

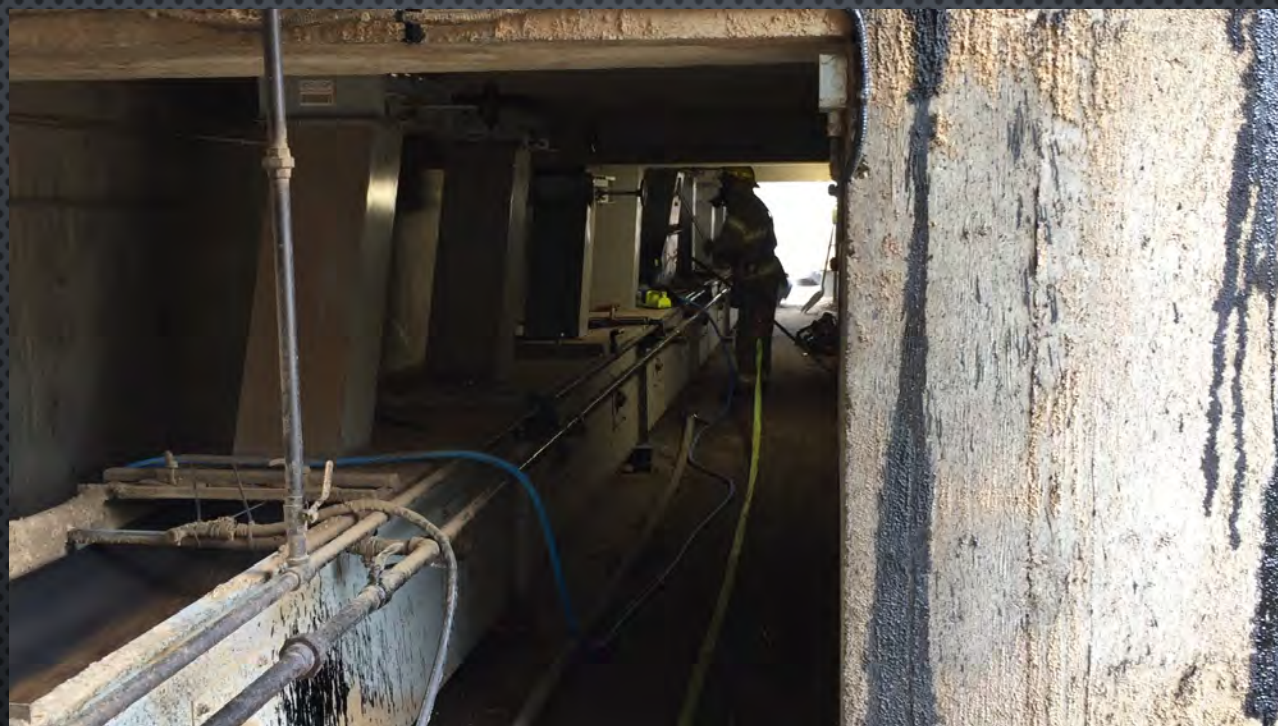
# GOOD MATERIAL

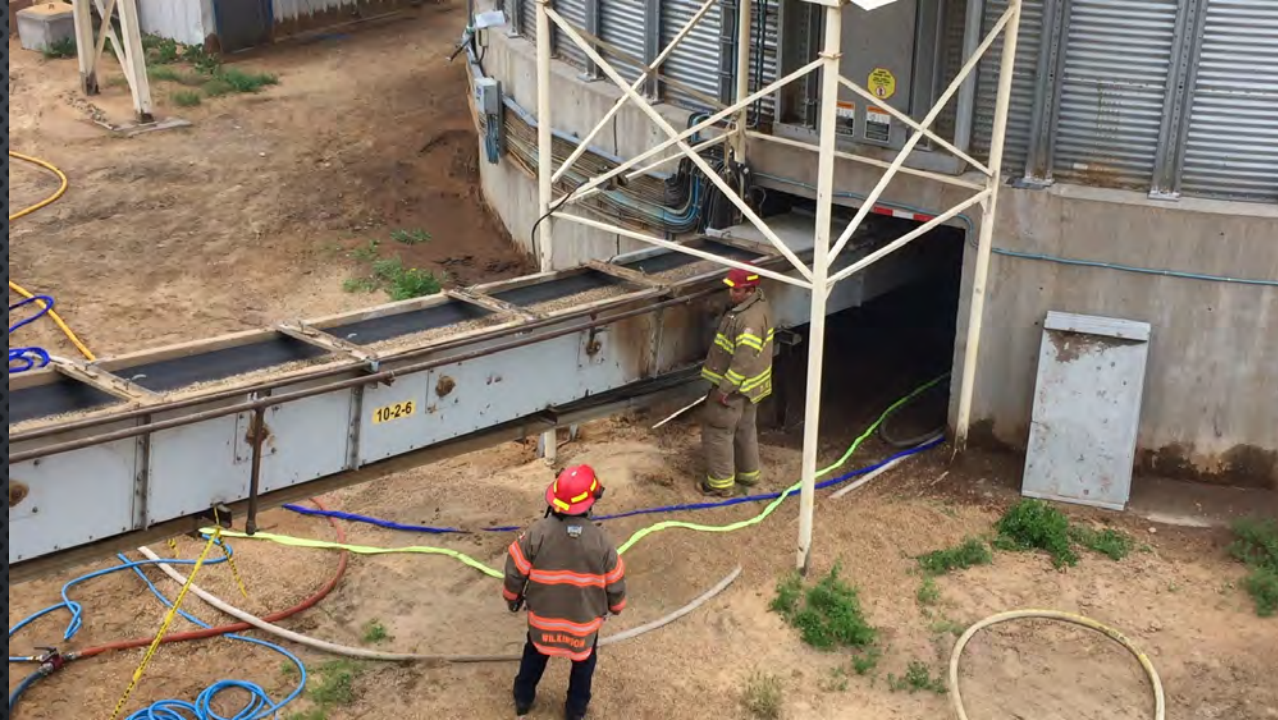
# WATERING MATERIAL WHILE LOADING TO CONTROL DUST AND EMBERS

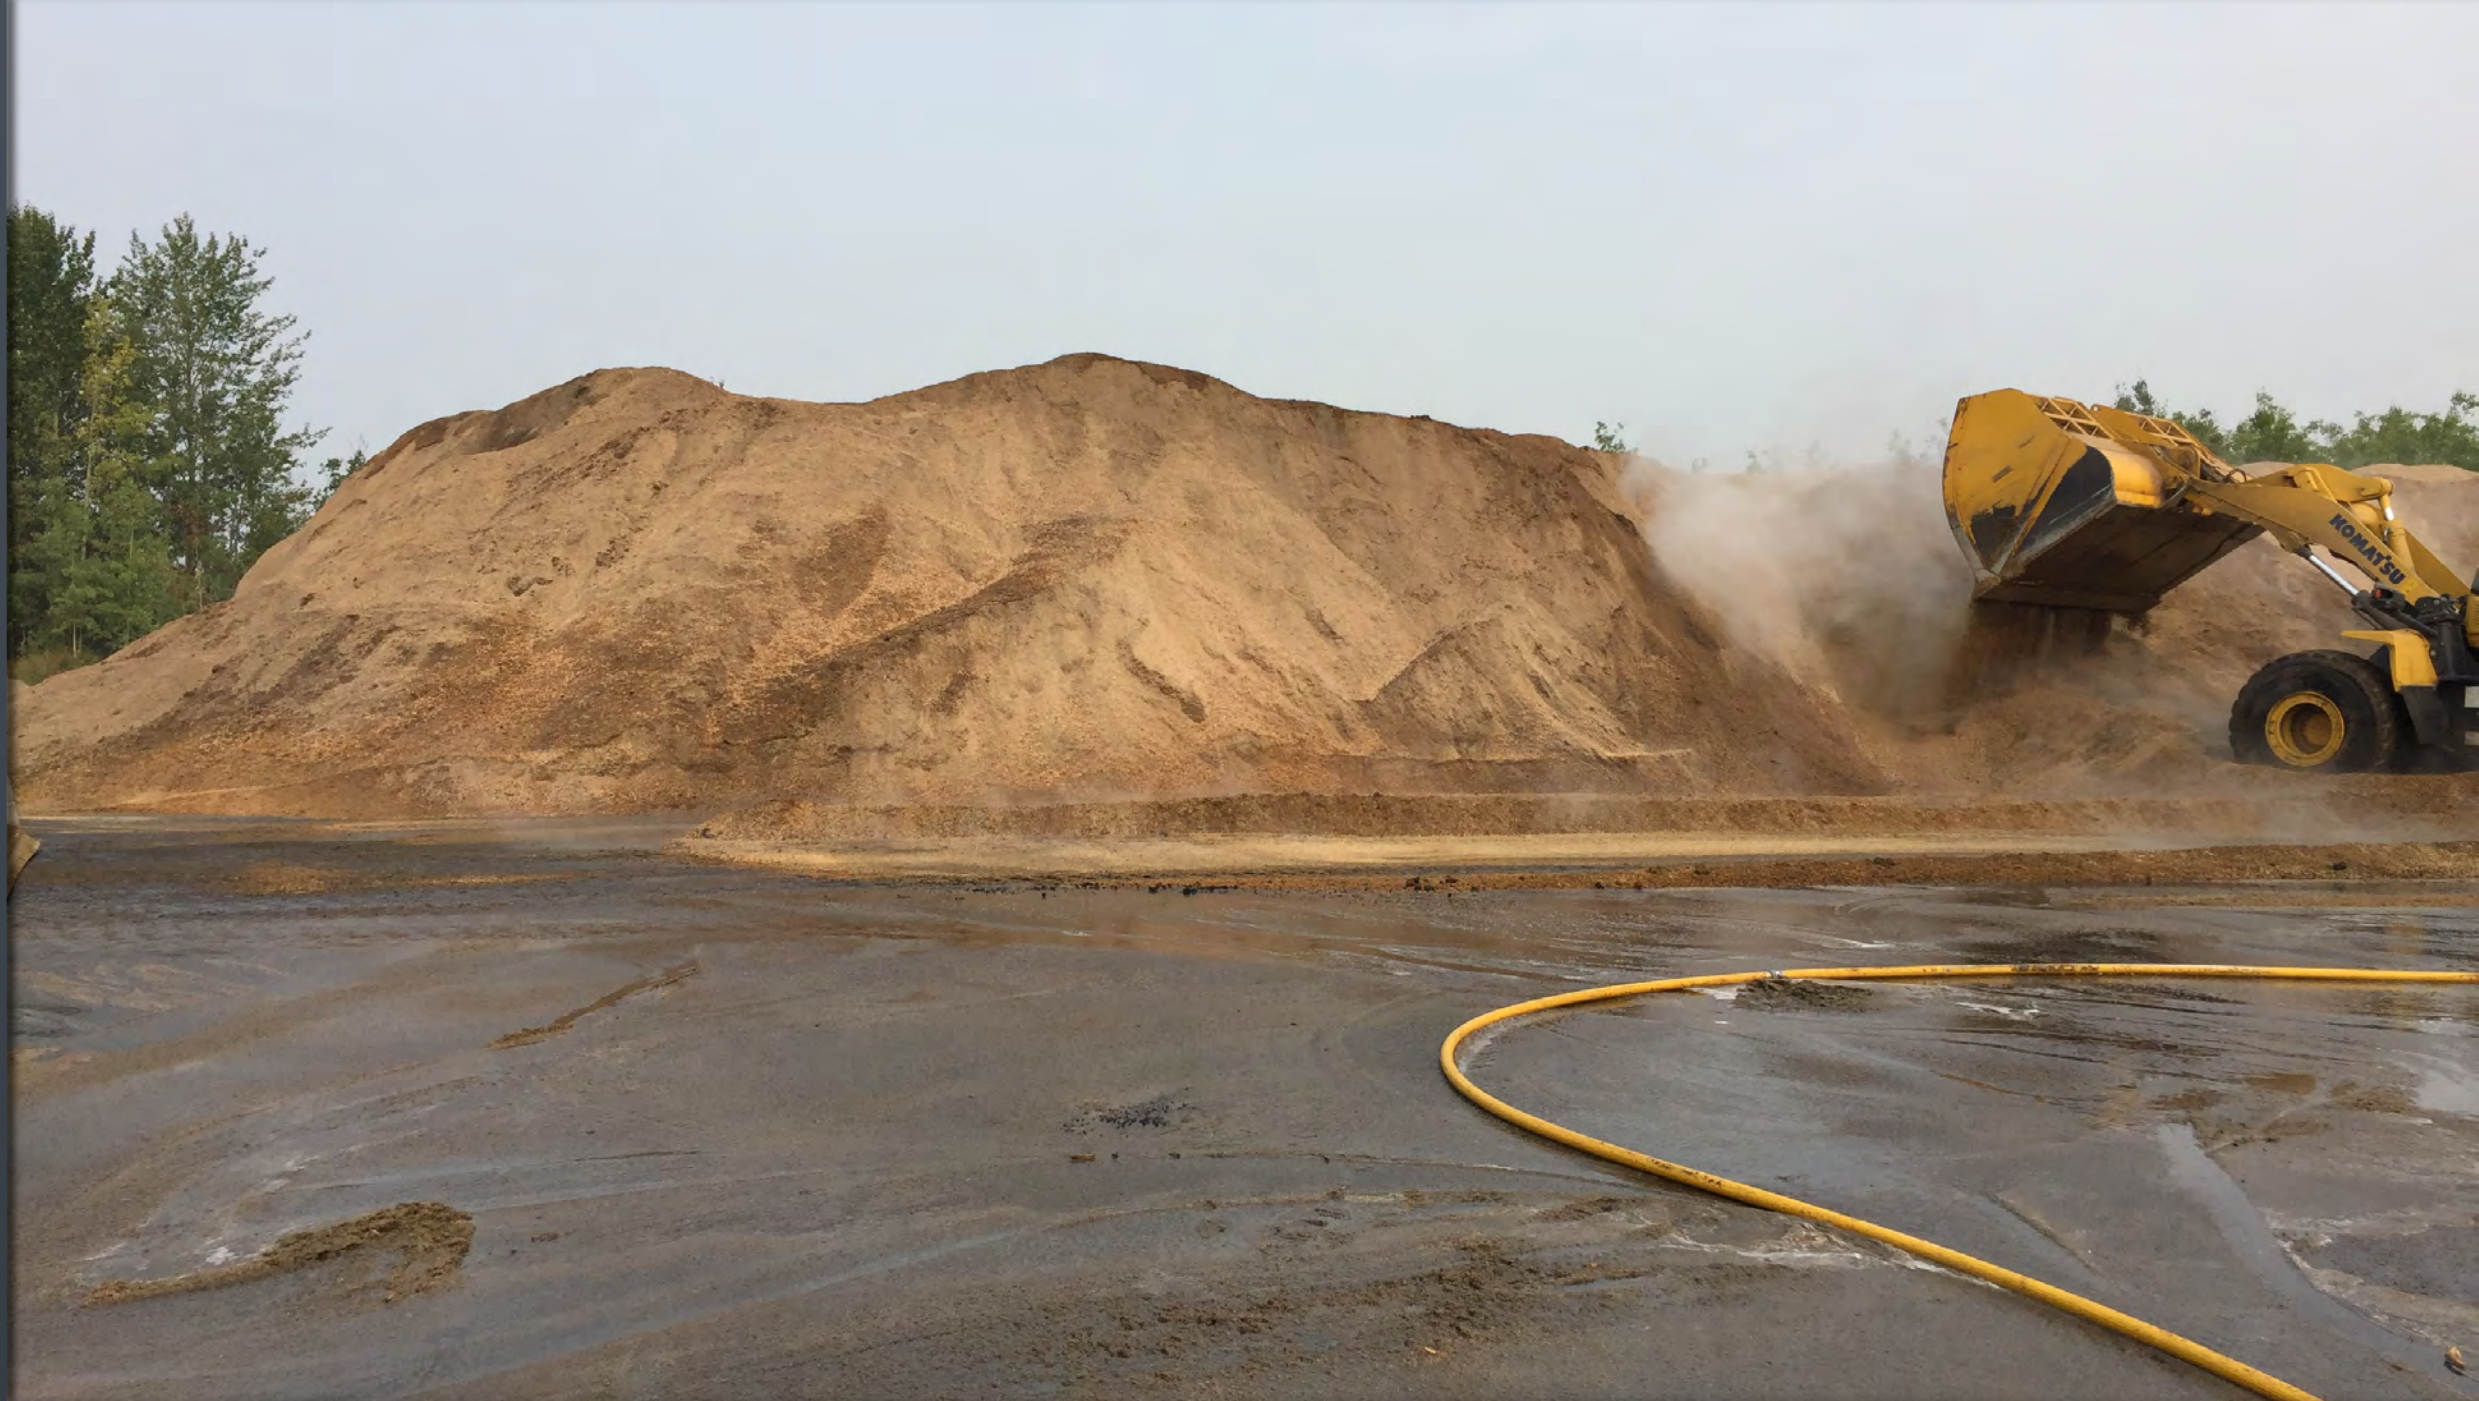
# UNLOADING PRODUCT ON ASPHALT

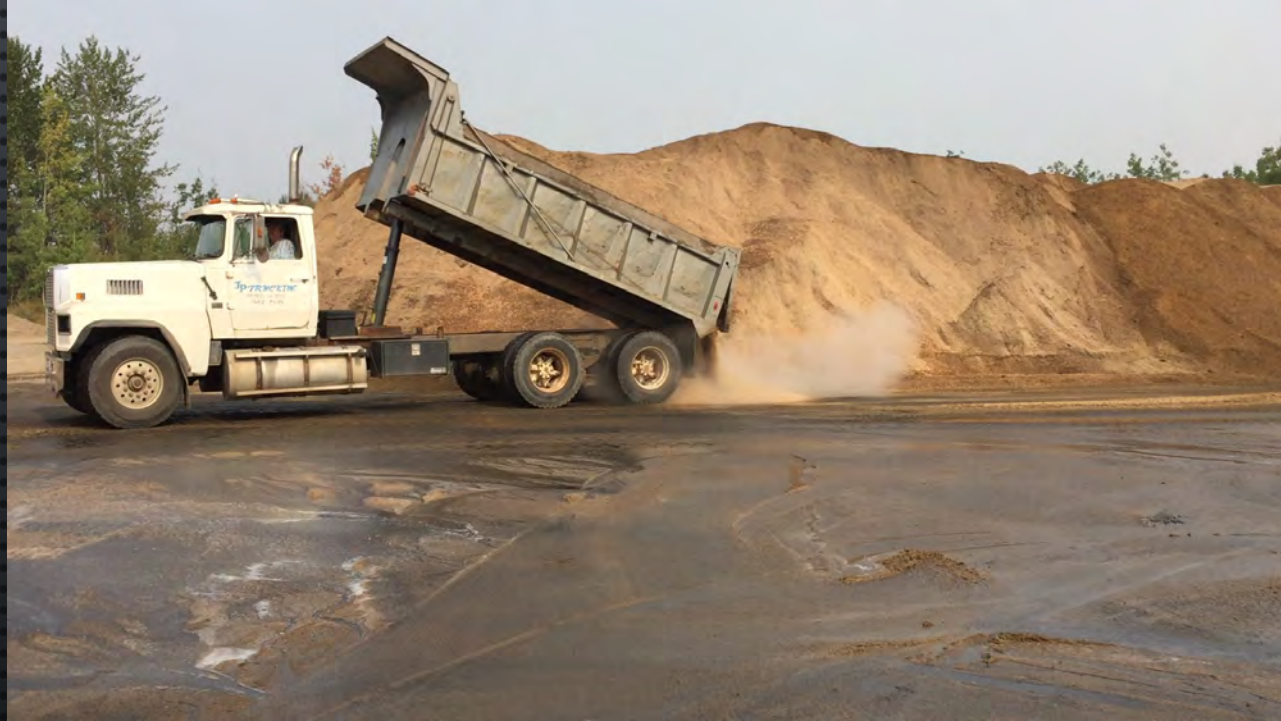
# SPREAD AND SPRAY

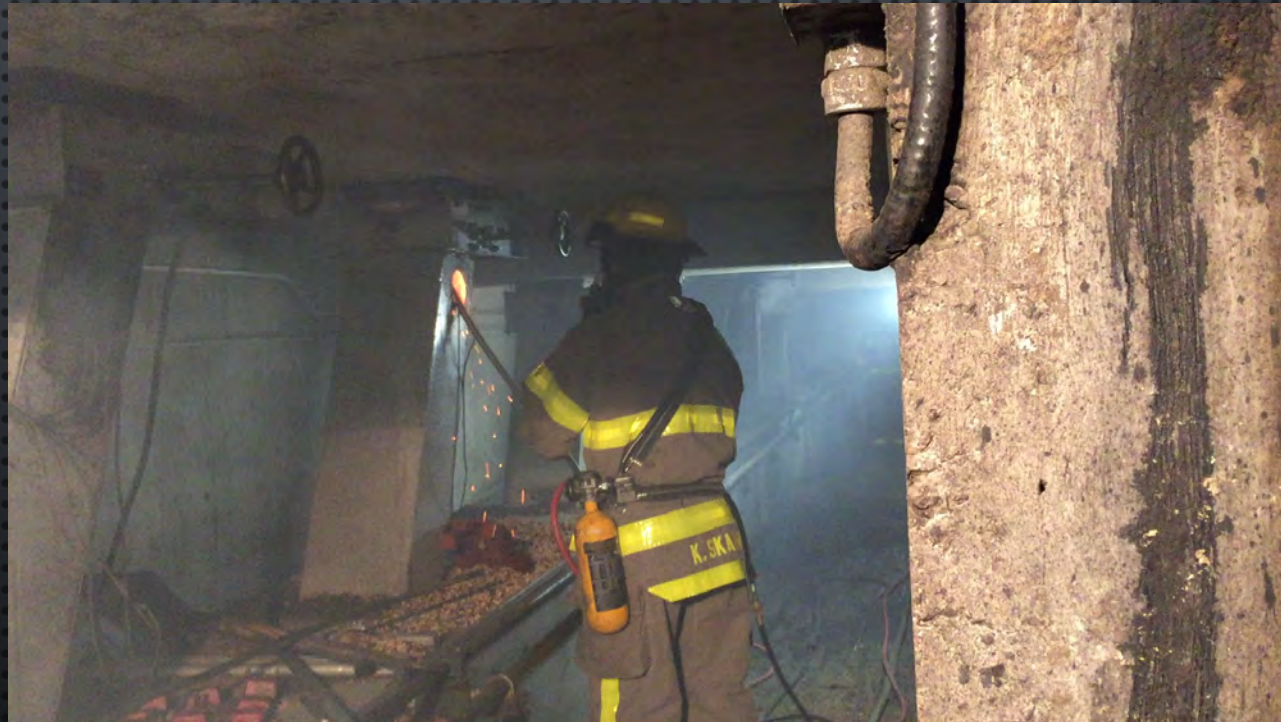
# SMOULDERING MATERIAL IN CONVEYOR MELTING BELT

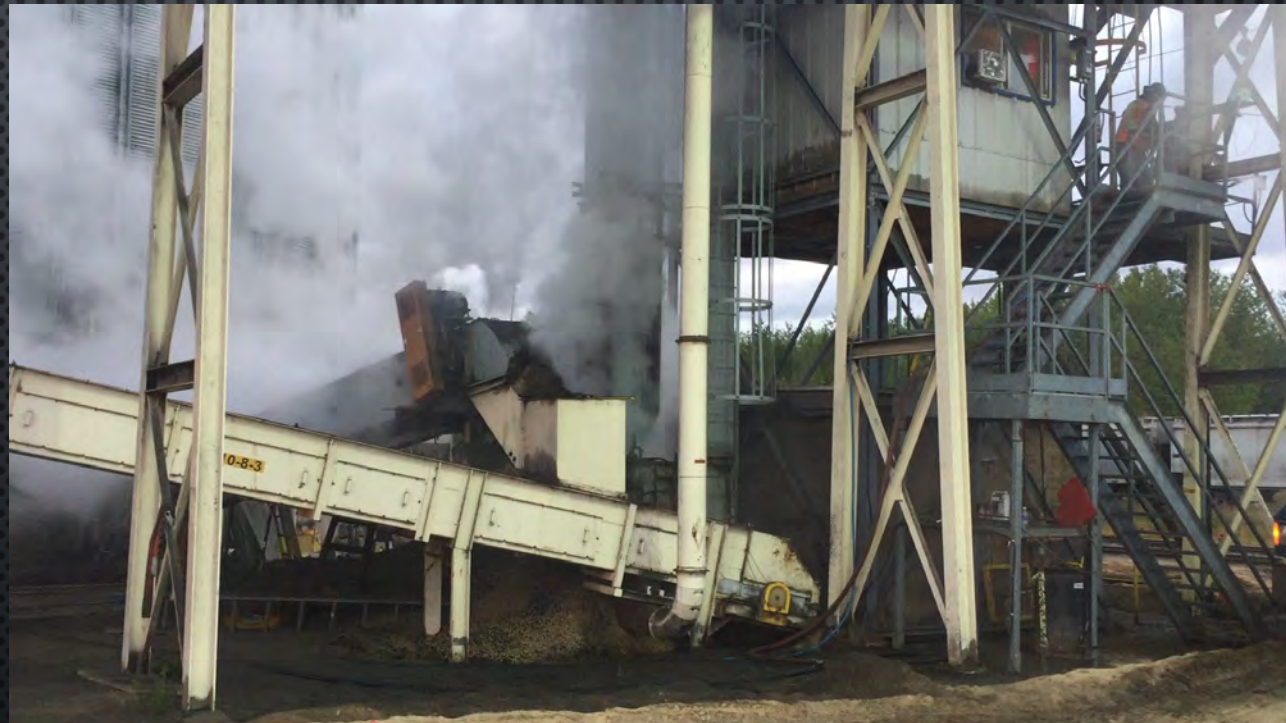
# SMOULDERING MATERIAL IN BUCKET ELEVATOR

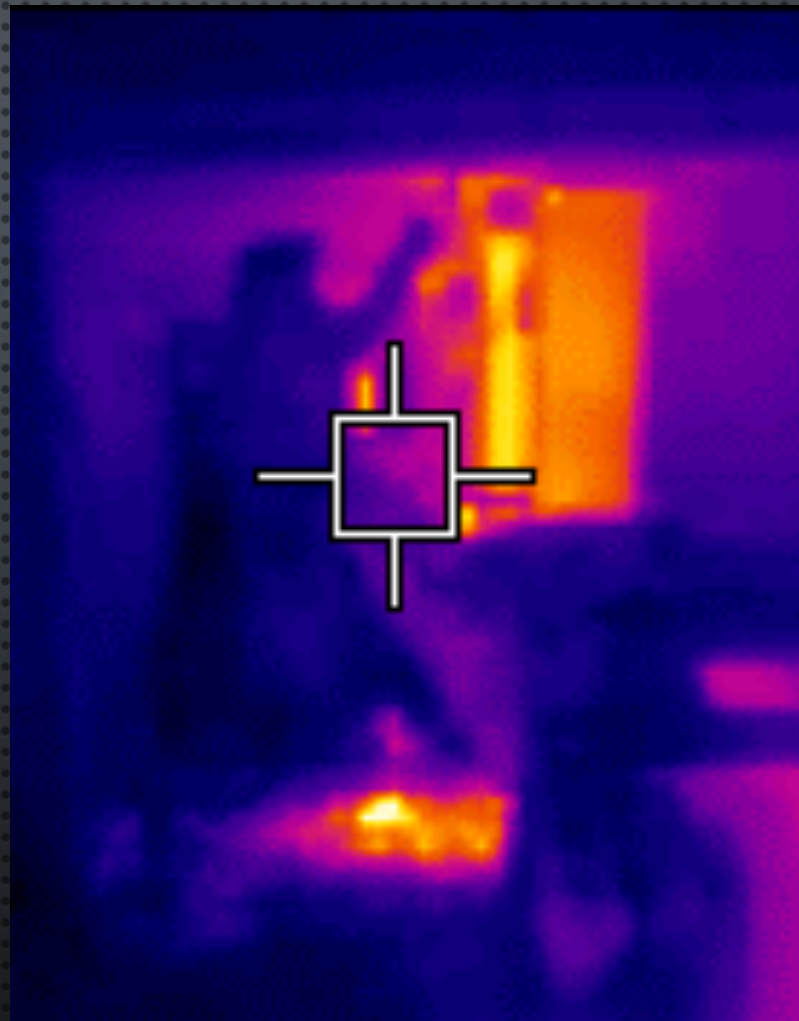
INTERRUPTION IN REMOVAL  
FOR GATE MAINTENANCE  
AND BELT REPLACEMENT

SHOP VAC ATTACHED TO  
DELUGE LINE TO MONITOR  
OXYGEN LEVEL IN HEADSPACE  
WITH AIR MONITOR

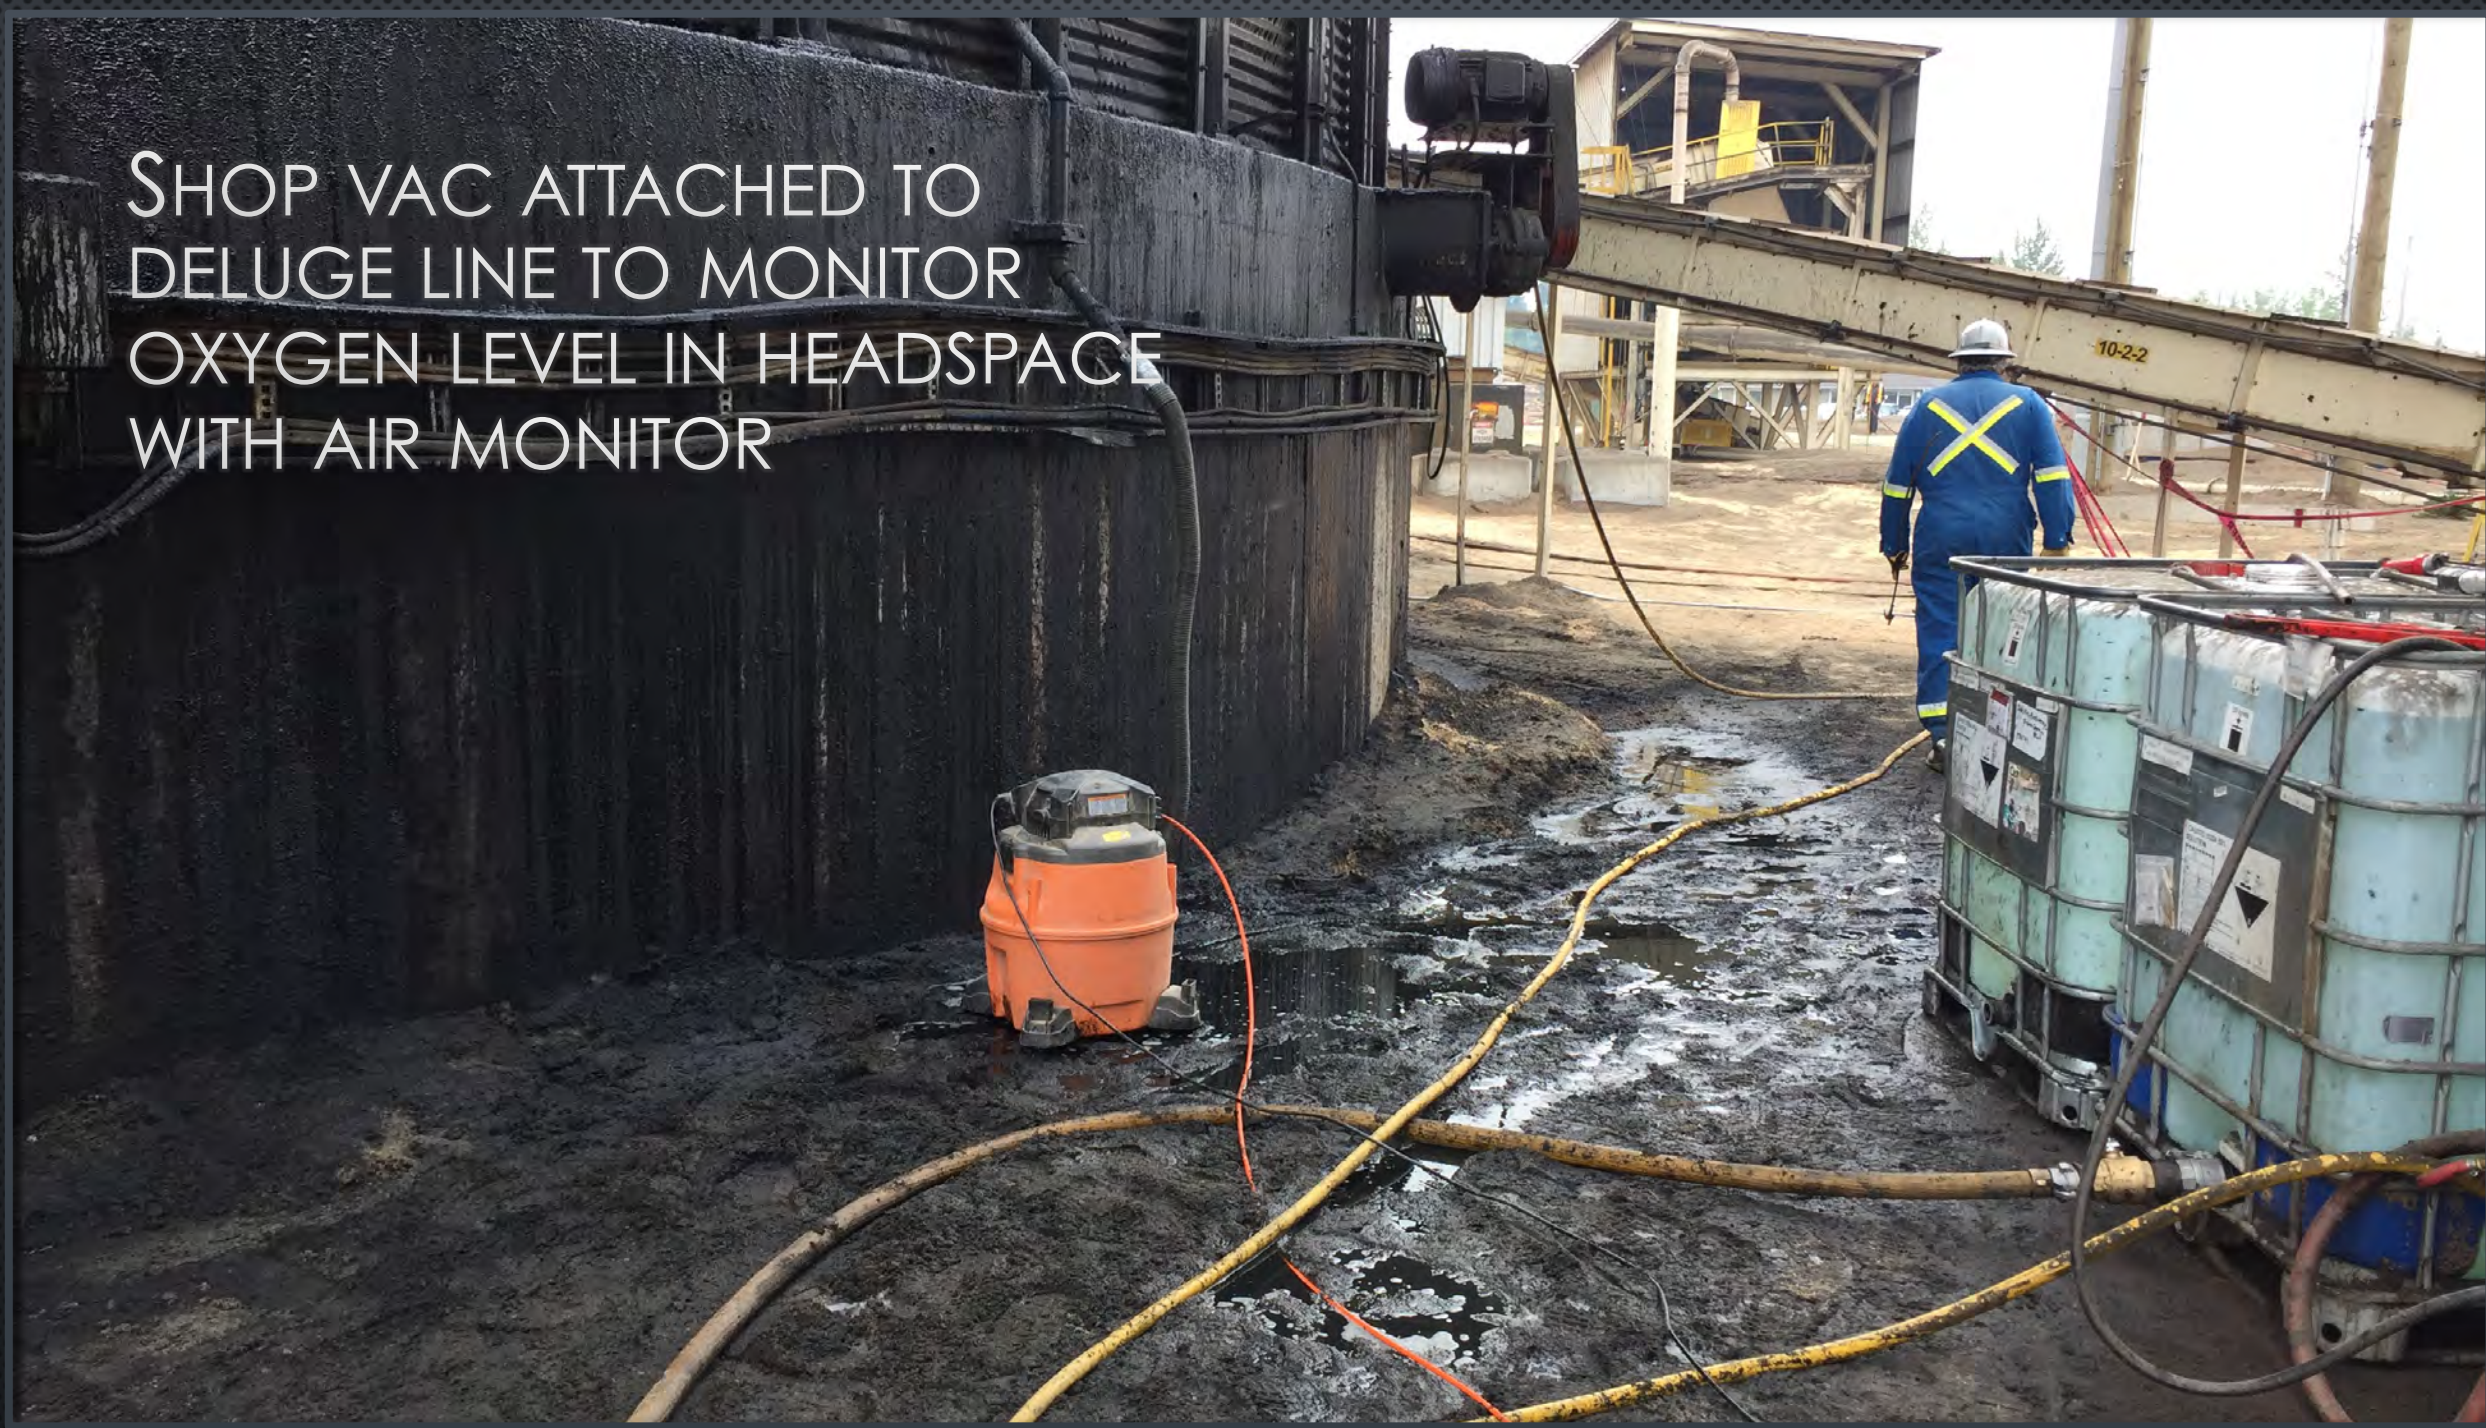
CLASS A FOAM MIXED IN  
TOTES AND PUMPED INTO  
HEADSPACE VIA DELUGE LINE
