Pacific BioEnergy

SILO SMOULDER

WPAC OTTAWA

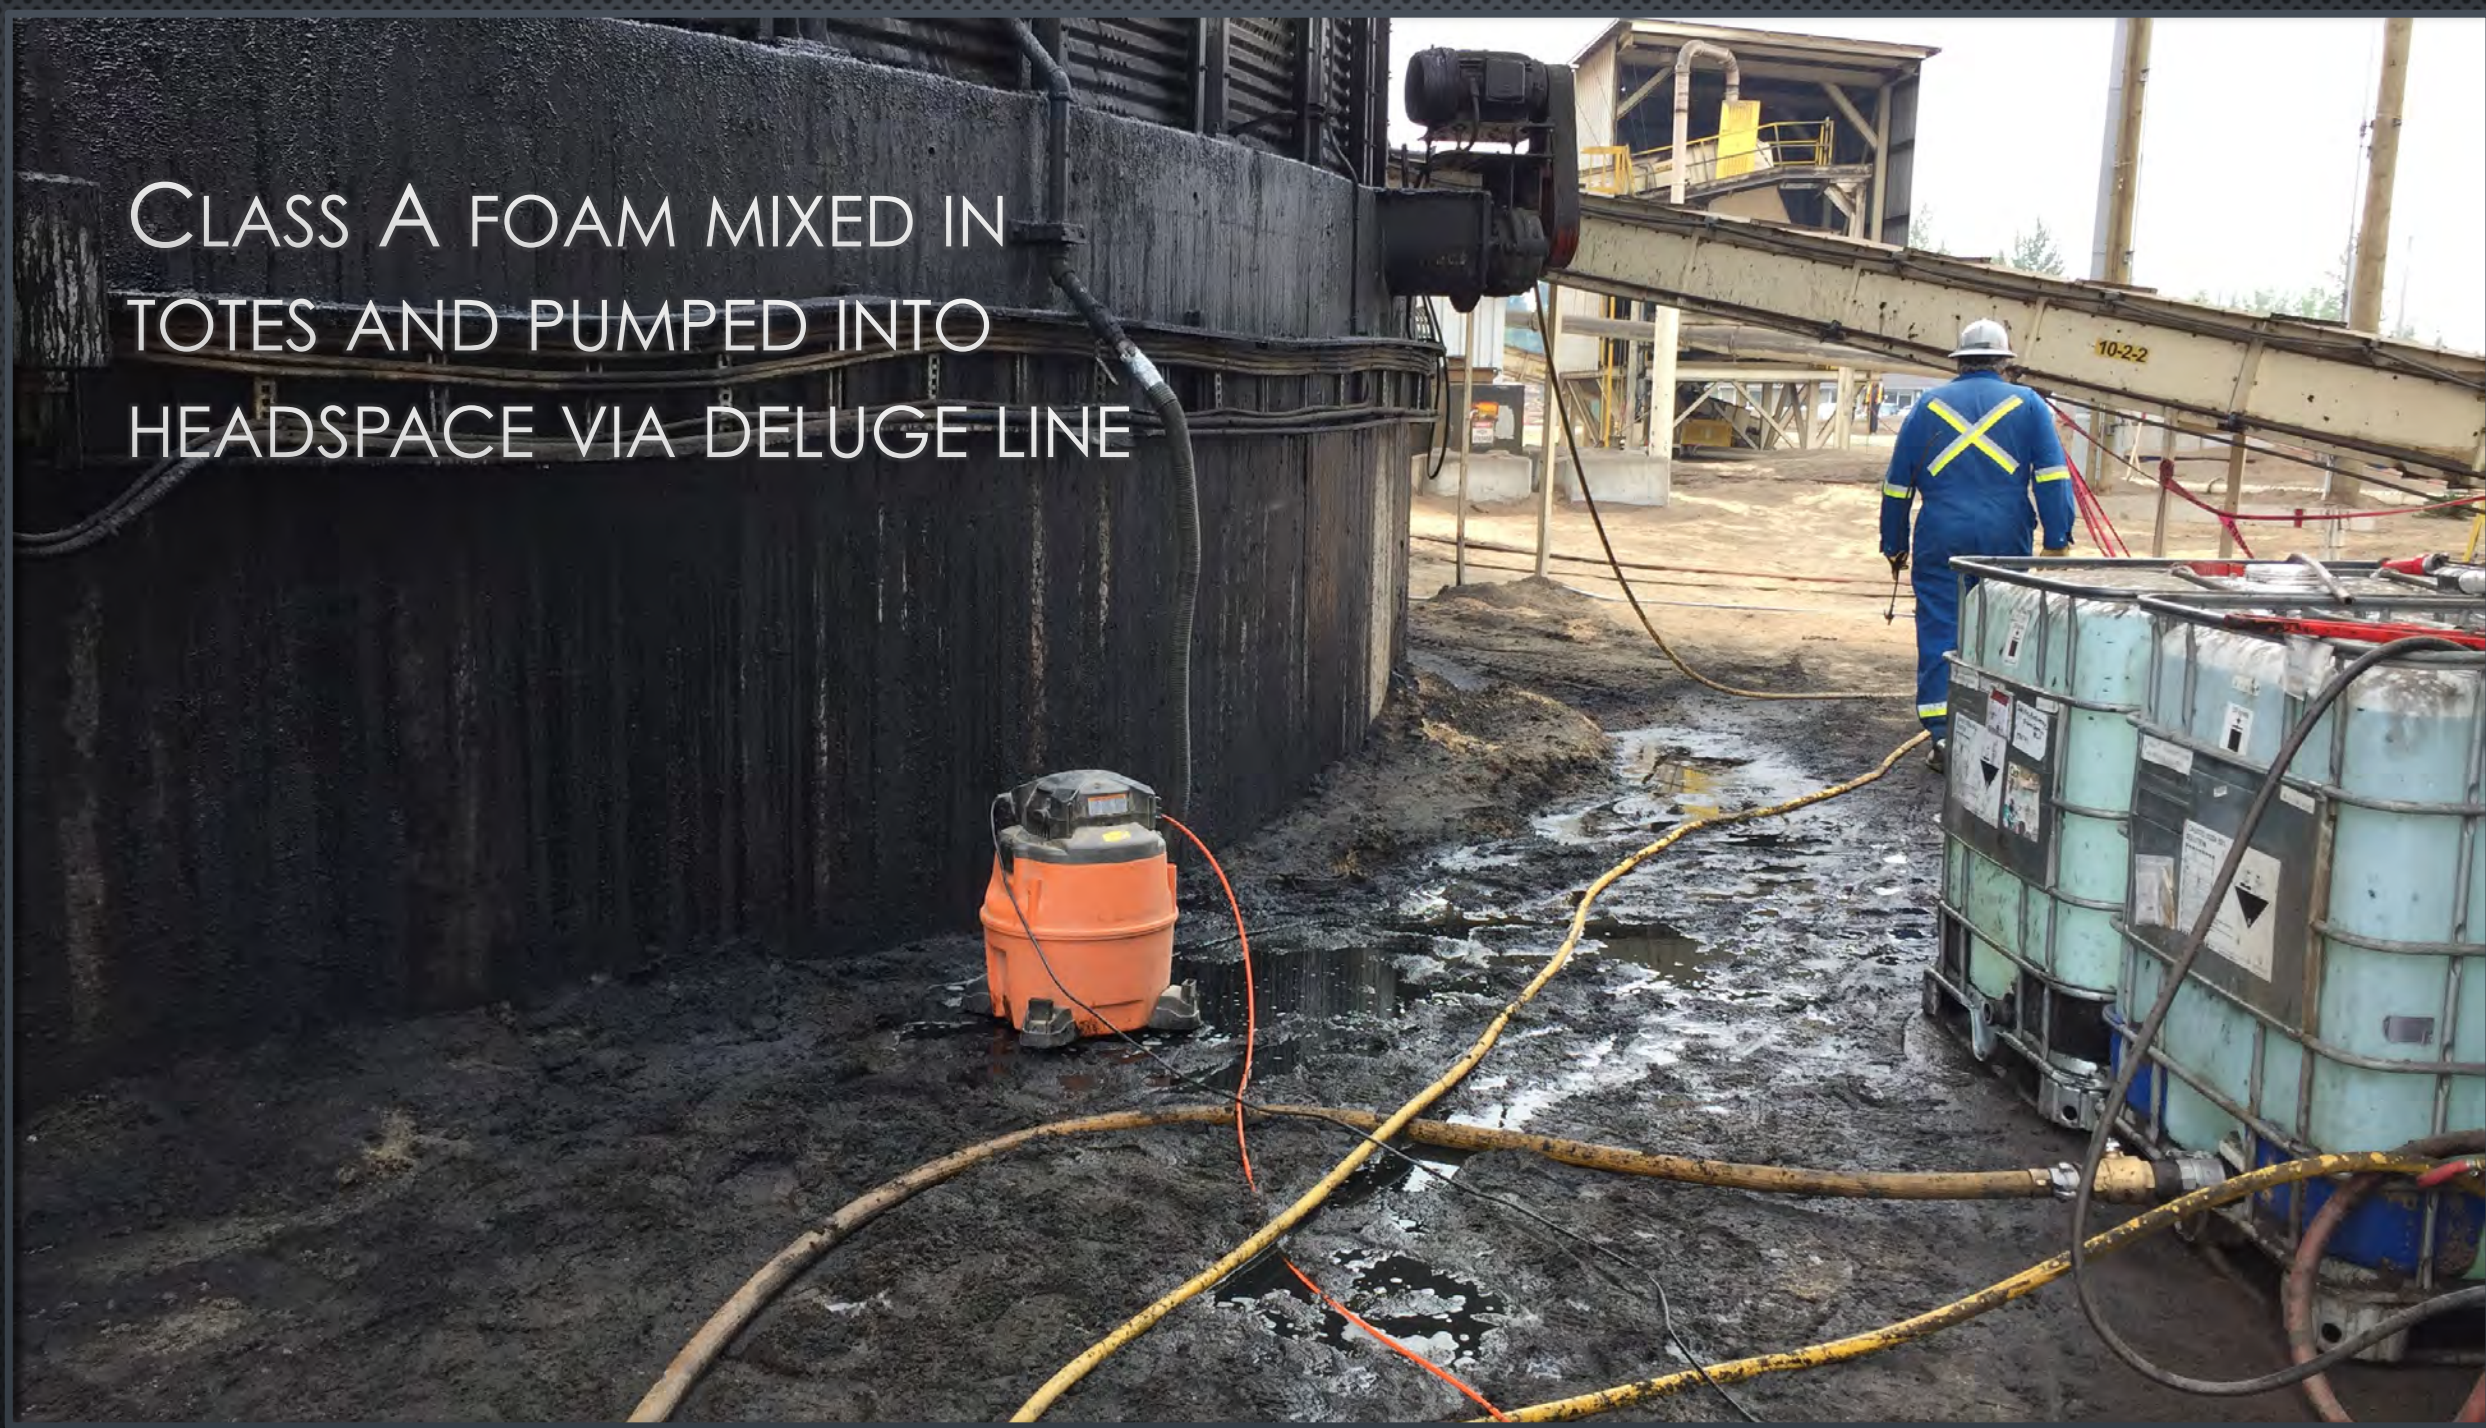
# THERMAL IMAGES USED TO DETERMINE REMAINING MATERIAL IN SILO

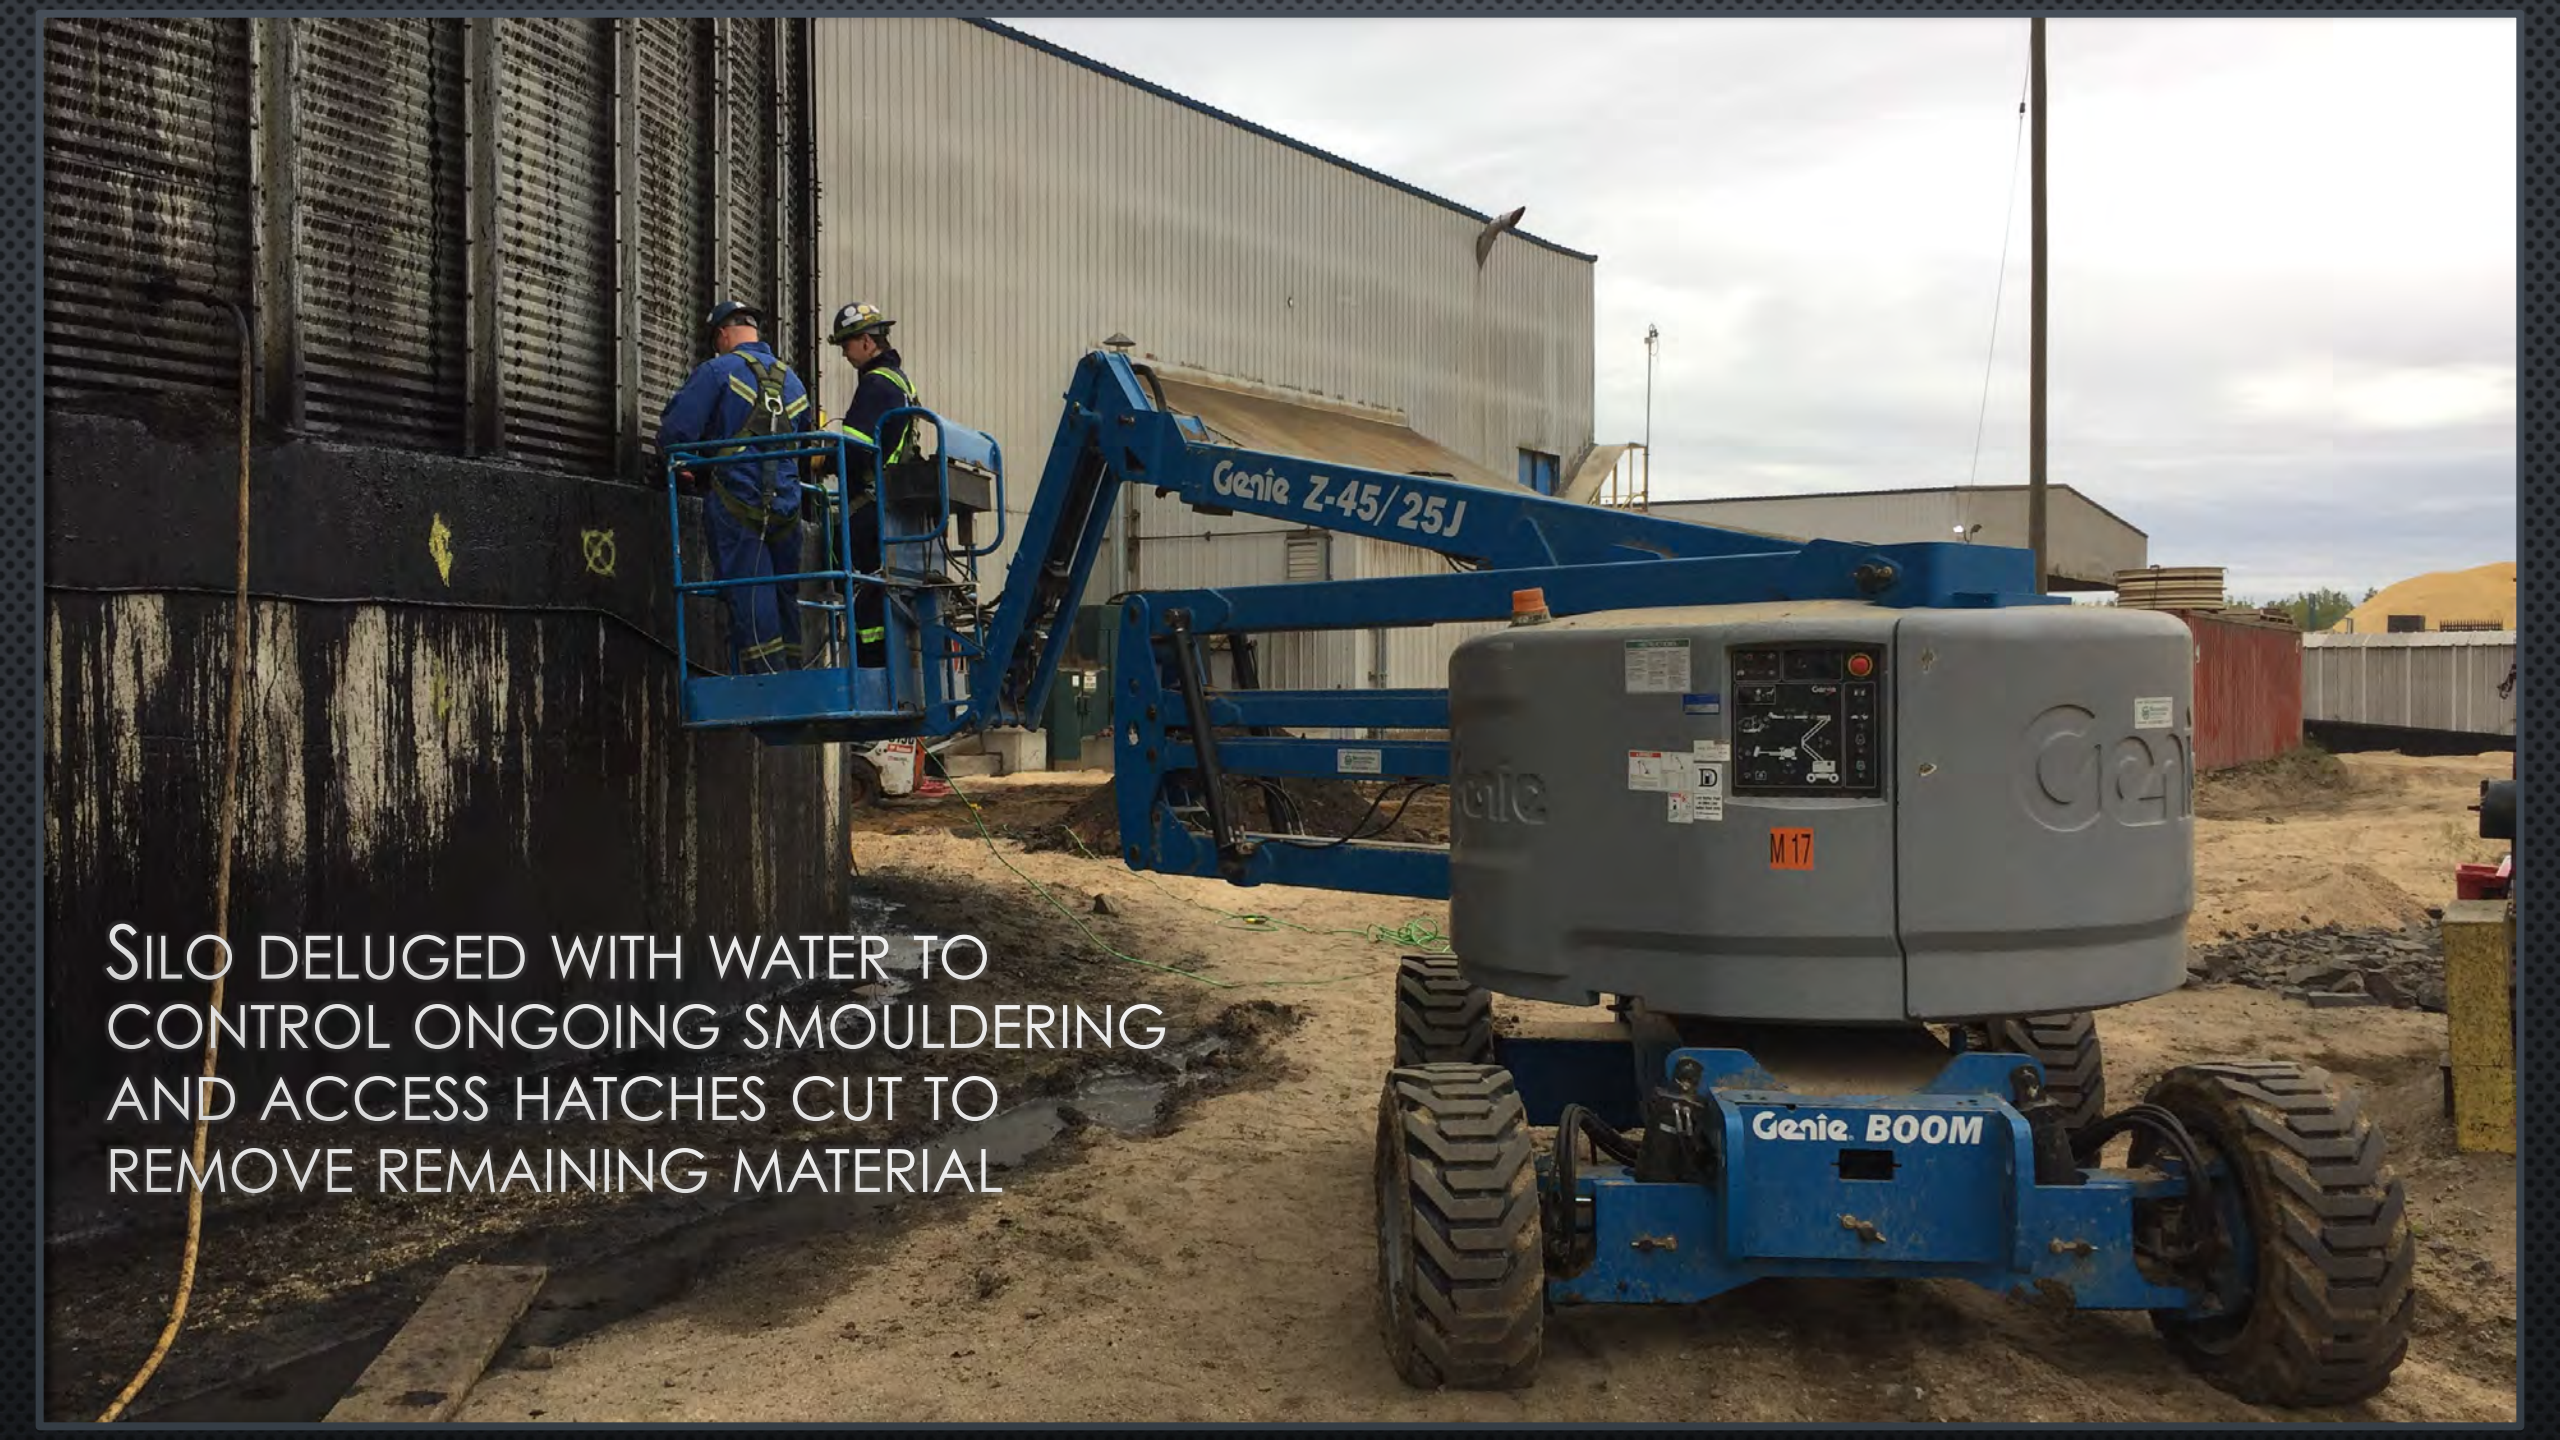
SILO DELUGED WITH WATER TO  
CONTROL ONGOING SMOULDERING  
AND ACCESS HATCHES CUT TO  
REMOVE REMAINING MATERIAL

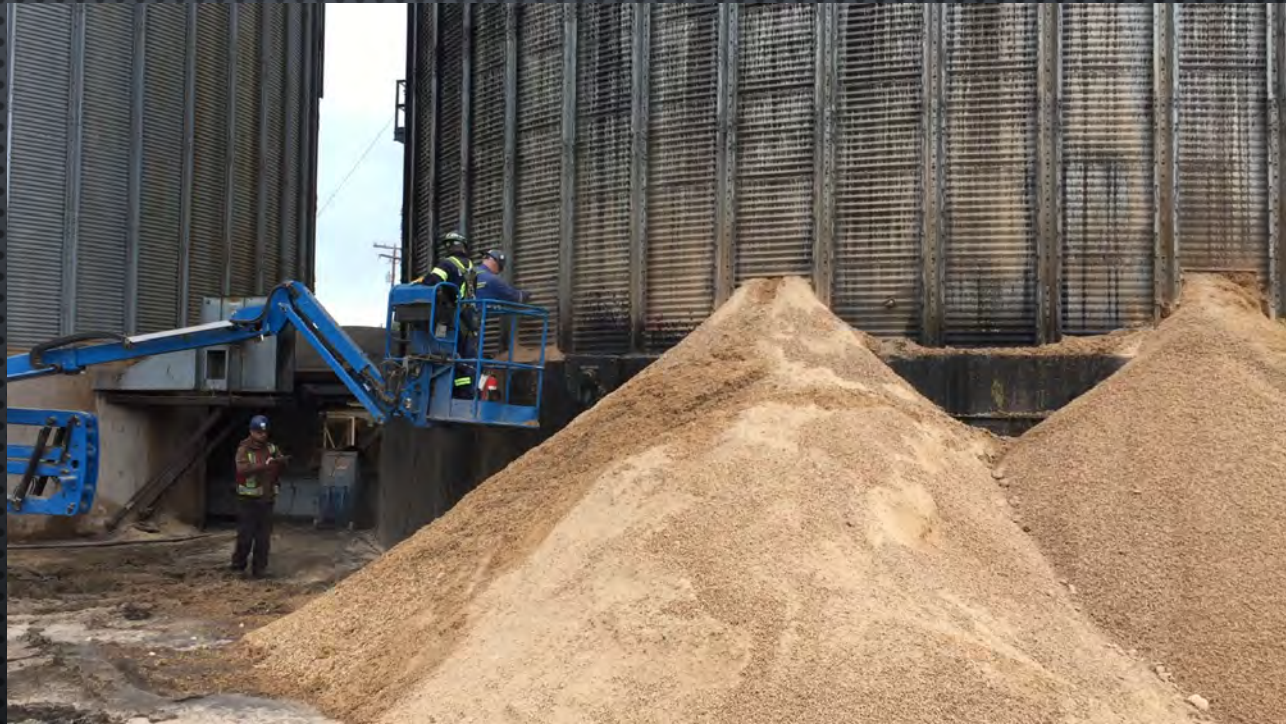
# GOOD FLOW OF MATERIAL PRIOR TO SATURATION

POST HOLE AUGER  
ATTACHMENT FOR BOBCAT

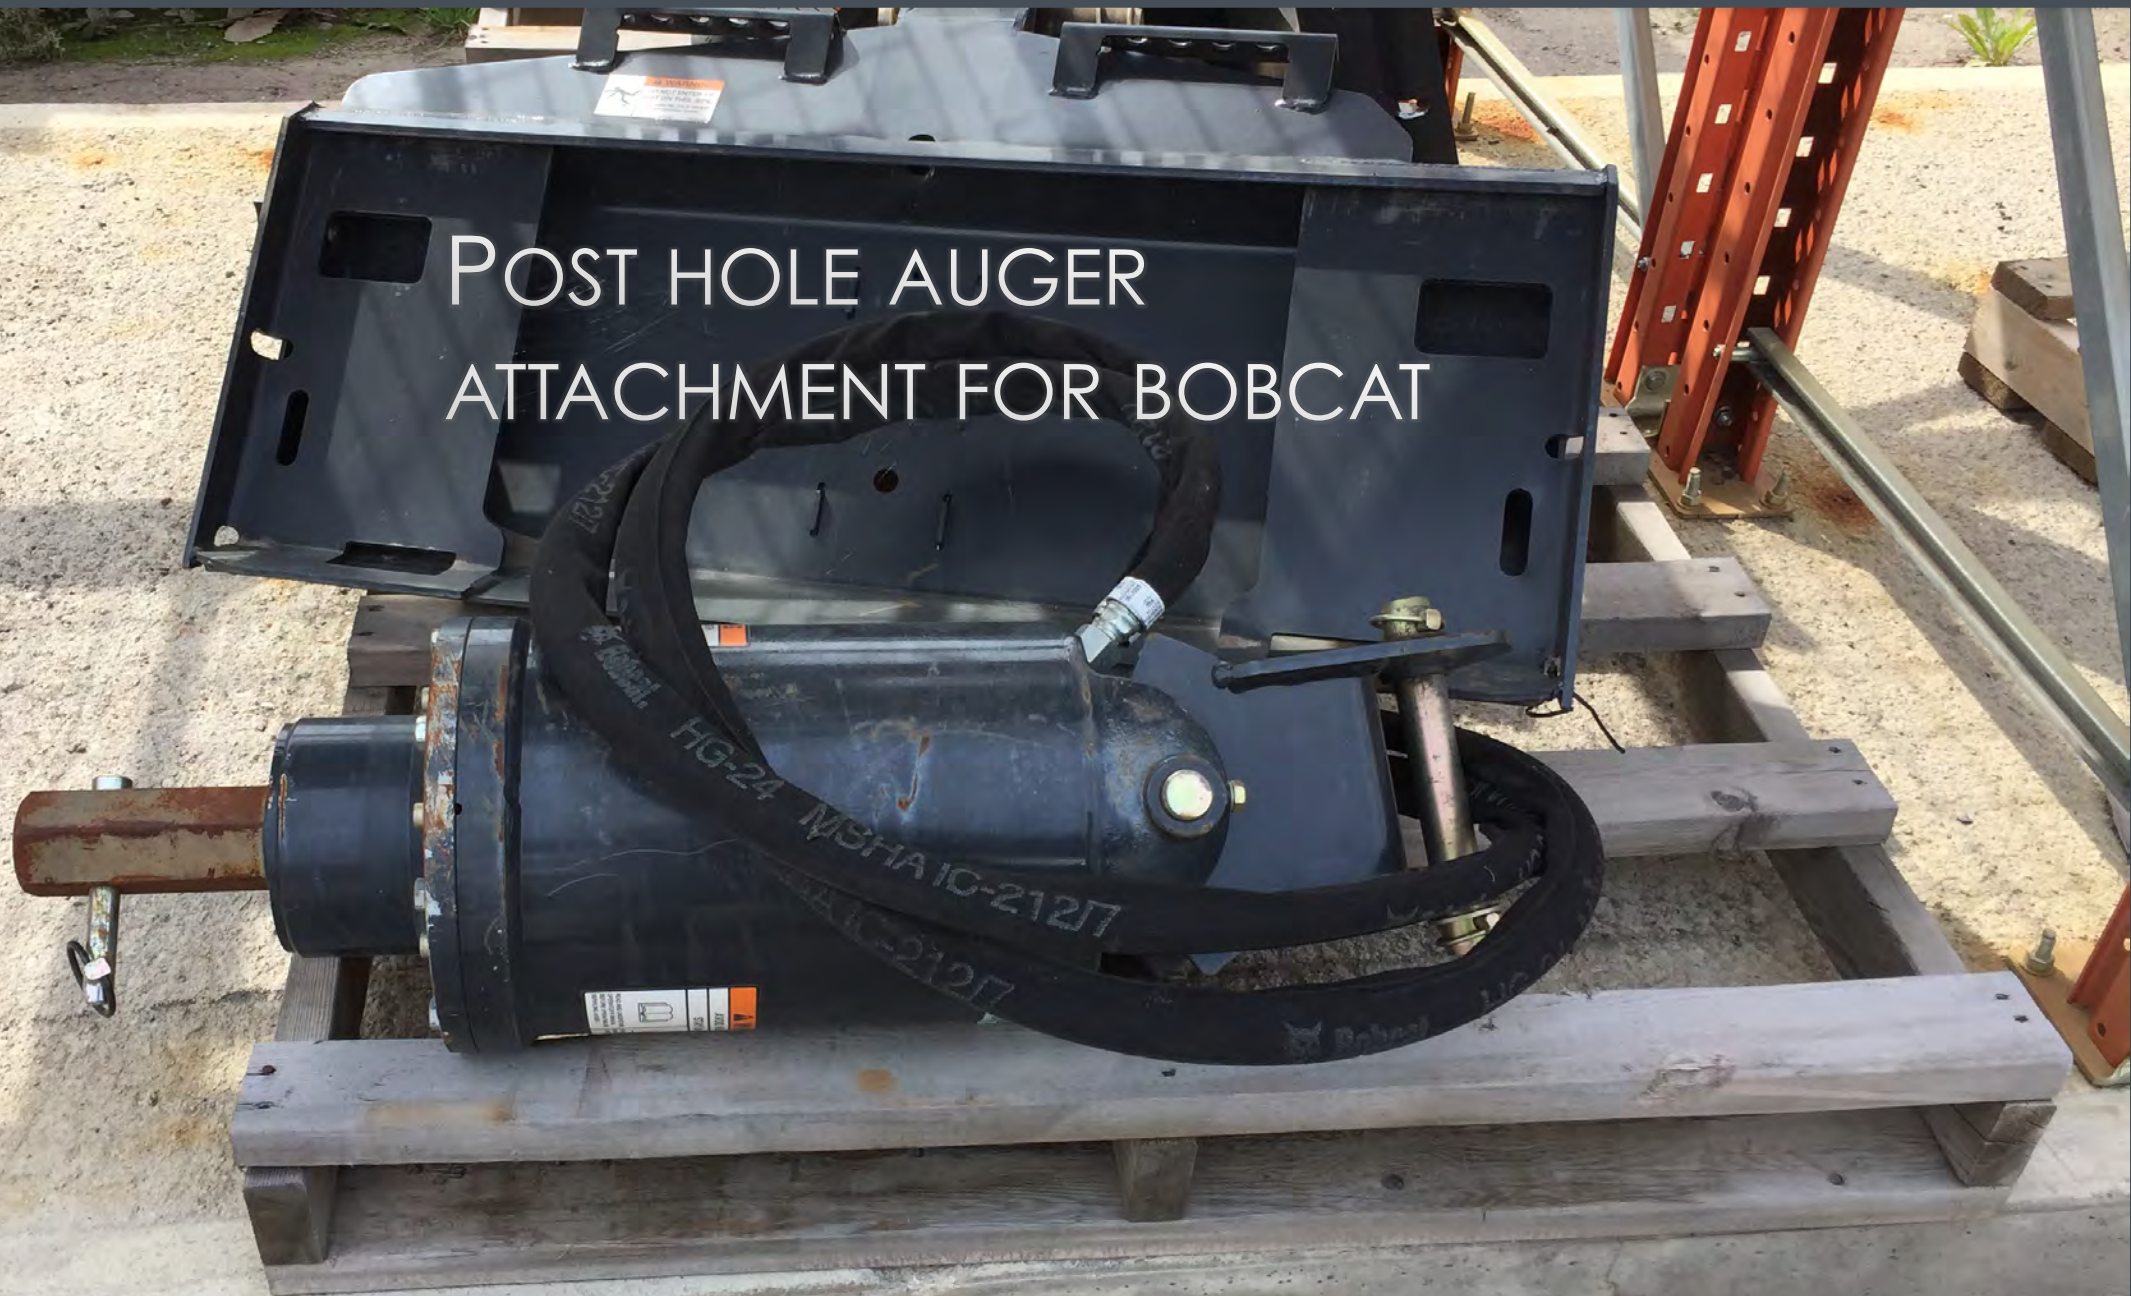
POST HOLE AUGER BIT WITH  
ADDITIONAL 9" AUGER  
SECTIONS FOR 20 FT OF REACH

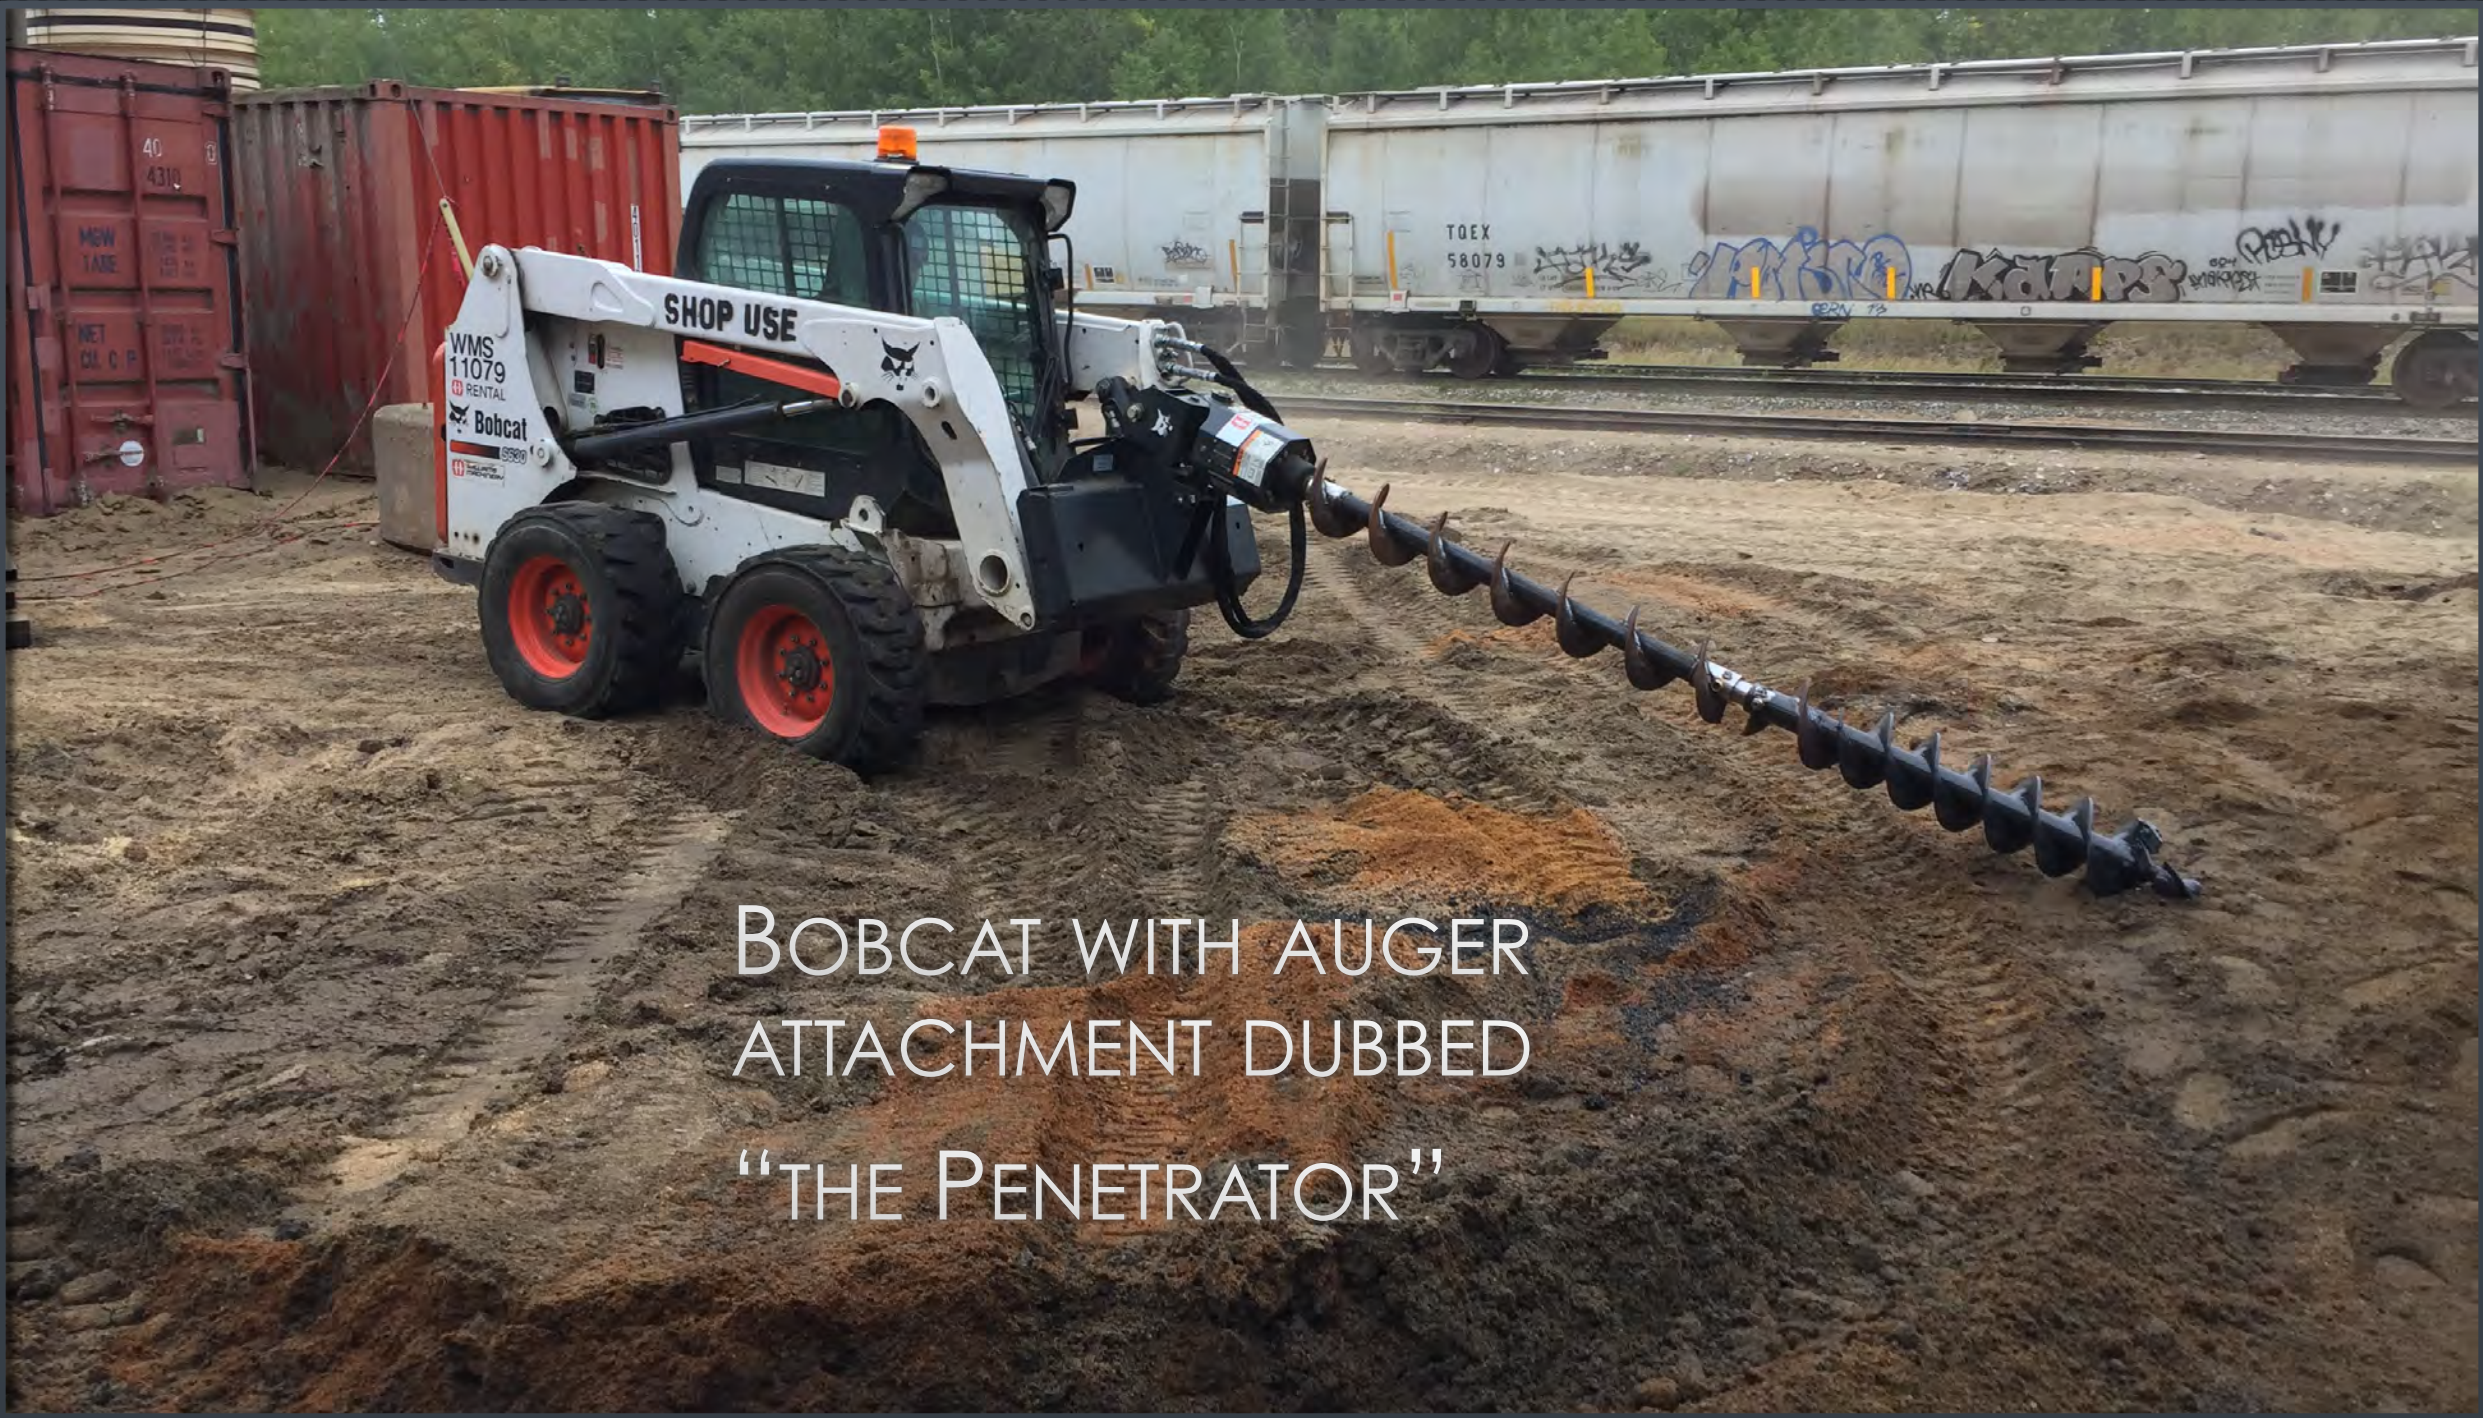
BOBCAT WITH AUGER  
ATTACHMENT DUBBED  
"THE PENETRATOR"

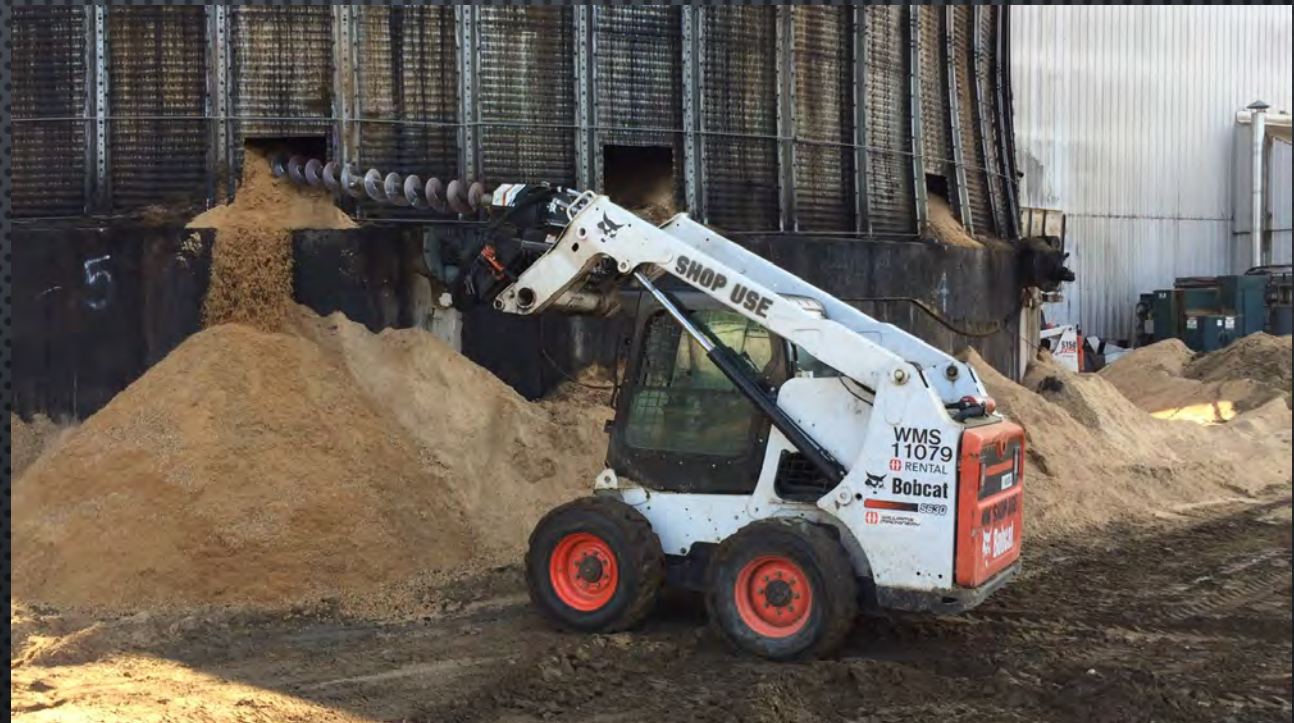
# THE PENETRATOR IN ACTION

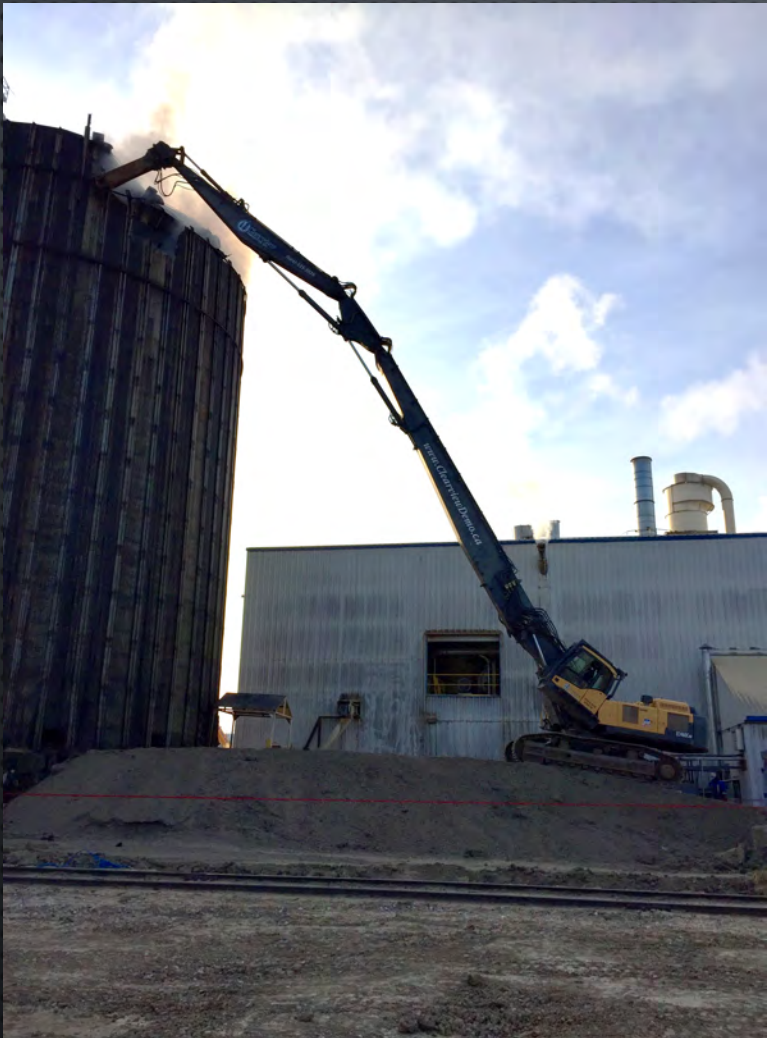
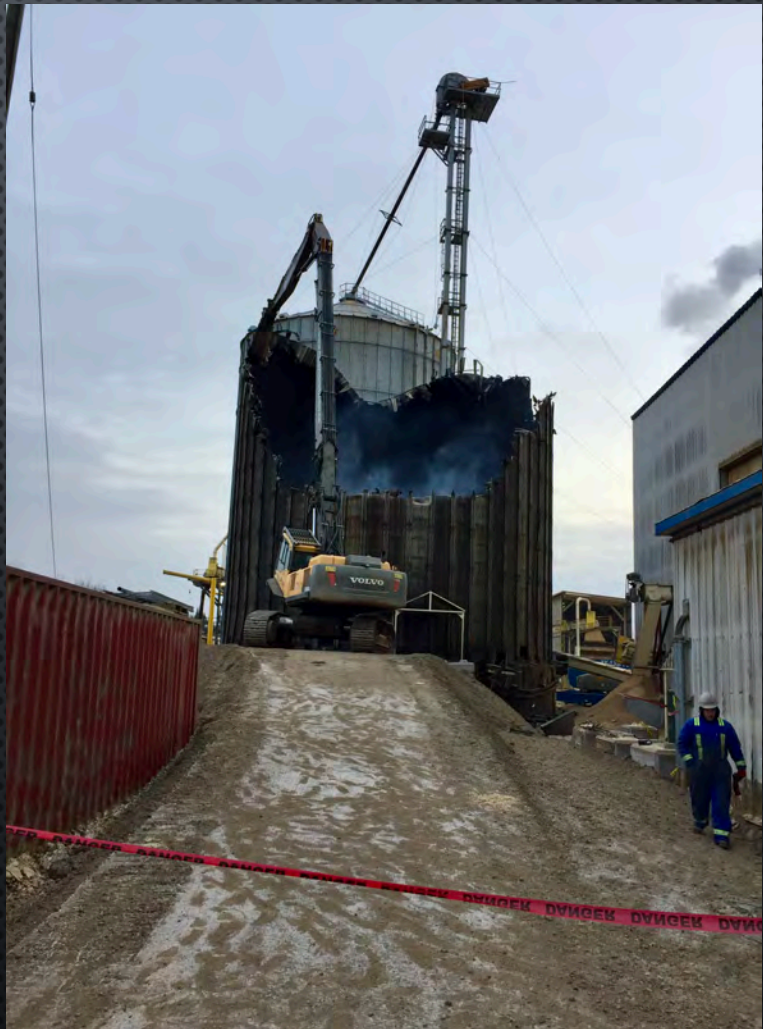
# DEMOLITION OF DAMAGED SILO DURING OPERATIONS
