SAFE WOOD PELLET STORAGE WORKSHOP

Case Studies on Major Incidents that Resulted from
Runaway Self-Heating Consequences and Lessons
Learnt

Presented by John Swaan – Operations Expert-FutureMetrics

Daigas Case Study: Silo Fire at Sodegaura Biomass Power Plant

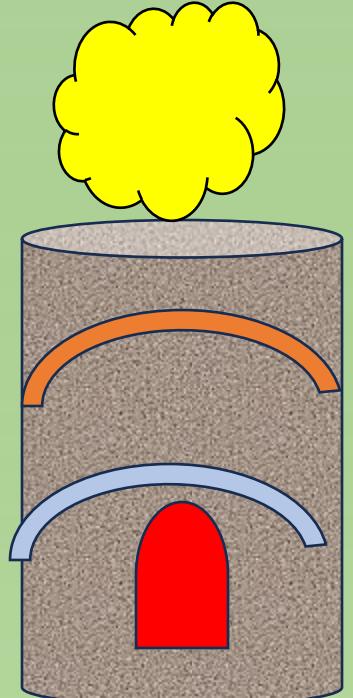
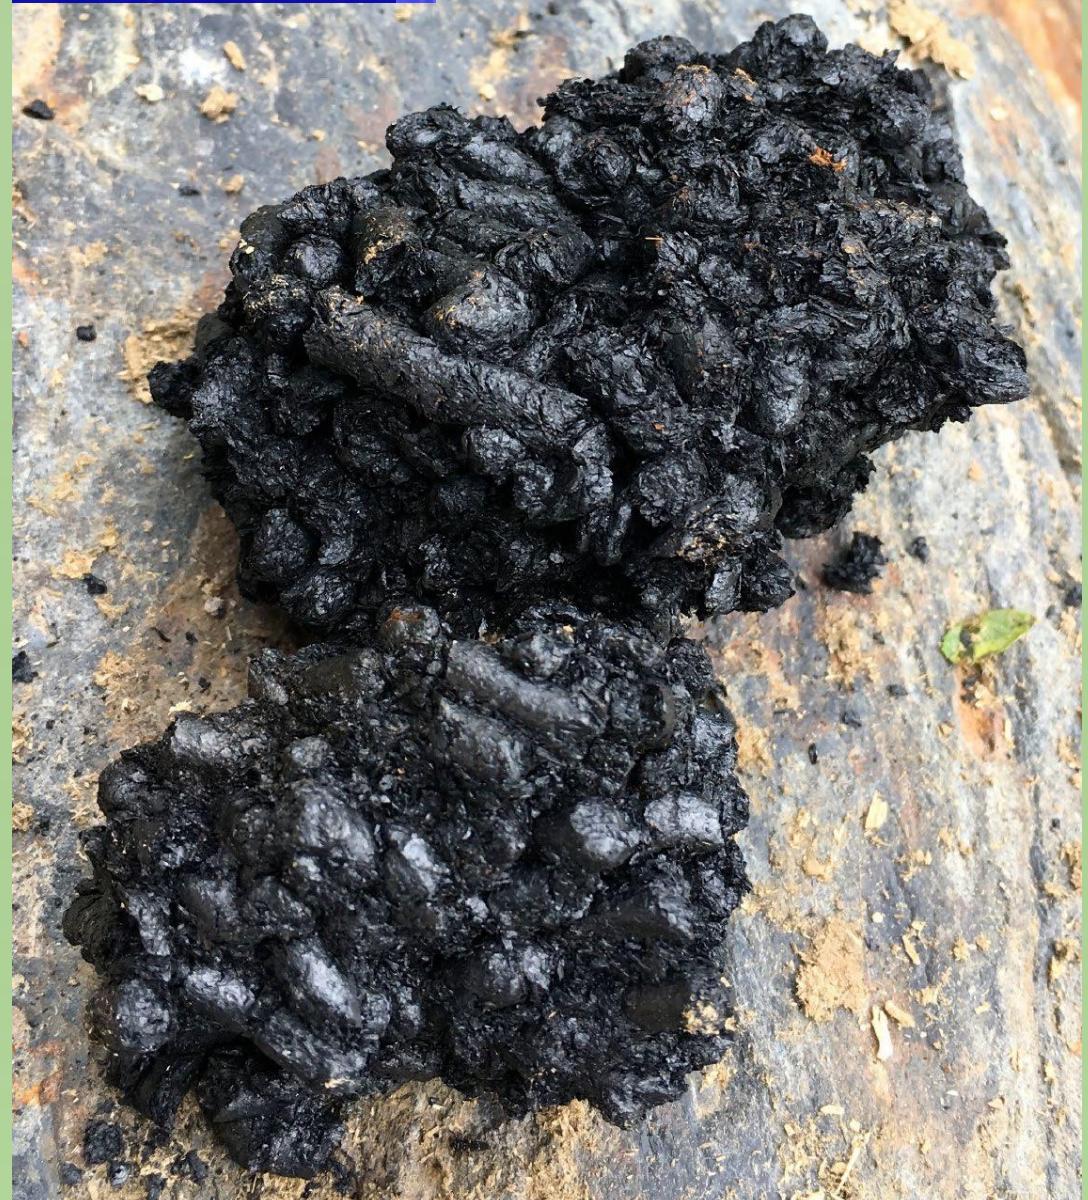
So what caused the explosion???

- Pyrolysis of the smoldering pellet generate CH4, CO, CO2, H2 gases.
- Lowering (aborting) the level of wood pellets in silo down to the smoldering pellets allowed O2 to make contact with the smoldering pellets releasing CH4 causing the ignition and subsequent explosion.
- Smoldering pellets glue together and become clumps that cause bridging and blockage when aborting the silo

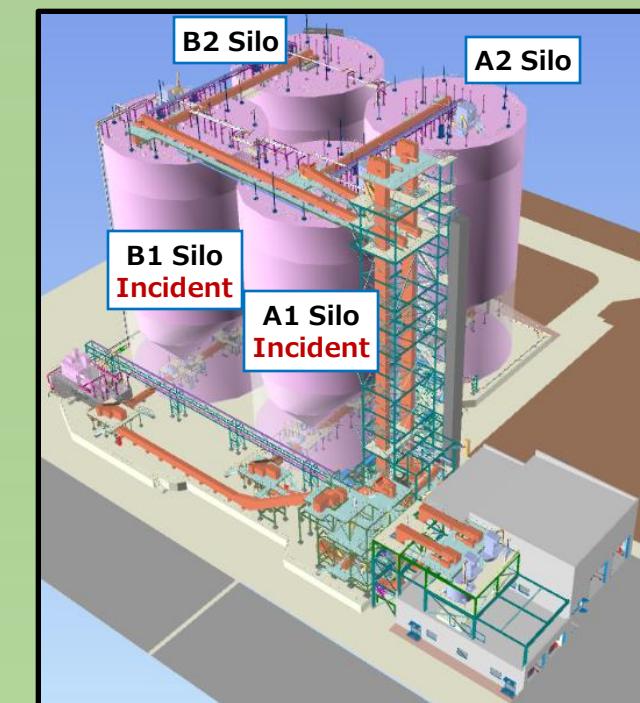
Date	Time	Events
Dec.31, 2022	8:58	The abnormal gas concentration in A1 silo was detected.
	night	Steam smoke from A1 silo was observed.
Jan.1, 2023	AM	A nitrogen lorry was arranged.
	12:30	N2 injection in A1 silo was started.
	22:00	N2 injection was stopped.
	22:12	White smoke was observed from A1 silo.
	22:31	Notify the fire department.
Jan.2, 2023	midnight	Water was sprayed inside A1 silo.
	morning	Nitrogen had been injected in A1 silo.
Jan.4, 2023	15:10	White smoke was observed from B1 silo.
		Nitrogen had been injected in each silos to calm down the

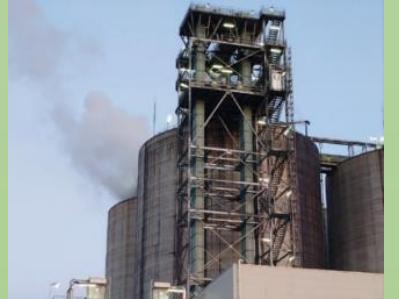
Jan. 6

- Internal condition of silo was checked using fixed-point photos and thermo-cameras.

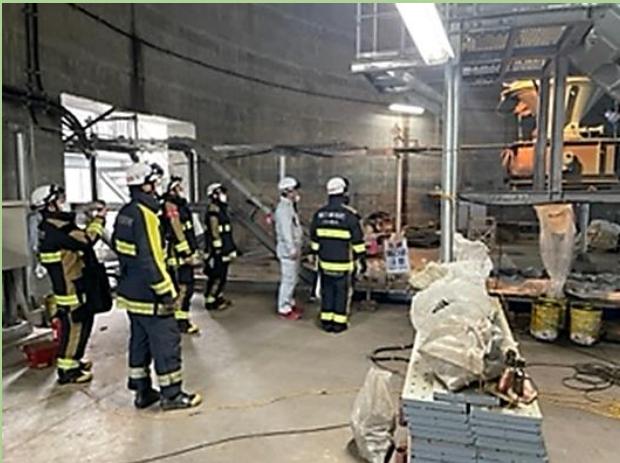
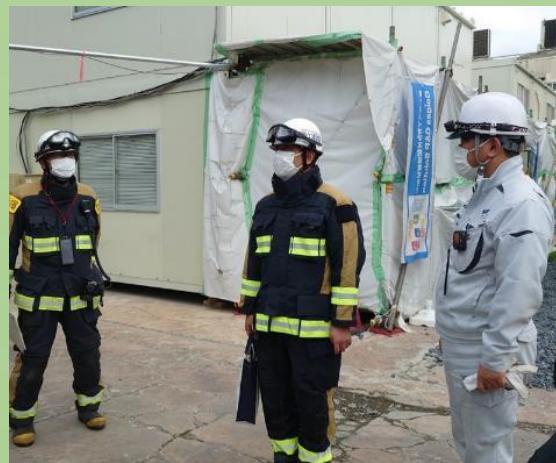
- On May 1, at 11:00 a.m., the fire chief of the Sodegaura City Fire Department inspected the storage site and the fire was declared extinguished.
- Emergency measures under Article 29 of the Fire Service Law were lifted during firefighting activities.

Inspection of the fire scene by the fire chief and declaration of extinguished

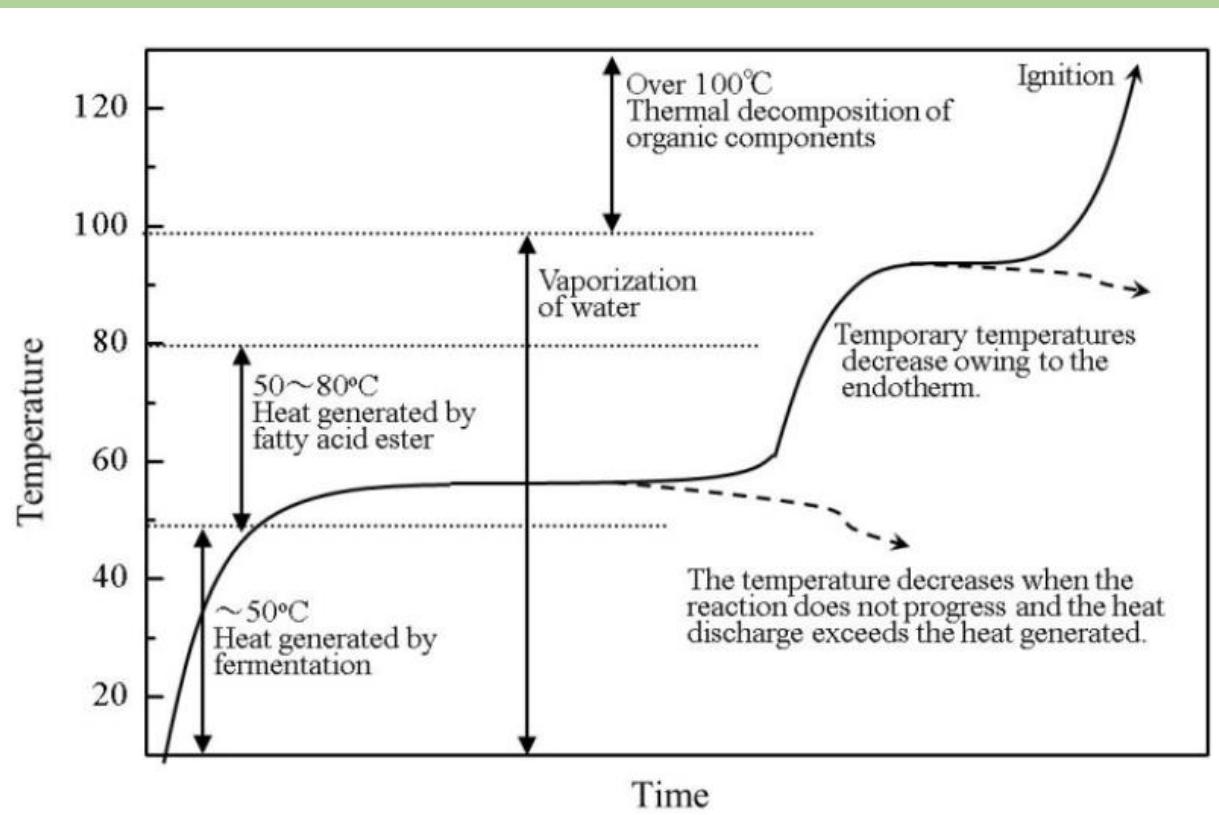
Figure 16. Combustion mechanism of biomass fuels.

When local moisture concentration occurs during wood pellet storage due to moist air inflow or condensation, heat of fermentation by microorganisms is generated, which, when stored, further generates heat through spontaneous oxidation and is considered to lead to ignition.

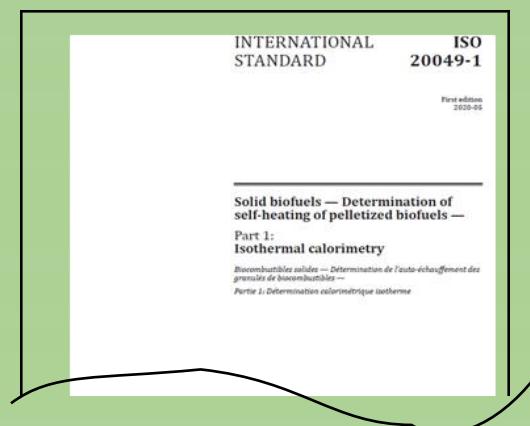
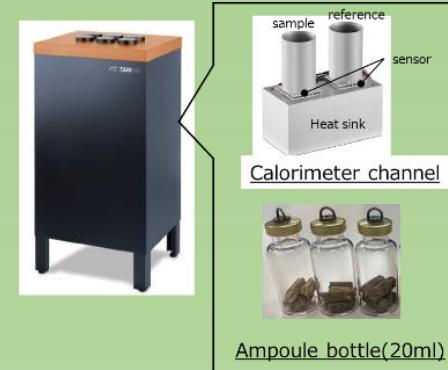
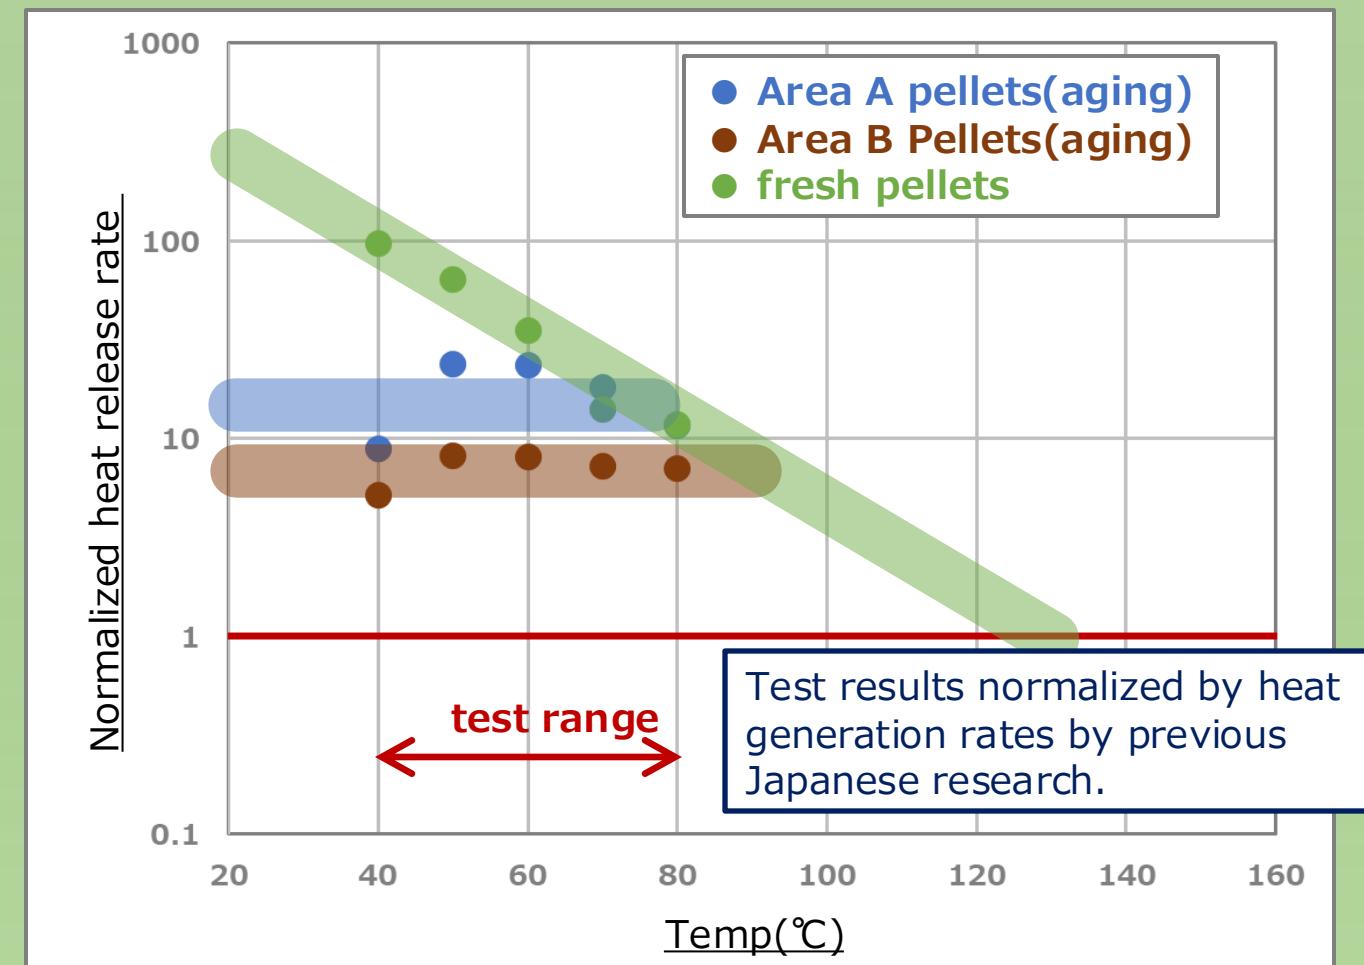
Experimental equipment
(Isothermal calorimetry)

Test Results : Self-heating characteristics of wood pellets

- Evaluated the self-heating characteristics of wood pellets based on ISO, and confirmed that the self-heating characteristics are 1~2 orders of magnitude higher than the previous findings in the low temperature range.
- Also, the self-heating property of **fresh** wood pellets was confirmed to be higher than that of stored pellets(**aging** pellets).
